## STAR ONLINE PUBLICATION

**Case Number:** S2008000056

**Symptom/Vehicle Issue:** Intermittently A No Crank No Start Condition Exists

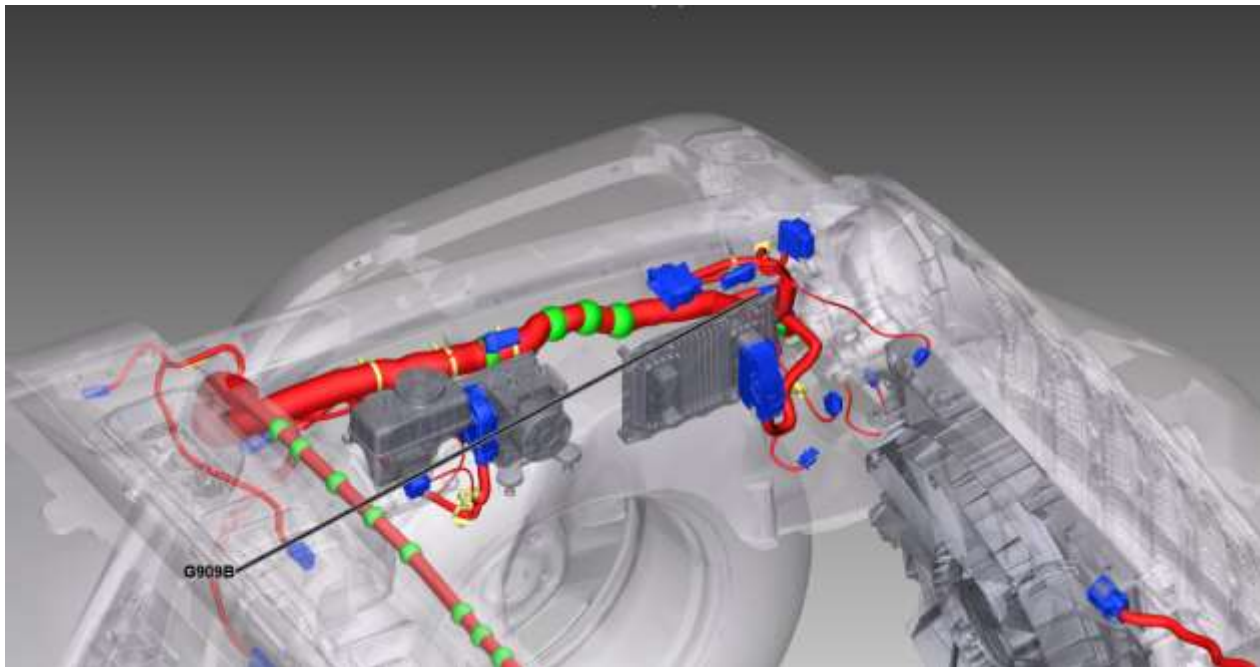
**G909B Location**

**Diagnosis:** Open the hood and inspect the G909B ground located within the upper front portion of left front fender. Physically inspect for a loose connection and potential corrosion at the ground stud.

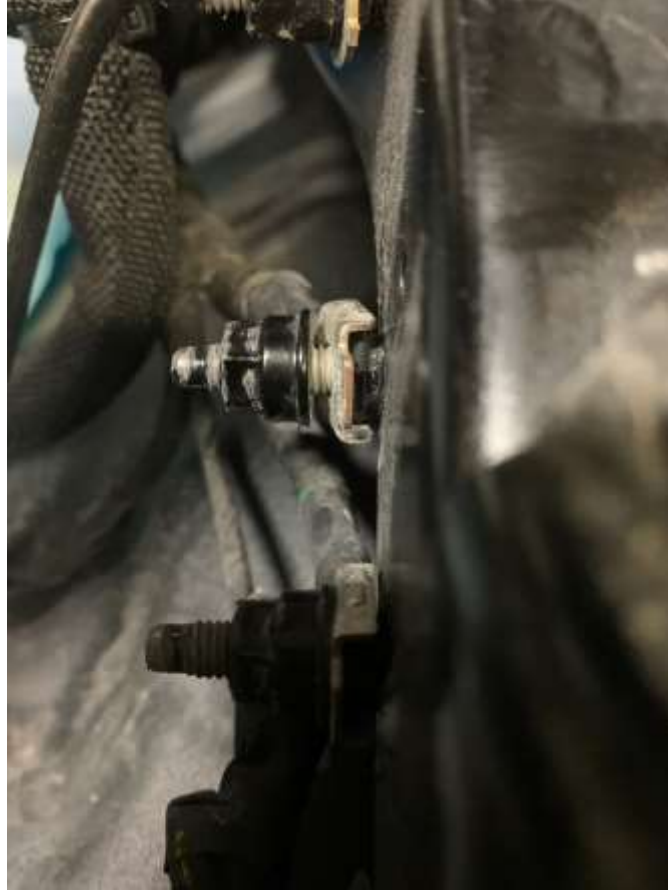
**Discussion:** A loose G909B ground may cause the engine to intermittently have a no crank no start condition.

**Loose G909B Ground Stud Nut**

**Repair:** Clean and tighten the G909B ground to secure the connection.
