STAR ONLINE PUBLICATION

Case Number: S2025000004

Symptom/Vehicle Issue: Customer complains of the MIL lamp on. Technician observes DTC P0456 EVAP System Small Leak or P0455 EVAP System Large Leak detected set in PCM.

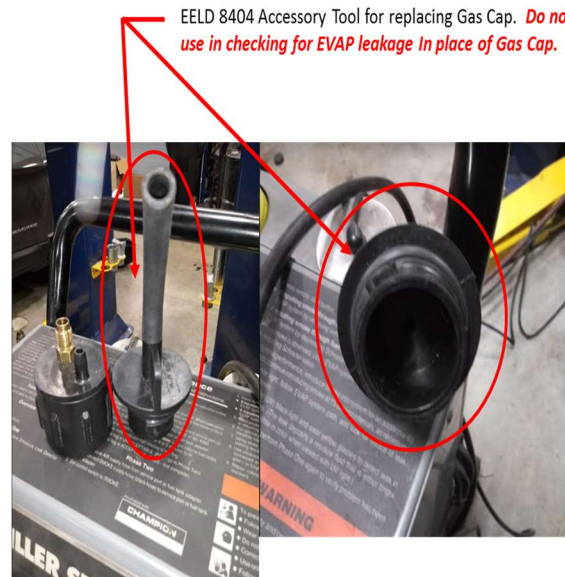
Fig. 1

Discussion: When performing the analysis for P0456 and P0455, need to run the wiTECH SLVT. After a confirmation of leakage is detected during the wiTECH SLVT, perform the EVAP Small Leak Verification test using the EELD 8404C smoke/air machine. When performing the wiTECH SLVT or using the EELD smoke/air machine do not remove the original gas cap for determining if an EVAP leakage is occurring. Using the EELD 8404 Accessory Tool shown in figure 1 in place of the gas cap could mask the EVAP leakage due to size of o-ring on the Accessory Tool.

By using the EELD 8404 Accessory Tool shown in figure 1, the leakage was not detected from the Fuel Filler Tube with a gouge in the sealing area of the Gas Cap, as shown in Figure 2.

Follow the Service Diagnostics for P0456 and P0455 to properly analyze the leak. For determining if the leakage is occurring in the gas cap area follow the directions in the *FUEL TANK SIDE EVAPORATIVE EMISSION LEAK DETECTION* section by setting the smoke switch on and connecting to the canister tube.
