NUMBER: 18-035-20

DATE: April 8, 2020

Fuel Vapor Hose Not Connected

2020	(WD)	Dodge Durango
2020	(WK)	Jeep Grand Cherokee

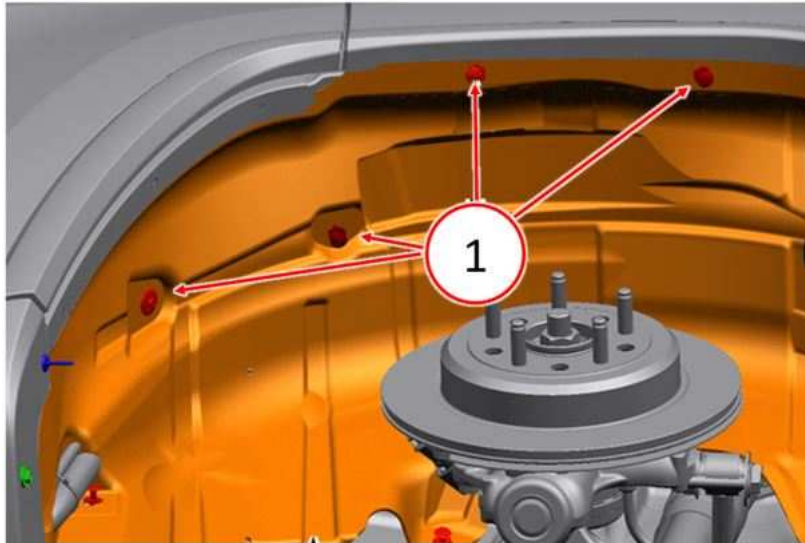
Fig. 1
Left Rear Wheel Well

3. Remove four pushpin retainers at the top of the wheel well (Fig. 1) .

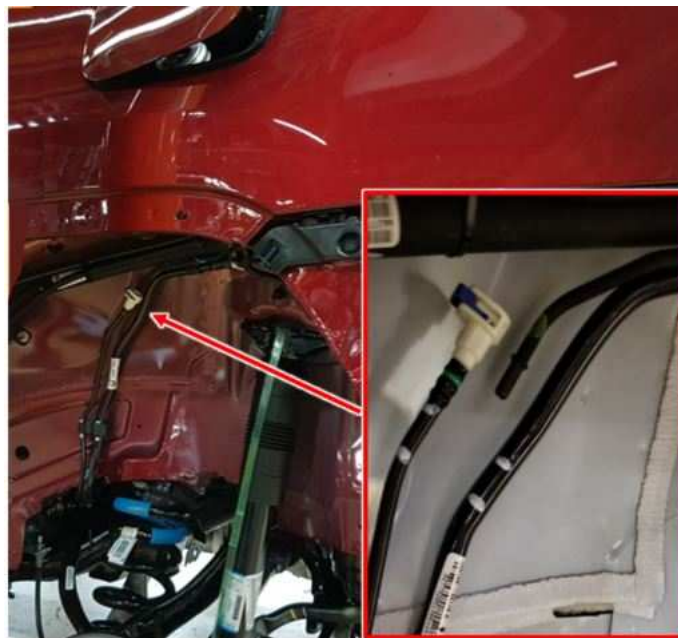
Fig. 2
Vapor Hose Location

4. Pull the top of the wheel well down to gain access to the vapor hose (Fig. 2) .

5. Is the vapor hose disconnected?
- YES>>> Proceed to [Step 1](#) of the Repair Procedure.
 - NO>>> This Bulletin has been completed. Use inspect LOP (25-01-17-95) to close the active RRT.

1. Connect and lock the quick connector. Refer to the detailed service procedure available in DealerCONNECT> Service Library under: 14 - Fuel System / Fuel Delivery, Gas / Fitting, Quick Connect / Standard Procedure
2. Reinstall the left rear wheel well, putting all four pushpin retainers back in.
3. Install the tire and wheel assembly. Refer to the detailed service procedure available in DealerCONNECT> Service Library under: 22 - Tires and Wheels / Wheels / Standard Procedure
4. Lower the vehicle.
5. Clear all DTCs that may have been set in any module due to this repair procedure.
