NUMBER: 08-045-20

Body Control Module (BCM) Reconfigure for Forward Collision Warning (FCW)

2020	(GA)	Alfa Romeo Giulia
2020	(GU)	Alfa Romeo Stelvio

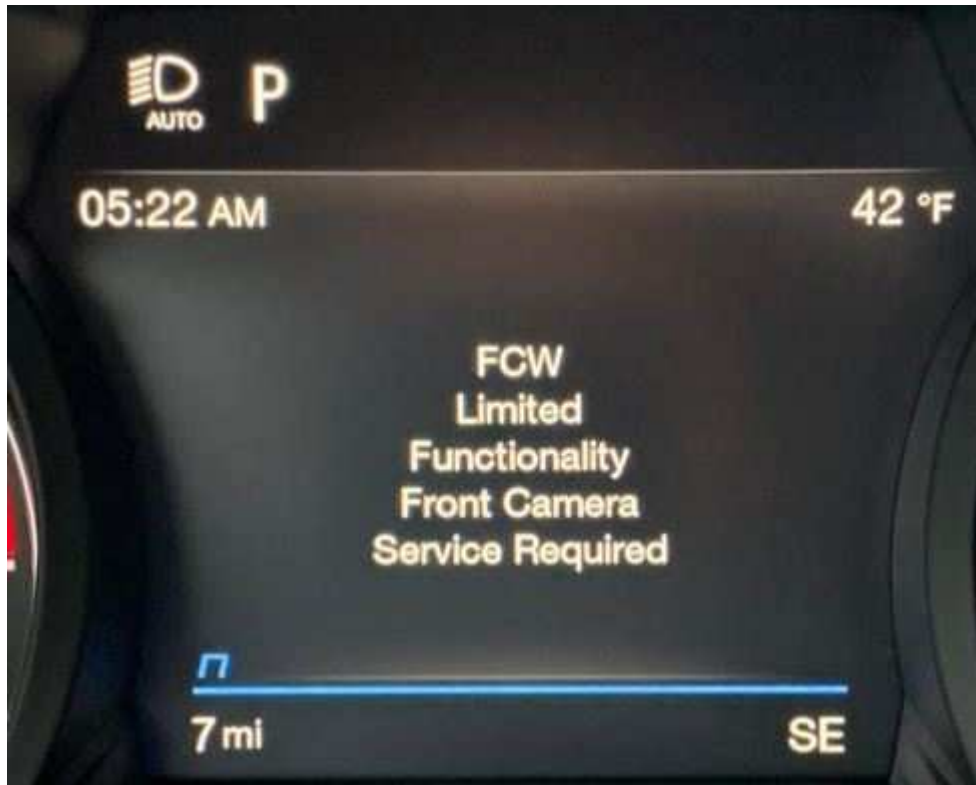
- The Electronic Vehicle Information Center (EVIC) displays "Forward Collision Warning (FCW) Limited Functionality Front Camera Service Required" (Fig. 1) .

Fig. 1
EVIC FCW Message

1. Using the scan tool (wiTECH 2), perform a "Restore Vehicle Configuration".
2. Perform a "Proxi Configuration Alignment".
3. DTCs will still be active. Cycle the ignition off, the back on and the codes should change from "Active" to "Stored".
4. Clear all DTCs that may have been set.
5. Remove the Micro Pod from the vehicle.
6. Cycle the ignition off, exit the vehicle, lock the doors and let the vehicle sleep for 10-15 minutes (**keep the FOBs away from the vehicle to ensure them from waking up the bus**).
7. Place the ignition in the on position and connect the (wiTECH 2). Verify the codes have not returned.
