NUMBER: 07-001-20 REV. A

Water Pump Inlet Tube Fastener Torque

2018 - 2020 (JL) Jeep Wrangler

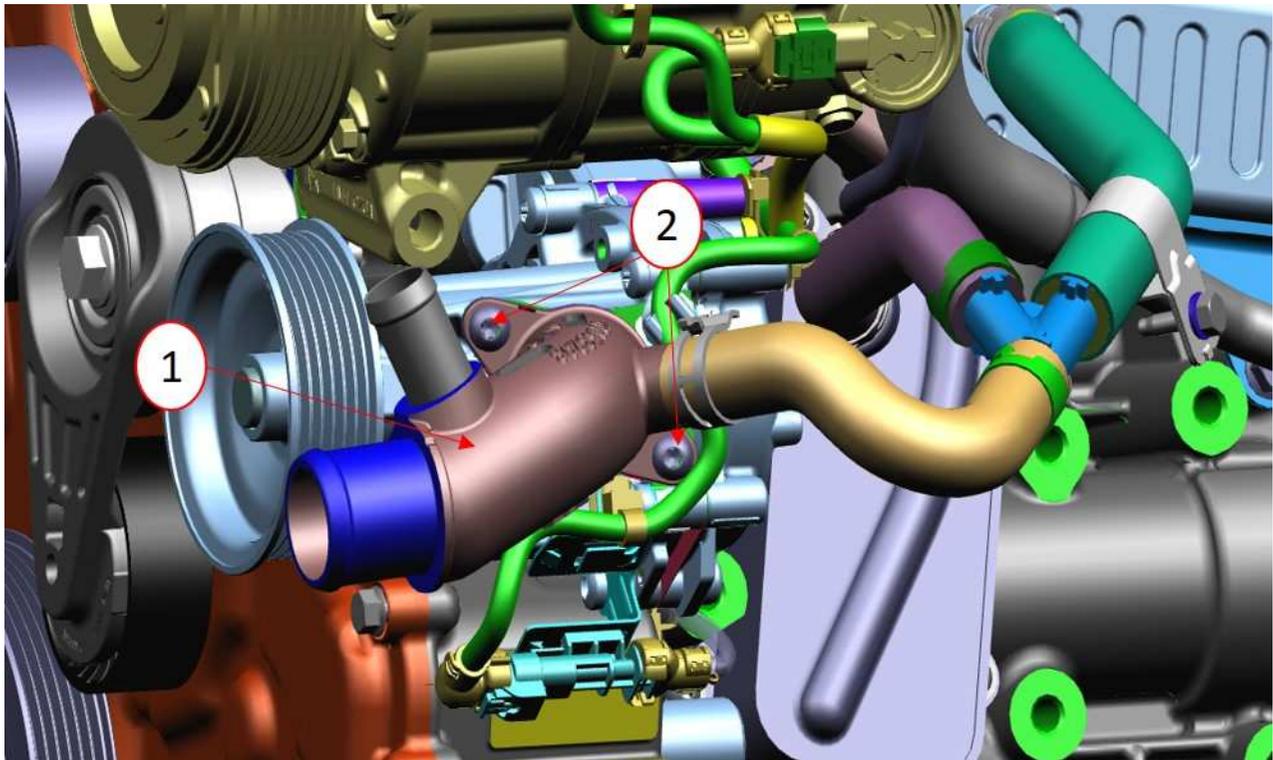
Fig. 1
Water Pump Inlet Tube Fasteners

1. Pressure check the coolant system. Refer to the detailed service procedures available in DealerCONNECT> Service Library under: Service Info>07 - Cooling / Diagnosis and Testing >Leak Testing>Pressure Tester Method.
2. Was coolant found to be leaking from the water pump inlet tube at the engine (Fig. 1) ?
 - YES>>> Proceed to [Step 1](#) of the Repair Procedure.
 - NO>>> Coolant was not leaking from this area. This Bulletin does not apply. Normal diagnosis should be performed.

1. Torque the water pump inlet tube fasteners to exactly 11 N·m (97 in. lbs) (Fig. 1) .

2. Pressure check the coolant system. Refer to the detailed service procedures available in DealerCONNECT>Service Library under: Service Info>07 - Cooling / Diagnosis and Testing >Leak Testing>Pressure Tester Method.
3. Is coolant still leaking from the water pump inlet tube at the engine (Fig. 1) ?
 - YES>>> Further diagnosis should be performed.
 - NO>>> This bulletin has been completed.
