NUMBER: 08-048-20

GROUP: 08 - Electrical

DATE: April 18, 2020

UAX, UCX, UAV and UCV Radio Over the Air Software Version Updates

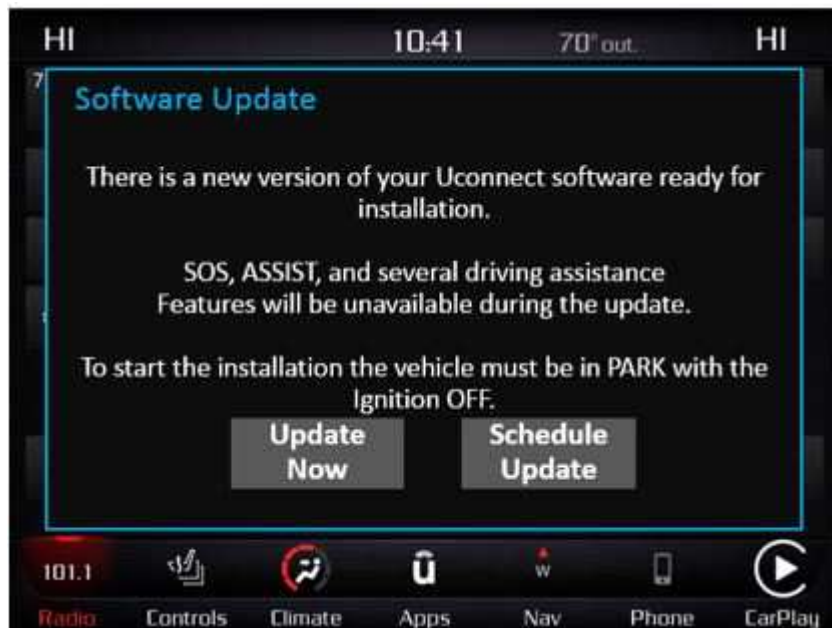
Fig. 1
Software Acceptance Screen

Vehicles sold in the U.S. and Canada can now receive software updates "over-the-air". Updates to software will occur in a phased roll-out. The software is updated through the built-in cellular modem in the radio. Customers will see a notification on their radio screen when new software is available for their radio (Fig. 1). The owner will have the option to update the radio or schedule the update for later. There is not an option to decline the update indefinitely, the update must be performed.

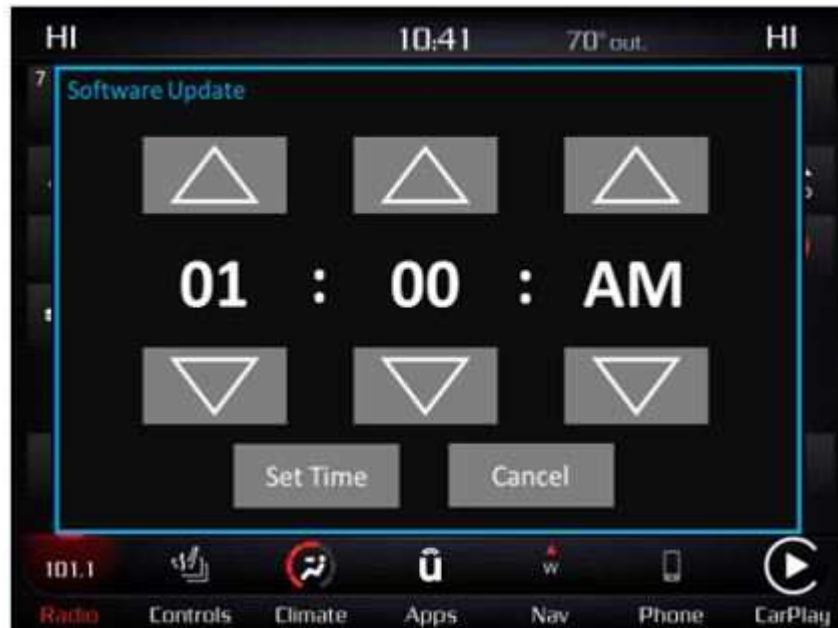
Fig. 2

NOTE: If selecting “Schedule Update” the screen below will be displayed. The customer can select the exact time they want the update to begin (Fig. 2) .

Schedule Update Screen

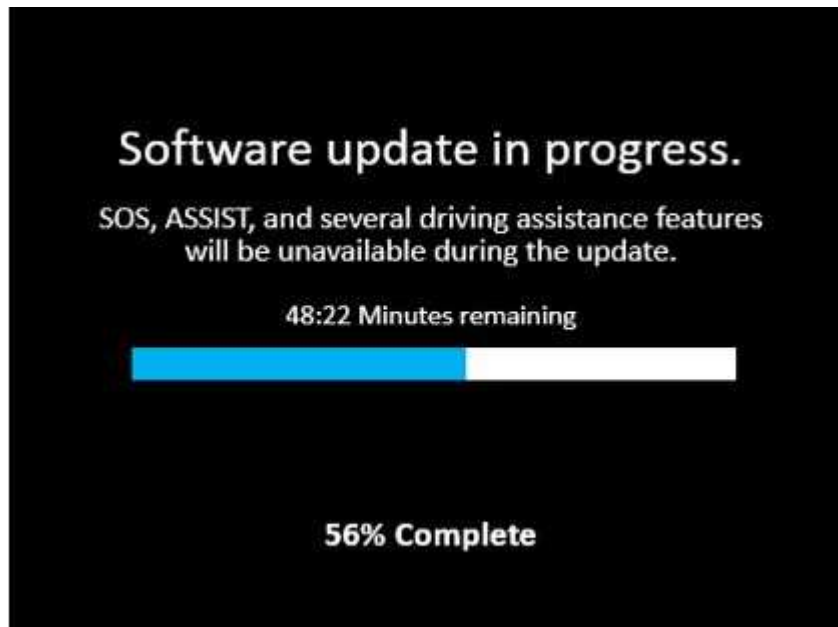
Fig. 3

1. The vehicle needs to be in the park position, or have the vehicle in neutral with parking brake engaged if equipped with a manual transmission. The ignition needs to be off.
2. Whether the customer selects “Update Now” or “Schedule Update” and sets a time, they can shut off the vehicle and leave. The update will be completed automatically (Fig. 3) .

Update In Progress Screen

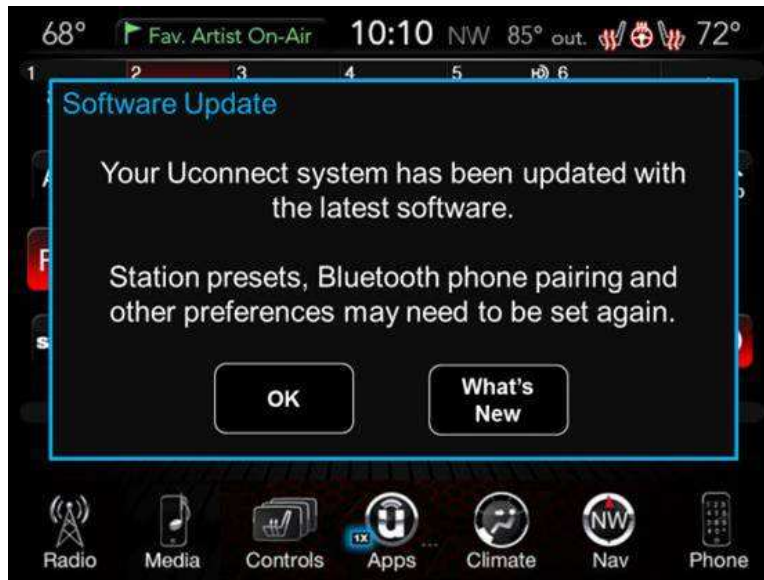
Fig. 4
Confirmation Screen

3. Upon completion of update, the radio will display a confirmation message (Fig. 4) .
