Service Bulletin

Bulletin No.: 17-NA-102

Subject: Active Shutters Inoperative, Malfunction Indicator Lamp (MIL) Illuminated - DTCs P059F, U1501, U1510, U1511 Set

Brand:	Model:	Model Year:		VIN:		Engine:	Transmission:
		from	to	from	to		
Cadillac	ATS	2016	2017				
	CTS

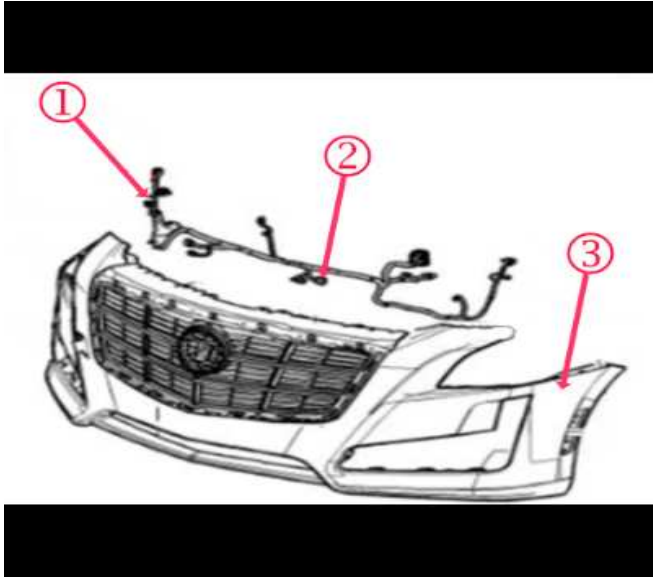
5573103

5. Verify condition and the integrity of the connection of front fascia harness to headlamp wire harness (1) and shutter actuator (2).
6. If required, replace the front fascia harness.

- If the shutter operation has failed testing, proceed with the procedure.
3. Follow SI diagnostics for set DTC.
4. Remove the front bumper fascia (3). Refer to the appropriate *Front Bumper Fascia Replacement* in SI.

7. Reinstall the front bumper fascia. Refer to the appropriate *Front Bumper Fascia Replacement* in SI.
8. Verify proper shutter operation.
 - If the active shutters wiring harness has been found not to be the cause of the DTCs set, refer to SI for further diagnostics.
