Service Bulletin

Bulletin No.: 18-NA-020

Subject: Malfunction Indicator Lamp Illuminated with DTC P0300 and/or P0299/P2227 Set

Brand:	Model:	Model Year:		VIN:		Engine:	Transmission:		
		from	to	from	to				
Buick	Envision	2016	2020	-	-	Equipped with 2.0L Engine (RPO LTG)	All		
Chevrolet	Equinox	2018							Equipped with 2.0L or 1.5L Engine (RPOs LTG, LYX)
GMC	Terrain

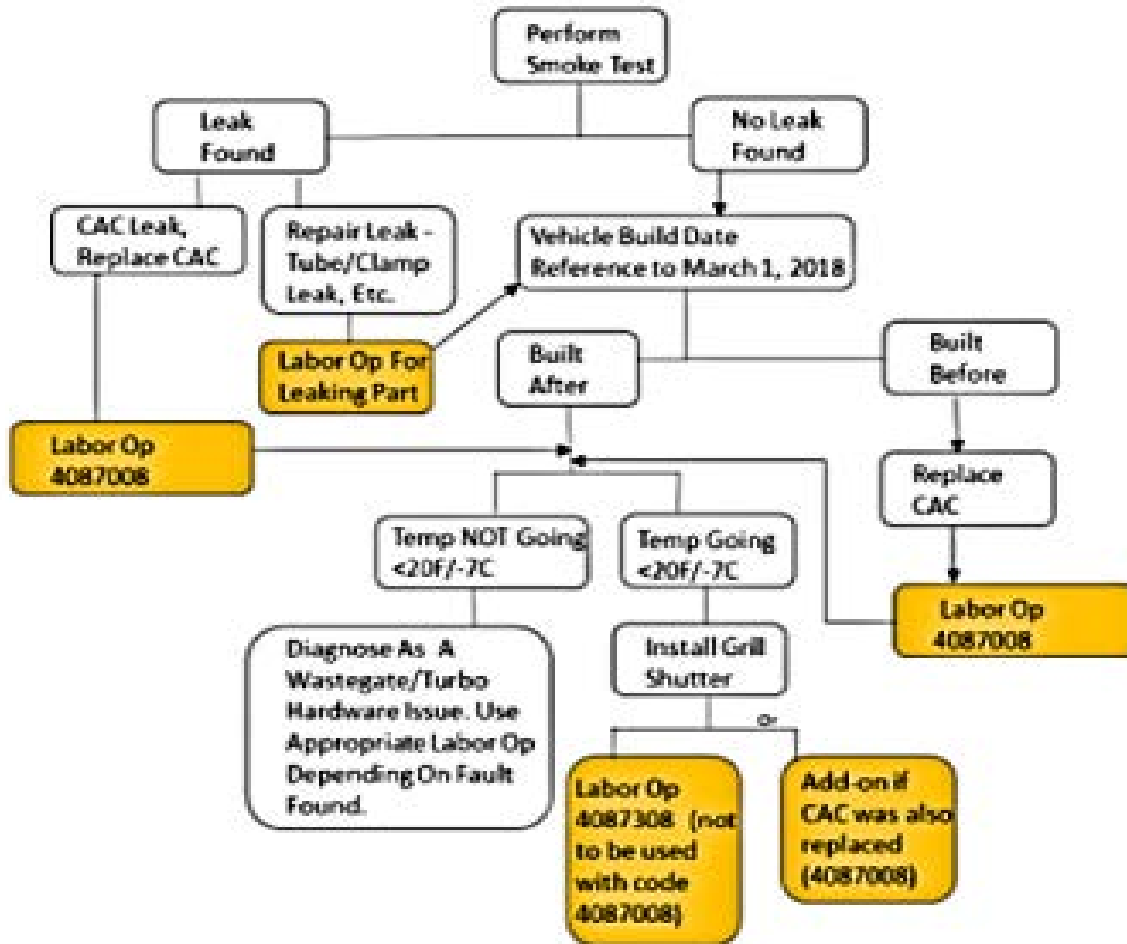
DTC P0299 (with or without P2227) Equinox and Terrain

Involved Region or Country	U.S. and Canada
Condition	Some customers may comment on a malfunction indicator lamp illuminated. During diagnosis, a technician may find DTC P0299, P2227, or P0300 set/stored.
Cause	This condition may be caused by a moisture build up inside the charge air cooler. Long drives through rainy conditions and/or high humidity conditions (heavy fog) can cause moisture to collect in the charge air cooler. A heavy acceleration can draw moisture into the engine causing DTC P0300. In cold temperatures, ambient and PCV moisture can freeze in the charge air cooler, restricting flow, and causing DTC P0299 and/or P2227.
Correction	Perform a smoke leak test of the charge air cooler, then follow the repair steps in the appropriate Service Procedure below, depending on the build date and vehicle outside temperature experience. Note: Charge Air Cooler Shutter is only to be used in northern states or provinces where temperatures are consistently 20°F/-7°C or less in the winter. Note: In rare cases where the addition of a charge air cooler shutter doesn't prevent CAC freezing, install the lower portion of the soft grill cover. Remove cover from the grill when temperatures are consistently above 20F/-7C.

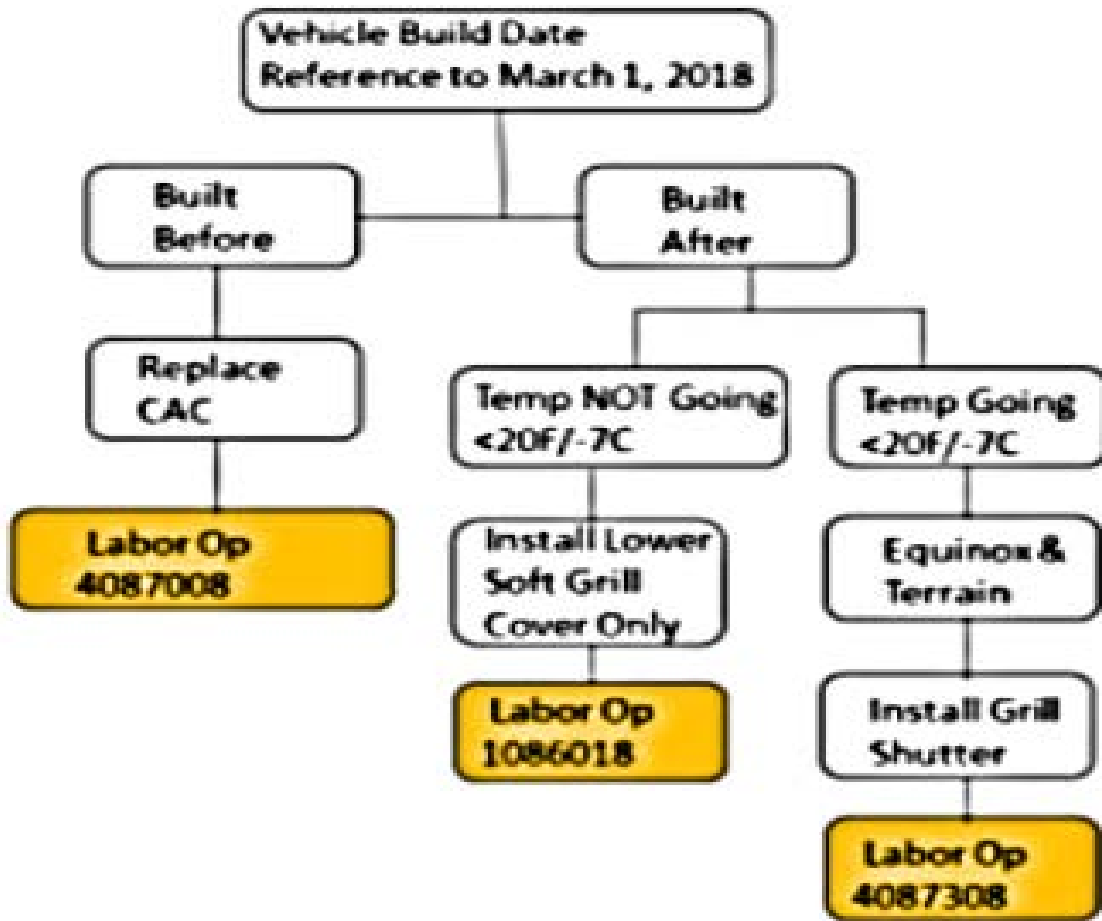
Important: In warmer climates with high humidity, P0300 may be set during extended highway driving due to the condensation of moisture in the charge air cooler. Installing the lower portion of the soft grill cover will help

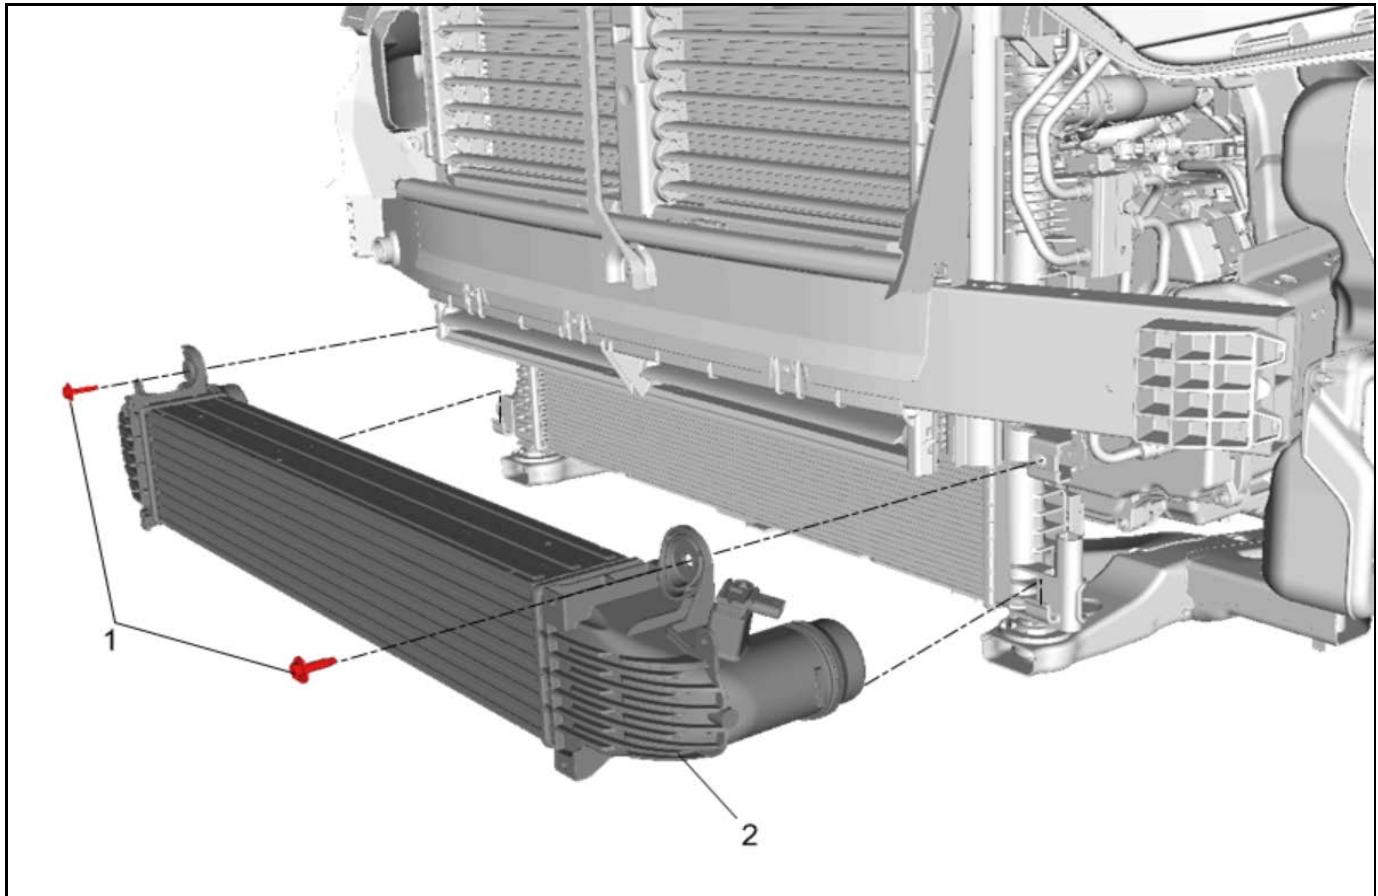
4597334

Important: The newly designed charge air cooler is wider and is **NOT** compatible with the existing lower baffle on the vehicle. The baffle will need to be replaced to accommodate the larger charge air cooler.

1. Perform a smoke leak test of the charge air cooler.

- If a leak is determined, replace the charge air cooler with the newly designed part. Refer to *Charge Air Cooler Replacement* in SI.
- If there is NO leak, but a P0300, P0299 and/or P2227 are present, **AND the vehicle was built ON or BEFORE January 5, 2019**, then replace the charge air cooler with the newly designed part. Refer to *Charge Air Cooler Replacement* in SI.
- If there is NO leak, but a P0300, P0299 and/or P2227 are present, **AND the vehicle was built AFTER January 5, 2019**, refer to SI for further diagnosis.
