Service Bulletin

Bulletin No.: 18-NA-383

Subject: Water Found in Rear Interior of Cab, Water Leak at Rear Sliding Window

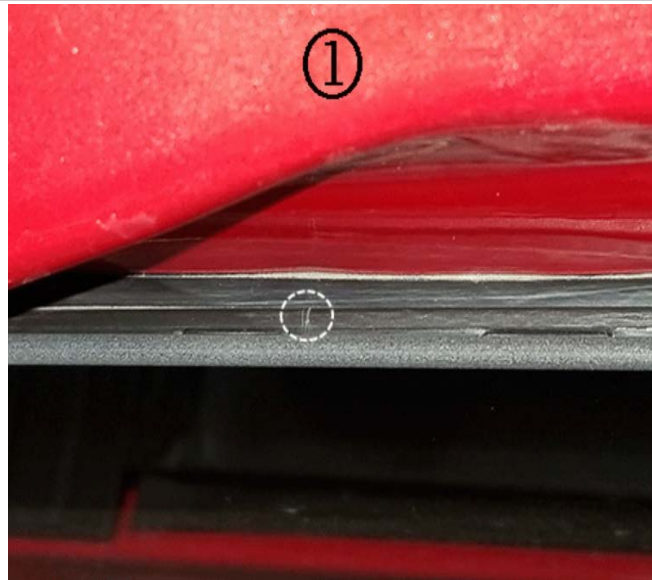
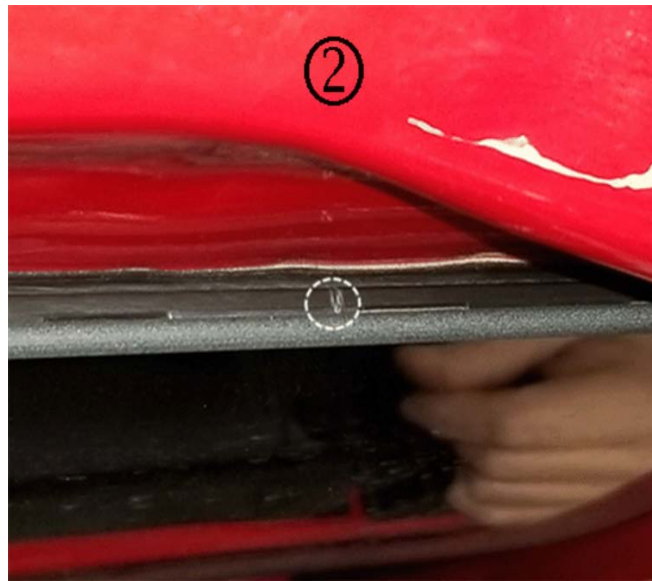
Note: The cracks can be in the left and/or right side of the rear sliding window plastic upper rail glass guide which is covered by the roof rear spoiler. Examples of a left (1), then right side (2) visual crack (with the spoiler removed) are shown in the graphics above.

The cause of the condition may be cracking in the rear sliding window plastic upper rail glass guide. The plastic upper rail glass guide may develop small fractures/cracking which allows water to pass through on the glass side of the urethane that attaches to the vehicle body.

R & R the roof rear spoiler and apply seam sealer to the rear sliding window top encapsulate, following the steps in the Service Procedure below.
