Service Bulletin

Bulletin No.: 19-NA-035

Subject: 8L45, 8L90 Park System Does Not Engage

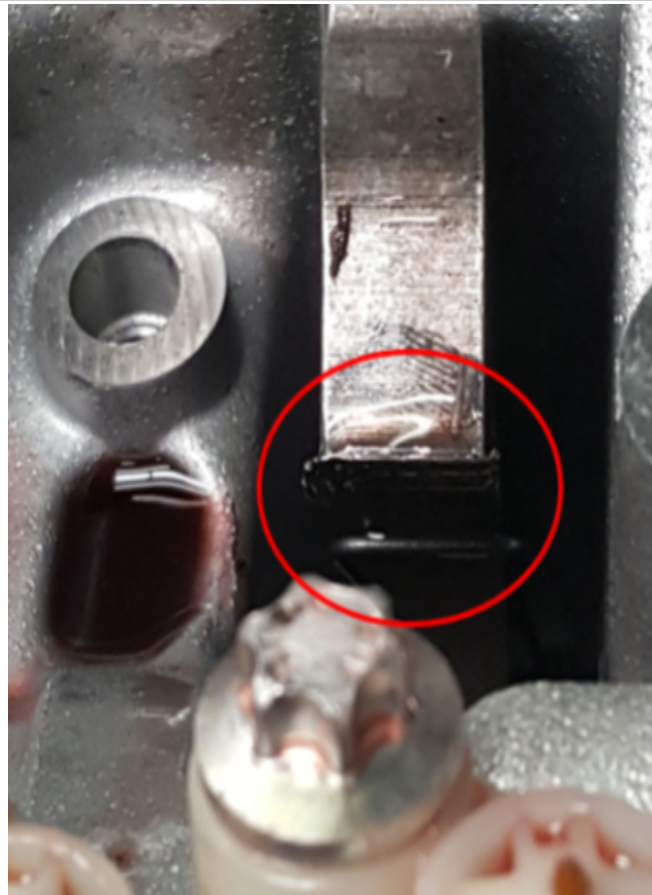
5247435

8. Inspect the park pawl for damage.

⇒ If damage to the Park Pawl Actuator and Park Pawl is present as described above, replace the following components:

- Park Pawl Actuator
- Park Pawl
- Main Shaft Detent Lever Hub Pin
- Park Pawl Actuator Bracket
- Park Pawl Actuator Bracket Bolts
- Output Carrier
