Service Bulletin

Bulletin No.: 19-NA-076

Subject: Blue Screen and Service Rear Vision System Message on Radio Display

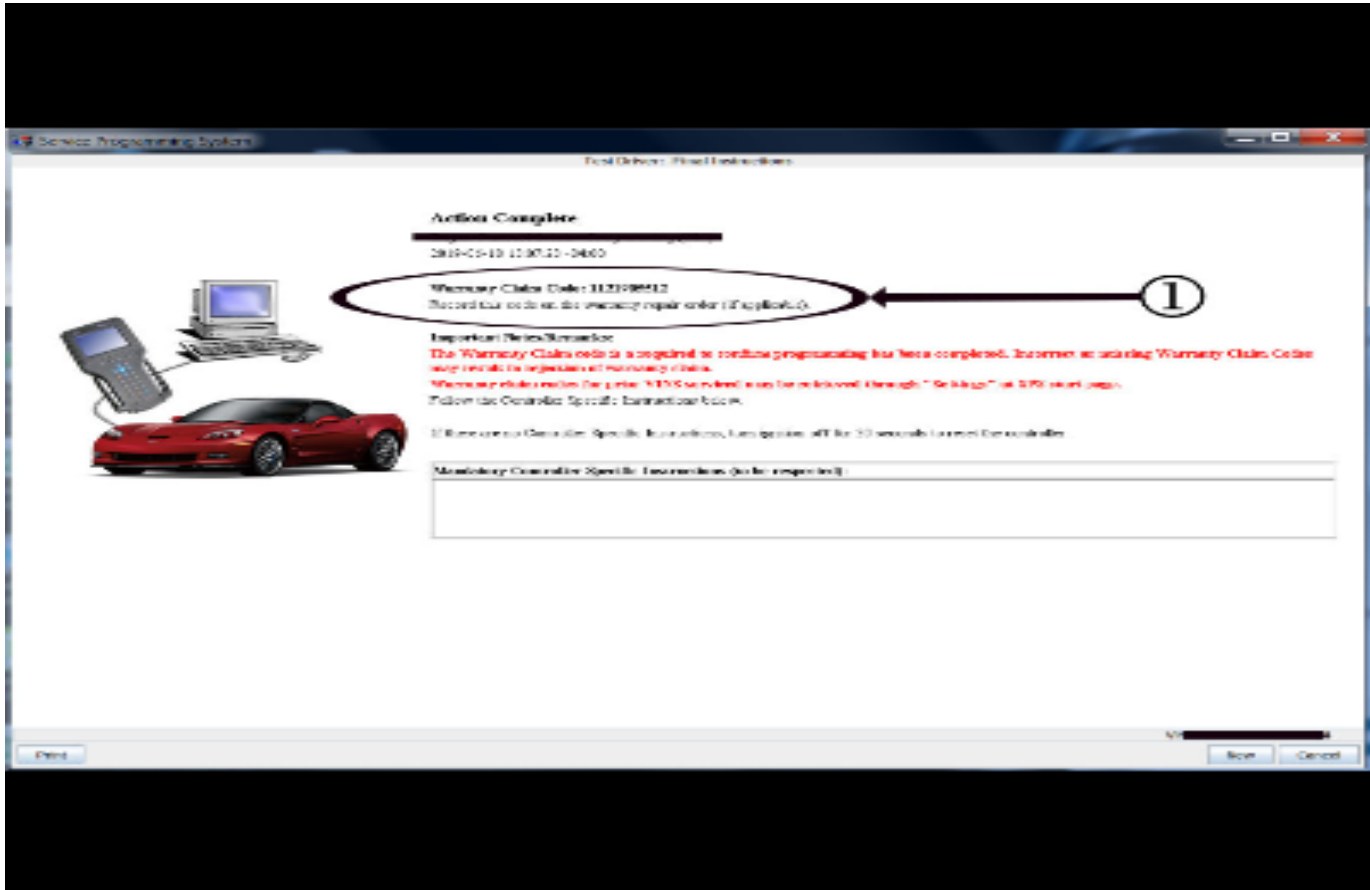
5431209

Important: TIS2WEB screen shown. Techline Connect screen is similar and will be included soon.

Important: To avoid warranty transaction rejections, you **MUST** record the warranty claim code provided on the SPS Warranty Claim Code (WCC) screen on the job card. Refer to callout 1 above for the location of the WCC on the SPS screen.

2. Record the SPS Warranty Claim Code on the job card for warranty transaction submission.
