Service Bulletin

Bulletin No.: 19-NA-084

Subject: Ground Effects Fit Issue at Rear Fascia Accessory Valance (Rear Diffuser)

Brand:	Model:	Model Year:		VIN:		Engine:	Transmission:
		from	to	from	to		
Chevrolet	Camaro	2019	2020			All	All

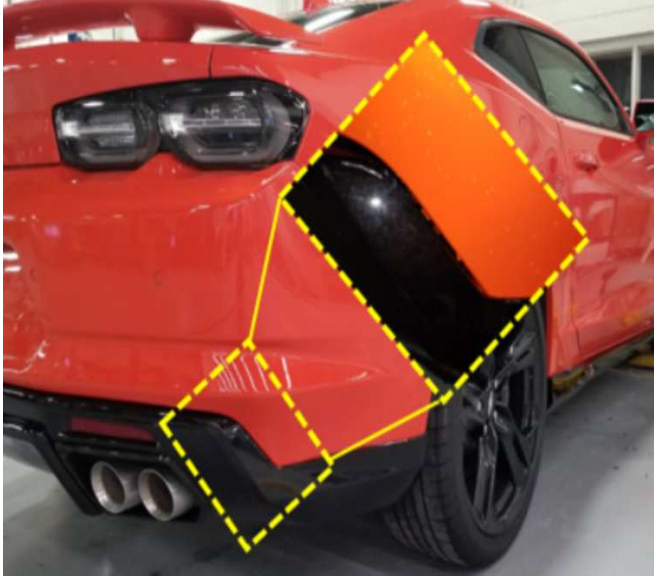
<p style="text-align: right;">5317583</p> <p>For vehicles with ground effects installed, customers may comment on seeing a fit issue on the rear fascia accessory valance (rear diffuser). They most specifically point out gaps at the areas on each side of the vehicle, where the diffuser and fascia interface, as shown above.</p>
Cause	The cause of the condition may be slight build variation between the rear diffuser and rear fascia.
Correction	This can be corrected by adjusting the fit of the rear diffuser to bumper fascia. Follow the Service Procedure below.
