# Service Bulletin

Bulletin No.: 20-NA-012

**Subject:** Radio Software Version V135116 Over-the-Air Update

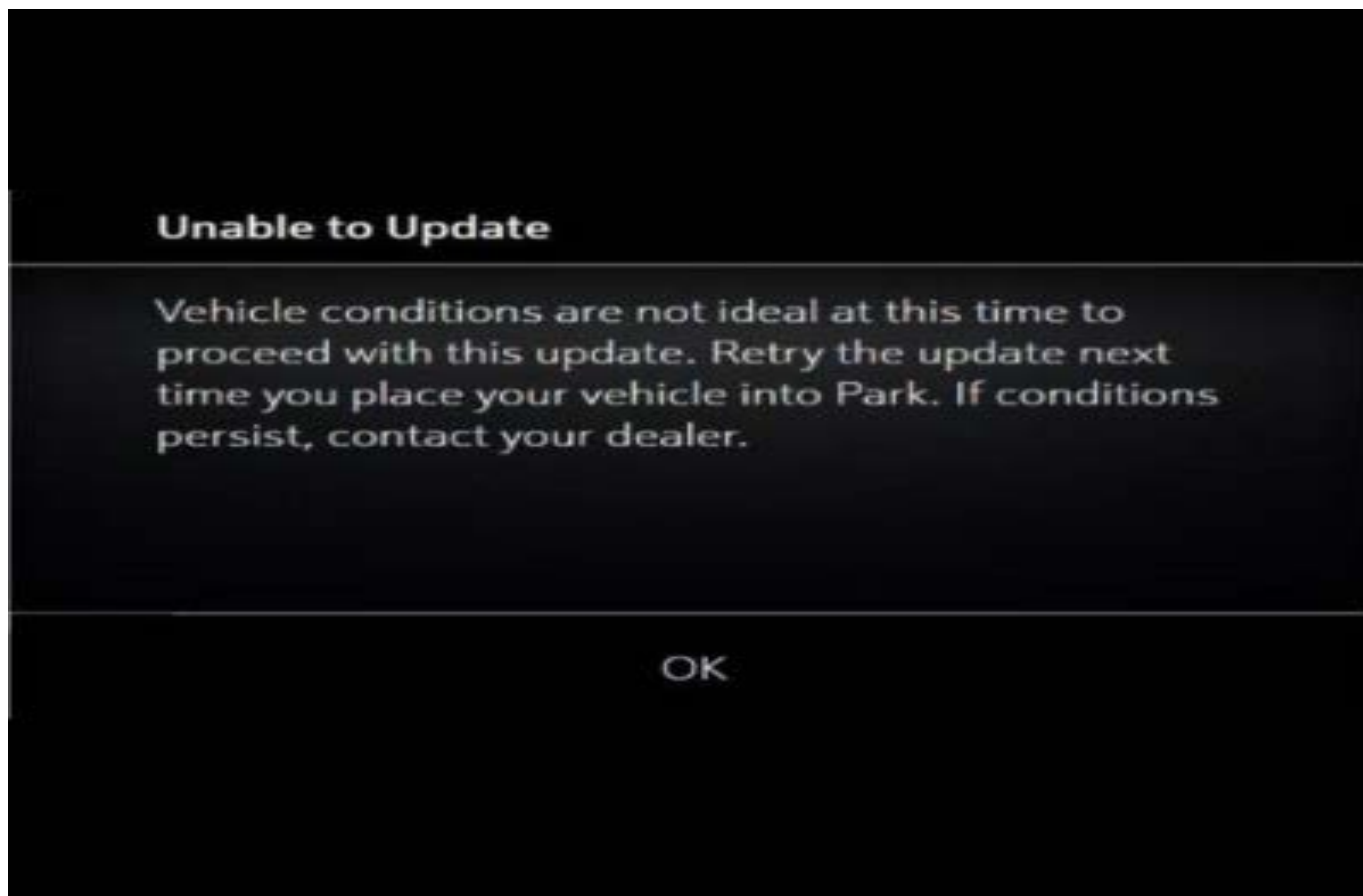
5495032

**Scenario 1:** Vehicle conditions are not ideal.

If the above screen is shown, download the update through TIS2Web and perform USB update. Ensure the vehicle battery is being maintained (using EL-49642 or battery maintainer) while performing this update.

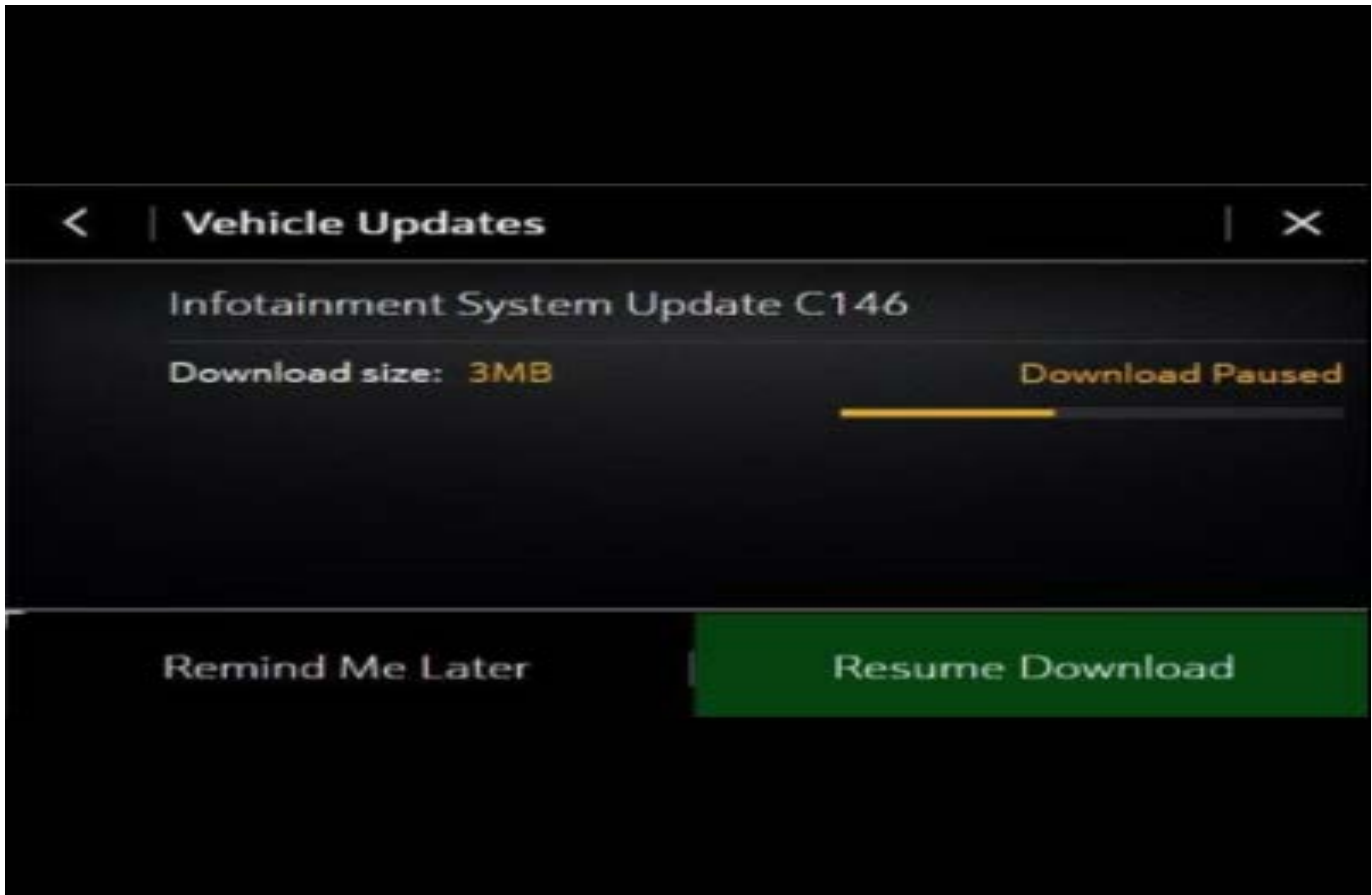
5494724

**Scenario 2: Consistently Paused Download**

If the above screen is shown and resuming the download repeatedly fails, a USB update will need to be performed. Turn the vehicle on, return to the home screen, and insert USB stick (see previous section). Verify the part number is correct and follow on screen prompts.

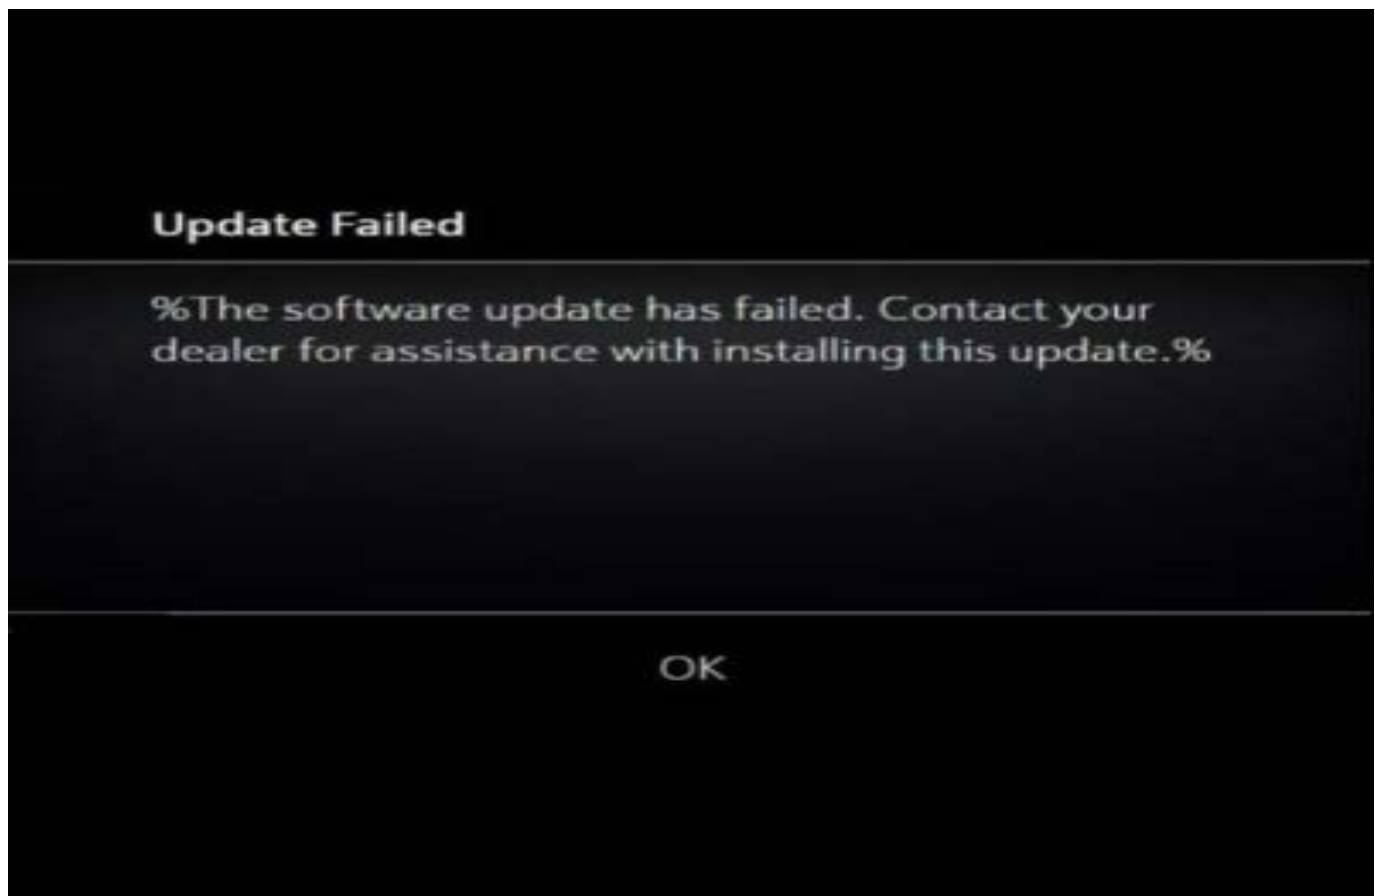
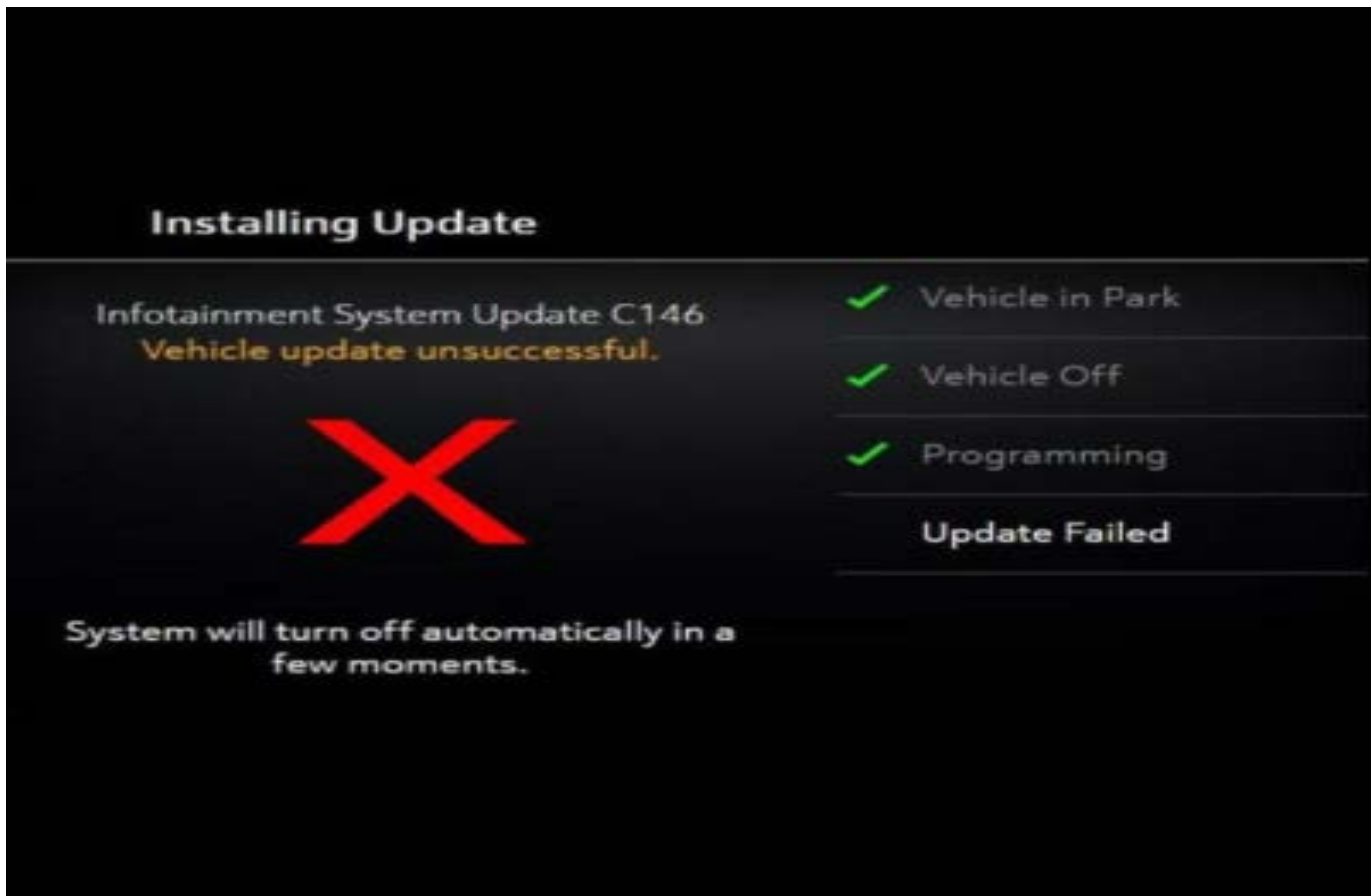
5494708

**Scenario 3:** Update Failed. Return to dealer screen.

If one of the above screens is shown, download the update through TIS2Web and insert a USB stick into the radio. A yellow progress bar should come on the screen and the update will proceed. If this screen above is shown when trying to update the radio through USB, reformat the USB drive to FAT32 on your PC, perform Return to Factory Defaults, and then try to download the update through TIS2WEB again.
