Service Bulletin

Bulletin No.: 20-NA-047

Subject: Front or Rear Crankshaft Oil Leak, Malfunction Indicator Lamp (MIL) Illuminated - DTC P1101 Set

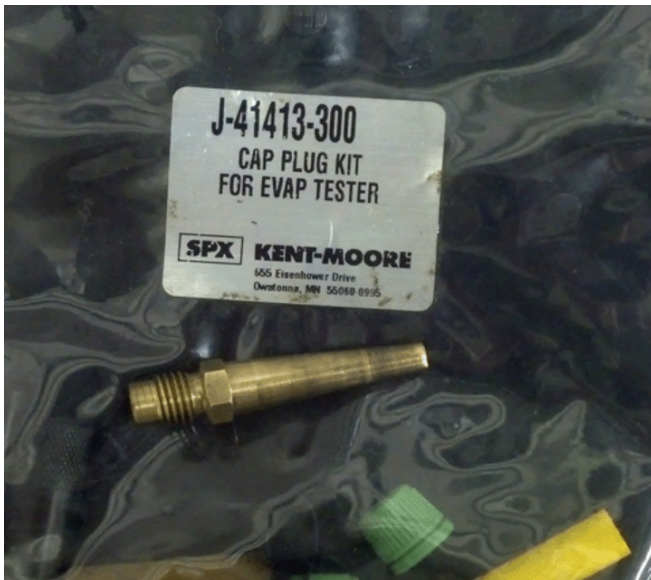
3416804

EEST hose adaptor

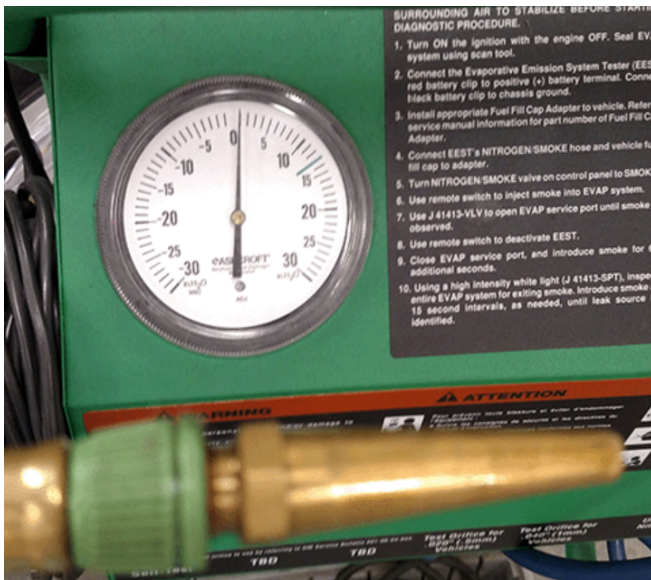
4573240

EEST Gauge at 0 reading

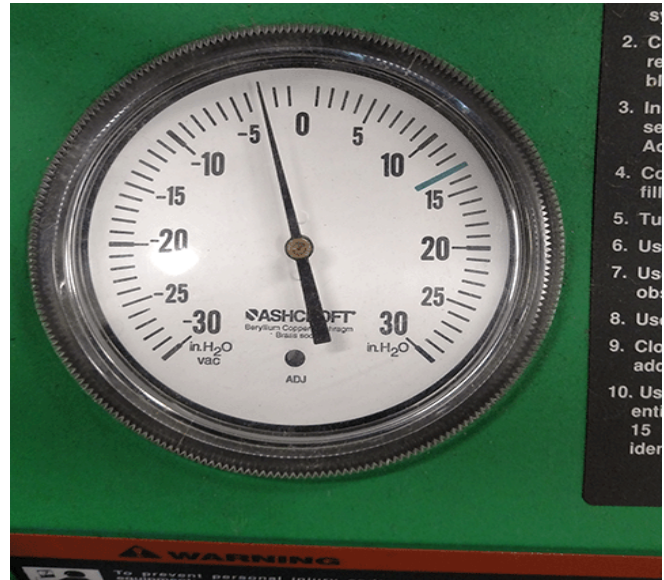
4573243

Normal crankcase pressure readings for the L3A, LE2, LFV and LYX are between -1 & -5 inches of water in park at hot idle.

- If the crankcase pressure is in the proper range, follow Strategy Based Diagnostics for engine oil leaks and/or P1101 per SI.
- If the crankcase pressure is excessively positive, above 0 inches of water (0 inches of HG / vacuum), then a positive crankcase pressure concern exists requiring further diagnostics.

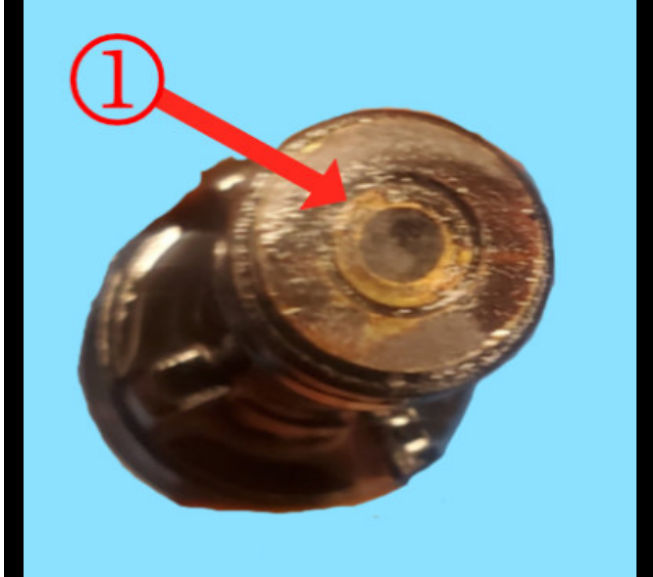
5513764

If diagnosing for oil leaks and/or DTC P1101 with no engine oil leaks and excessive positive crankcase pressure exists, an obstructed PCV orifice (1) would be suspect requiring a PCV orifice replacement.

Remove the camshaft cover and remove the PCV orifice and inspect for blockage. Replace the orifice as necessary along with the camshaft cover gaskets. Make sure the camshaft cover does not have any blockages in the PCV passages.
