Service Bulletin

Bulletin No.: 20-NA-048

Subject: Rattle Noise from Driver or Passenger Seat Belt

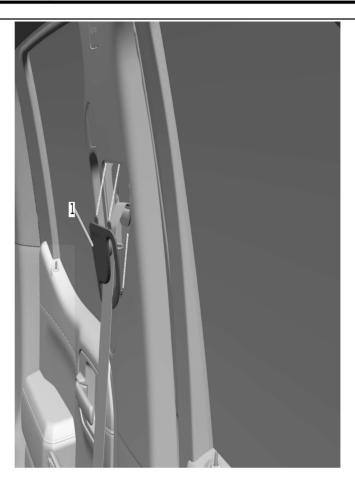
5424999

Involved Region or Country	North America, Europe, Russia, Middle East, Israel, Palestine, South America, Philippines, Australia, New Zealand, Egypt, Africa, South Africa
Additional Options (RPOs)	
Condition	Some customers may comment on hearing a rattle noise coming from the driver or passenger seat belt.
Cause	The cause of the condition may be too much clearance between the bezel and trim panel, which may allow a rattle noise generation.

Note: DO NOT replace the seat belt retractor for this issue, as the seat belt opening bezel has now been released as a service part.

Upon verifying the condition, replace both front seat belt opening bezels (1), 2 per vehicle. Refer to *Front Seat Belt Opening Bezel Replacement (Front Belt)*, in SI.
