# Service Bulletin

Bulletin No.: 20-NA-085

**Subject: Malfunction Indicator Lamp (MIL) Illuminated - DTCs P0018, P0019 and/or P0300 Set**

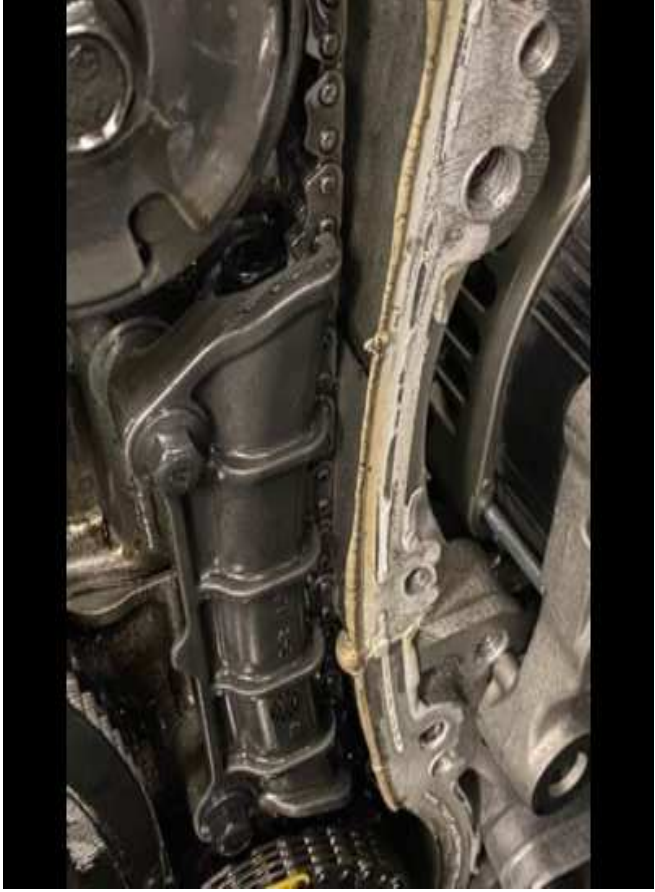
<p><b>Cause</b></p>

<p style="text-align: right;">5577608</p> <p>This condition may be caused by a missing timing chain guide insert.</p> <ul style="list-style-type: none"> <li>– Some engines built between 1/2/2019 and 3/1/2020, an inset was left off the far-left primary timing chain guide for the left primary timing chain. After a period of time, the timing chain wears through the guide support aluminum which leaves the timing chain very loose and the engine base timing will be off.</li> </ul>
<p><b>Correction</b></p>	<p><b>Note:</b> Some technicians may find when performing a compression test, a lower than normal compression reading may be found across bank 2.</p> <p>Perform an inspection:</p> <ol style="list-style-type: none"> <li>1. Remove the B2 (left) camshaft cover and look down at the timing chain on the left side.</li> <li>2. Inspect to see if the chain is rubbing against the engine block and cylinder head.</li> <li>3. Inspect for slight damage to the block or head. <ul style="list-style-type: none"> <li>– Some damage may be present but should not be detrimental to engine longevity.</li> </ul> </li> </ol> <p>⇒ If a repair is required:</p> <ul style="list-style-type: none"> <li>• Replace the left timing chain</li> <li>• Replace the left timing chain guide</li> <li>• Replace the left timing chain tensioner</li> <li>• If necessary, remove the oil pan and clean the metal out of the pan and pickup screen.</li> <li>• Perform an oil and filter change and ensure no further concerns with this vehicle</li> </ul>

Refer to *Secondary Timing Chain Guide Replacement - Left Side* and *Camshaft Timing Chain Components Installation* in SI.
