Service Bulletin

Bulletin No.: 20-NA-086

Subject: Unable to Deactivate Brake Boost System Using Global Diagnostic System (GDS) After Replacement of Master Cylinder Assembly

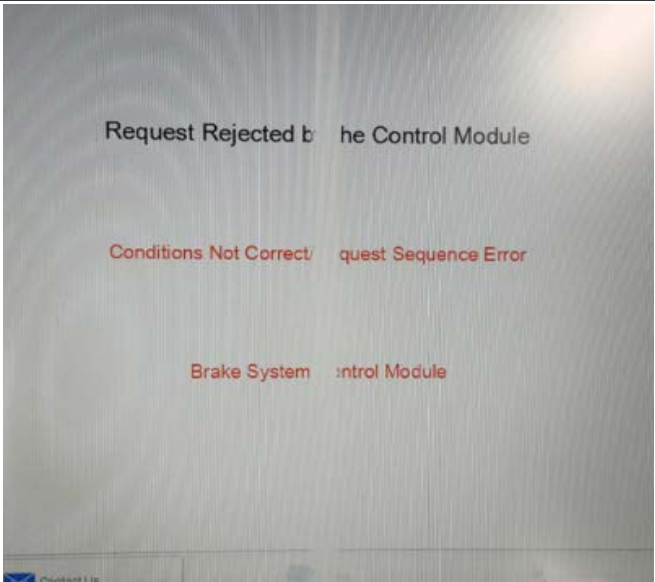
<p style="text-align: right; font-size: small;">5439029</p> <p>Technicians may notice a GDS2 error message, as shown in the picture above, occurring when trying to deactivate the brake boost system when performing the hydraulic bleed procedure.</p>
Cause	<p>This condition may be caused by the B20 Brake Fluid Level Switch Connector and the B34D Engine Coolant Temperature Sensor 4 Connector being swapped during reassembly.</p> <p>Note: If these connectors are swapped, DTCs C0049 SYM05 will be stored in the EBCM and a P2AFF SYM will be stored in the ECM.</p>
Correction	<p>Refer to the pictures below to verify that the connectors are in the correct location. Reverse the connections if necessary.</p>

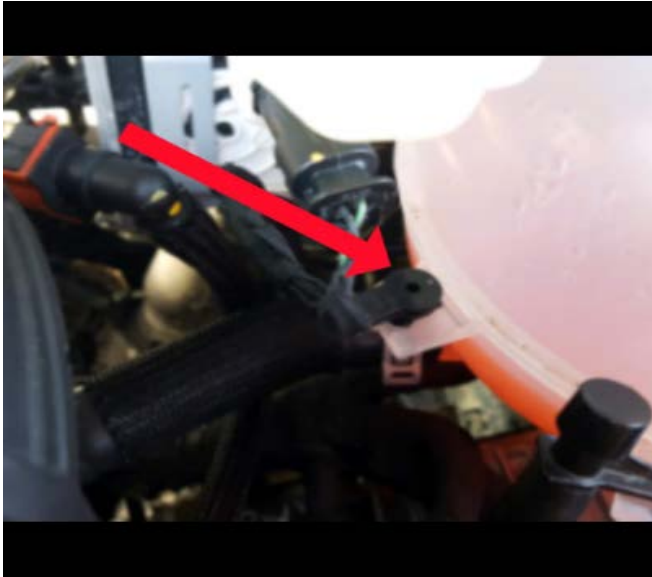
5439027

The picture above shows the Brake Fluid Level Sensor correctly connected.

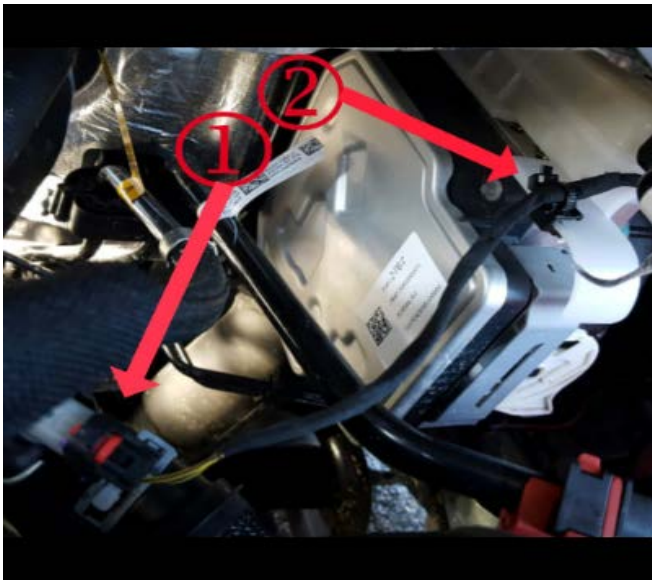
5439072

The picture above shows the Engine Coolant Sensor 4 correctly connected.
