Service Bulletin

Bulletin No.: 20-NA-087

Date: April, 2020

Subject: Blank Radio Display or No Audio

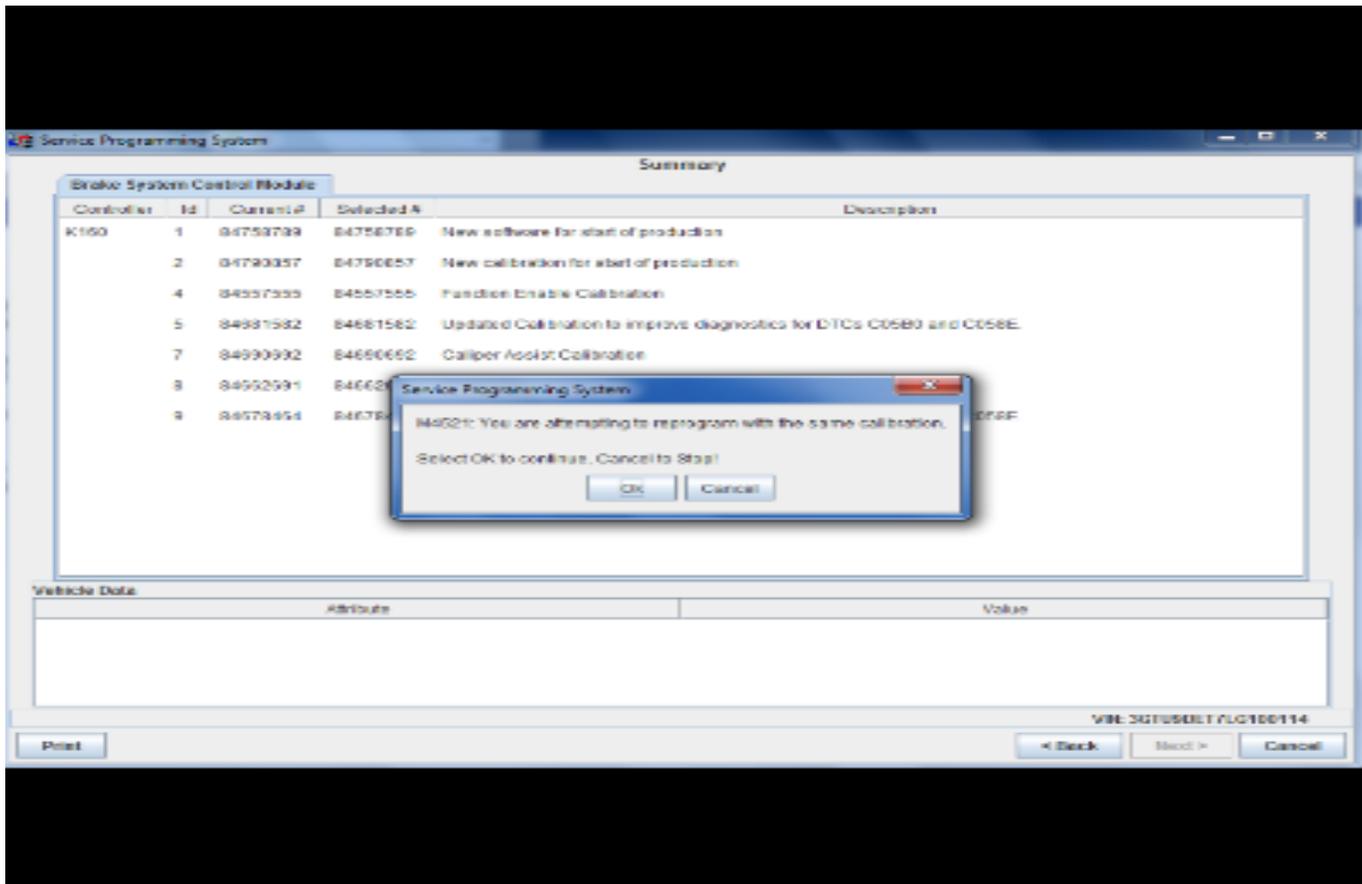
Important: TIS2WEB screen shown. Techline Connect screen is similar and will be included in the near future.

Important: If the Same Calibration/Software Warning is noted on the SPS screen, select OK and follow screen instructions. After a successful programming event, the WCC is located in the Service Programming System dialogue box of the SPS Summary screen. No further action is required. Refer to the Warranty section of the bulletin.

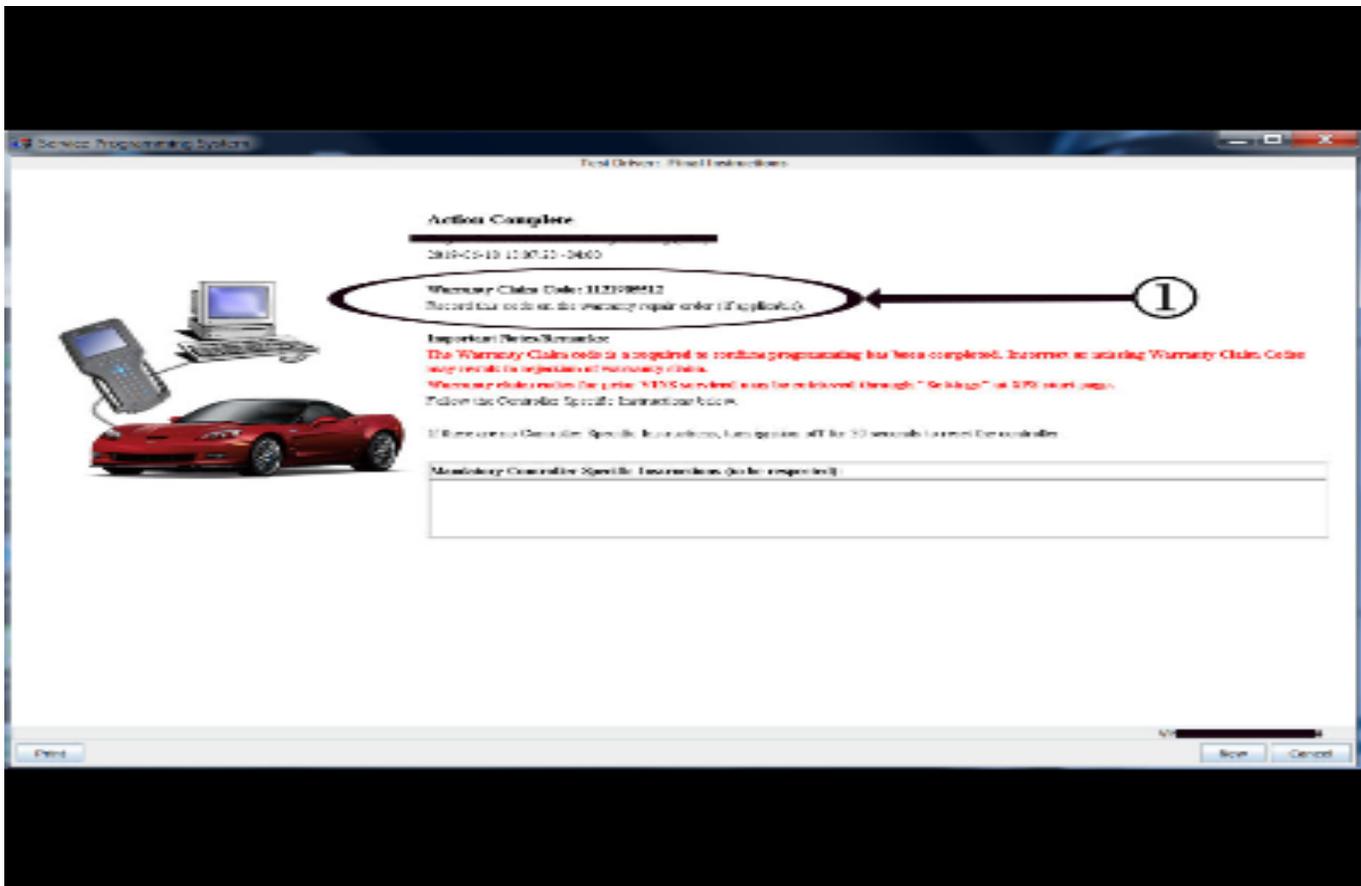
5431209

Important: TIS2WEB screen shown. Techline Connect screen is similar and will be included in the near future.

Important: To avoid warranty transaction rejections, you **MUST** record the warranty claim code provided on the SPS Warranty Claim Code (WCC) screen on the job card. Refer to callout 1 above for the location of the WCC on the SPS screen

3. Record SPS Warranty Claim Code on job card for warranty transaction submission.
