Service Bulletin

Bulletin No.: 20-NA-089

Subject: Low-Frequency Noise and Vibration Sound Heard in Passenger Compartment Under Wide Open Throttle

Brand:	Model:	Model Year:		VIN:		Engine:	Transmission:
		from	to	from	to		
Cadillac	CT5	2020	2020

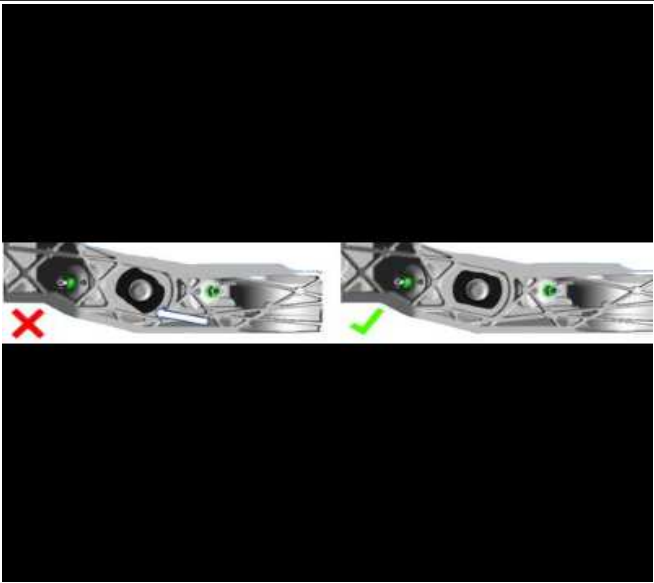
Involved Region or Country	North America
Additional Options (RPOs)	F46 (CHASSIS DRIVE LINE-ALL WHEEL DRIVE (AWD)/FOUR WHEEL DRIVE (4WD))
Condition	Some customers may comment that under wide-open throttle, there is a low-frequency noise and vibration that sounds like the muffler is grounding out against the body. The noise gets progressively worse as more miles accumulate on the car.
Cause	This condition may be caused by the Transmission Mount snubber being rotated out of position and rubbing against the inside pocket of the crossmember.
Correction	<div>

</div> <div>5573650</div> <ol style="list-style-type: none">1. Confirm the noise can be heard from inside the passenger compartment.2. Raise the vehicle. Refer to <i>Lifting and Jacking the Vehicle</i> in SI.3. Visually confirm by examining the Transmission Mount and snubber.4. Loosen the bolt and rotate the snubber until the anti-rotation feature engages. <p>Tighten Tighten the bolt to 100 N•m (74 lb ft).</p> <ol style="list-style-type: none">5. Lower the vehicle and test drive to confirm the noise is gone.
