# Service Bulletin

Bulletin No.: 20-NA-092

**Subject: Camera Display View Showing Wrong Make of Vehicle**

Brand:	Model:	Model Year:		VIN:		Engine:	Transmission:
		from	to	from	to		
Chevrolet	Silverado 1500	2020	2020			All	All

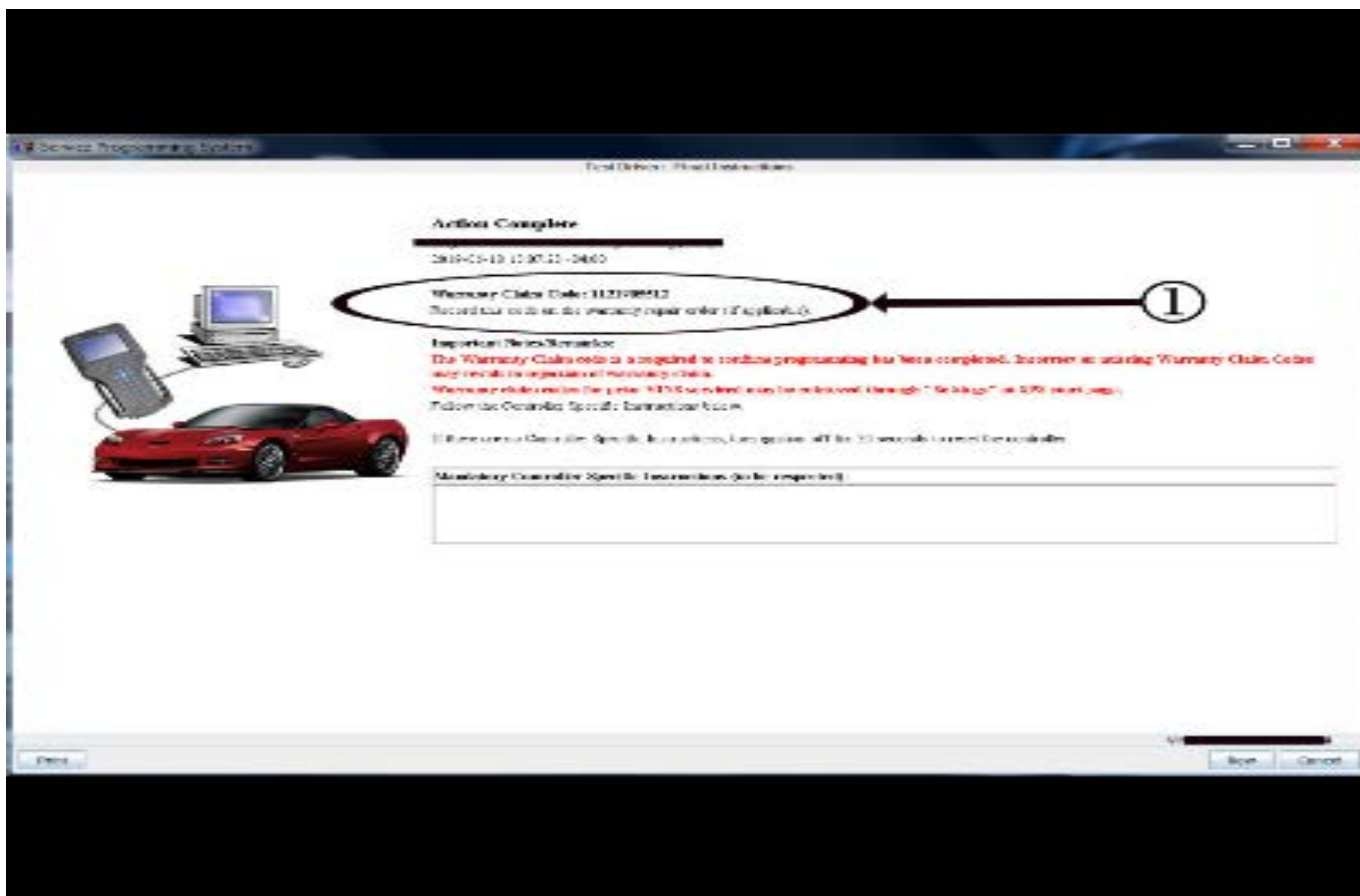
5431209

**Important:** TIS2WEB screen shown. Techline Connect screen is similar and will be included soon.

**Important:** To avoid warranty transaction rejections, you **MUST** record the warranty claim code provided on the SPS Warranty Claim Code (WCC) screen on the job card. Refer to callout 1 above for the location of the WCC on the SPS screen

2. Record SPS Warranty Claim Code on job card for warranty transaction submission.
