Service Bulletin

Bulletin No.: 20-NA-094

Subject: Steering Assist Reduced, Service StabiliTrak and/or Park Brake Released Message Displayed On the Instrument Panel Cluster (IPC) Most Commonly After Auto Stop, DTCs C0800, U0121 Set

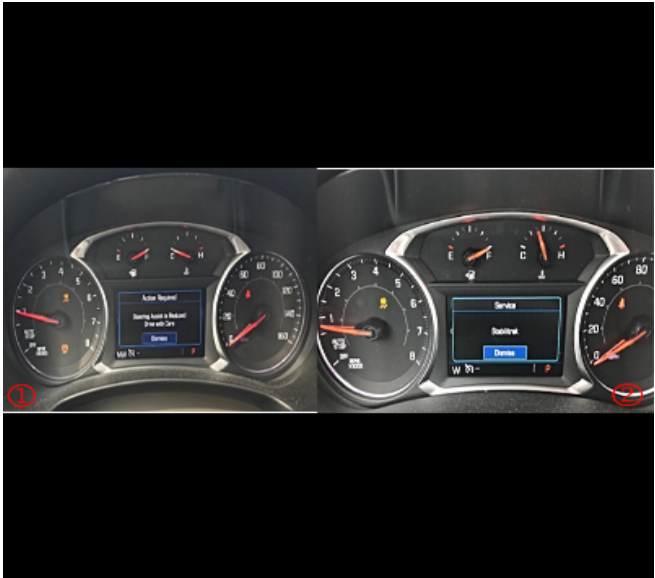
</div> <p style="text-align: right; font-size: small;">5587452</p> <p>Some customers may comment on a Steering Assist Reduced (1), Service StabiliTrak (2), as shown in the pictures above, and/or Park Brake Released message (Not shown) being displayed on the Instrument Panel Cluster (IPC) most commonly after auto stop.</p> <p>Note: There may be a steering assist reduction or, in extreme cases, loss of steering assist for a brief period (1-2 seconds). All of these symptoms appear most commonly after the engine restarts after an auto stop event.</p>
