Technical Service Bulletin

SUBJECT:			No: TSB-20-23-001
POTENTIAL TRANSMISSION SHUDDER/SURGE WITH POSSIBLE DTC (CVT-8) - REVISED			DATE: April 2020
			MODEL: See below
CIRCULATE TO:	<input type="checkbox"/> GENERAL MANAGER	<input checked="" type="checkbox"/> PARTS MANAGER	<input checked="" type="checkbox"/> TECHNICIAN
<input checked="" type="checkbox"/> SERVICE ADVISOR	<input checked="" type="checkbox"/> SERVICE MANAGER	<input checked="" type="checkbox"/> WARRANTY PROCESSOR	<input type="checkbox"/> SALES MANAGER

Certain vehicles with F1CJC/W1CJC (CVT-8) transmissions may exhibit a shudder or surge condition possibly caused by poor reaction of the hydraulic pressure circuit. With continued driving under these conditions, the CVT belt may slip repeatedly when accelerating, and abrasion powder may enter the hydraulic pressure circuit, causing a warning light to turn on with one of the following DTCs: P0776, P0730, P0741, P084A, P0969, P2719. The shudder/surge condition may also be described as engine flare, lack of acceleration, and/or car shake.

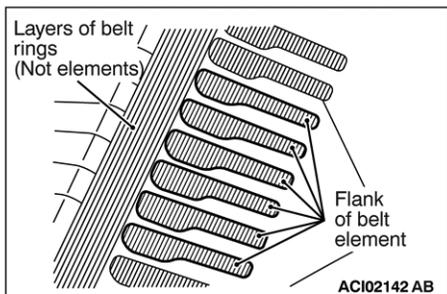
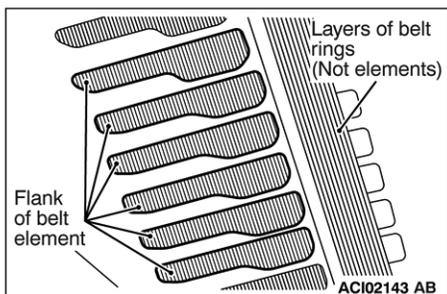
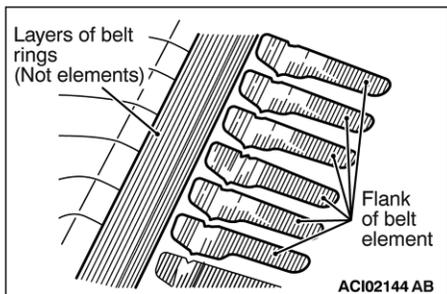
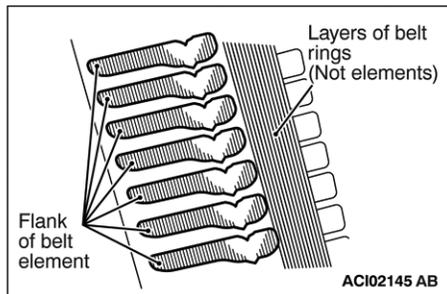
<OK SAMPLES>

- No damage is observed on flanks (grooved surfaces) of belt elements.

- If damage is found on either side of mating surfaces of the belt, CVT assembly replacement is required.
- If no damage is found on mating surfaces of the belt, a new valve body installation is required. Follow next steps.
