Technical Journal

Unusual noise while driving from sealing ring

REF NO: TJ 33524.2.0	ISSUING DEPARTMENT: Technical Service	CAR MARKET: United States and Canada	
PARTNER: 3 US 7510 Volvo Car USA		ISSUE DATE: 2020-03-25	STATUS DATE: 2020-04-02
FUNC GROUP: 7731	FUNC DESC: Hub, front	Page 1 of 3

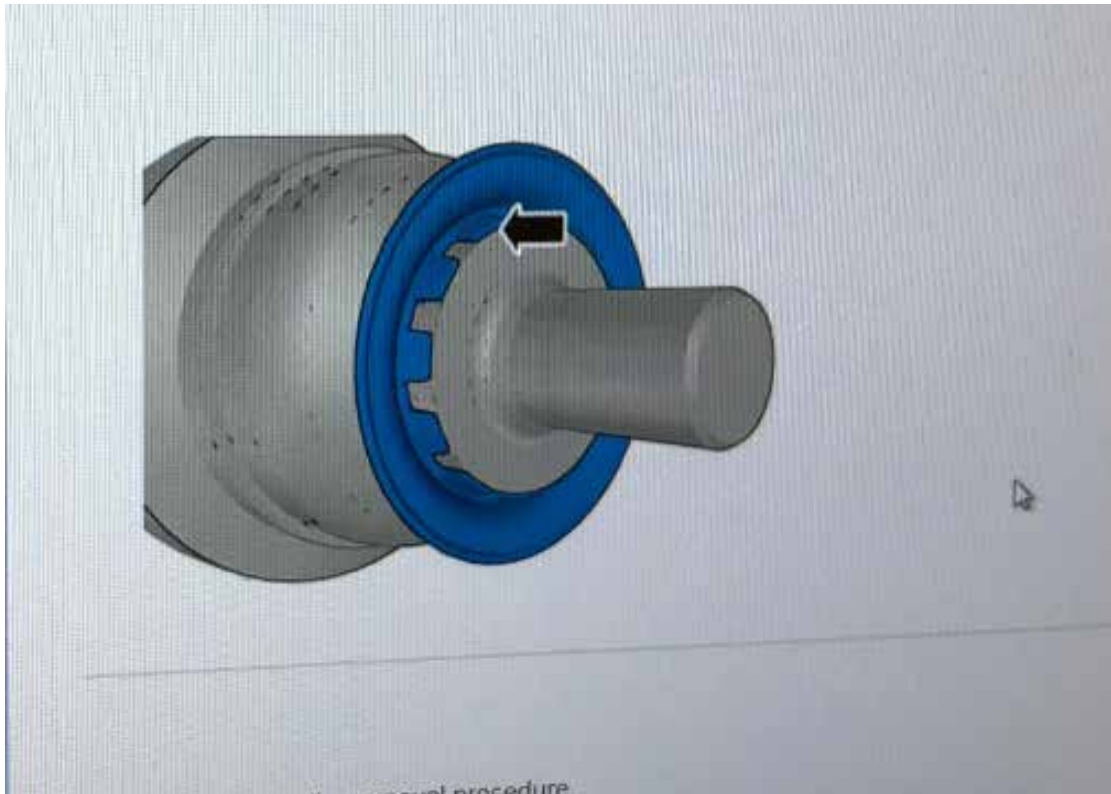
If customer experiences unusual noise from front drive shaft, please follow advice under Service.

If noise is confirmed, check first if the sealing ring is displaced, if so, proceed with replacement of the sealing ring according to VIDA.
