Subject: Engineering Information – Oil Leaking From Oil Pan

Brand:	Model:	Model Year:		VIN:		Engine:	Transmission:
		from	to	from	to		
Chevrolet	Silverado 1500 (New Model)	2019	2019	-	-	Equipped with 2.7L Engine (RPO L3B)	-
	Silverado 1500	2020	2020				
GMC	Sierra 1500 (New Model)	2019	2019				
	Sierra 1500	2020	2020

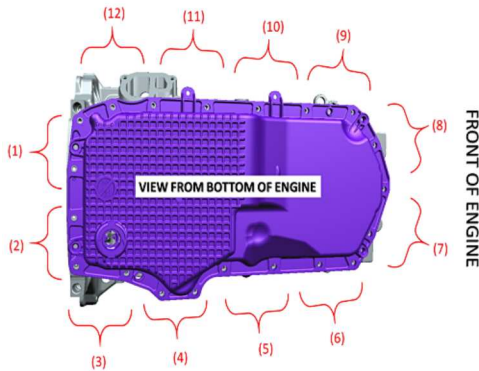
1. Visually inspect oil pan to identify traces of residual oil collection, and trace the leak path to the highest point (check if this is the oil pan to LCE joint).
2. If leak seems to be from oil pan to LCE joint, wipe excess oil and add engine dye.
3. Put additional miles on vehicle, and re-inspect with a black light to confirm that source of leak is in fact the oil pan to LCE joint.
4. If dye is detected, take clear snapshots of leak location / path at the oil pan to LCE joint.

5. Make an assessment on which leak "zone" 1–12, as shown in the picture above, that the oil is originating from.
