Complaint - Engine Will Not Start: Performing a PVTs Software Update Via the Dealer Web Portal (41/20)

Model line: **918 Spyder**
Cayenne (92A)
Macan (95B)
Panamera (970/971)
Boxster/Cayman (982)
911 Carrera (991)

Subject: **Control unit for auxiliary alarm system**

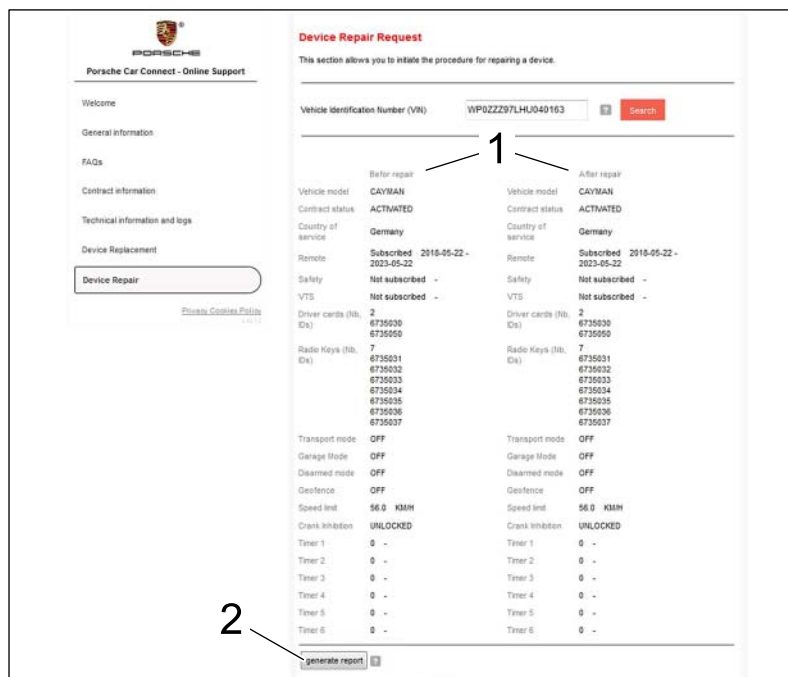
Equipment repair

2.5 Check whether all settings ⇒ *Equipment repair -1-* are the same. Then click the **"Create Report"** ⇒ *Equipment repair -2-* button.
