Complaint - Tail Light Has Visual Defects: Condition Assessment (161/18)

Model Line: **Cayenne (9YA)**

Subject: **Tail lights (standard)/Dark-tinted tail lights (I-no. 8SB)**

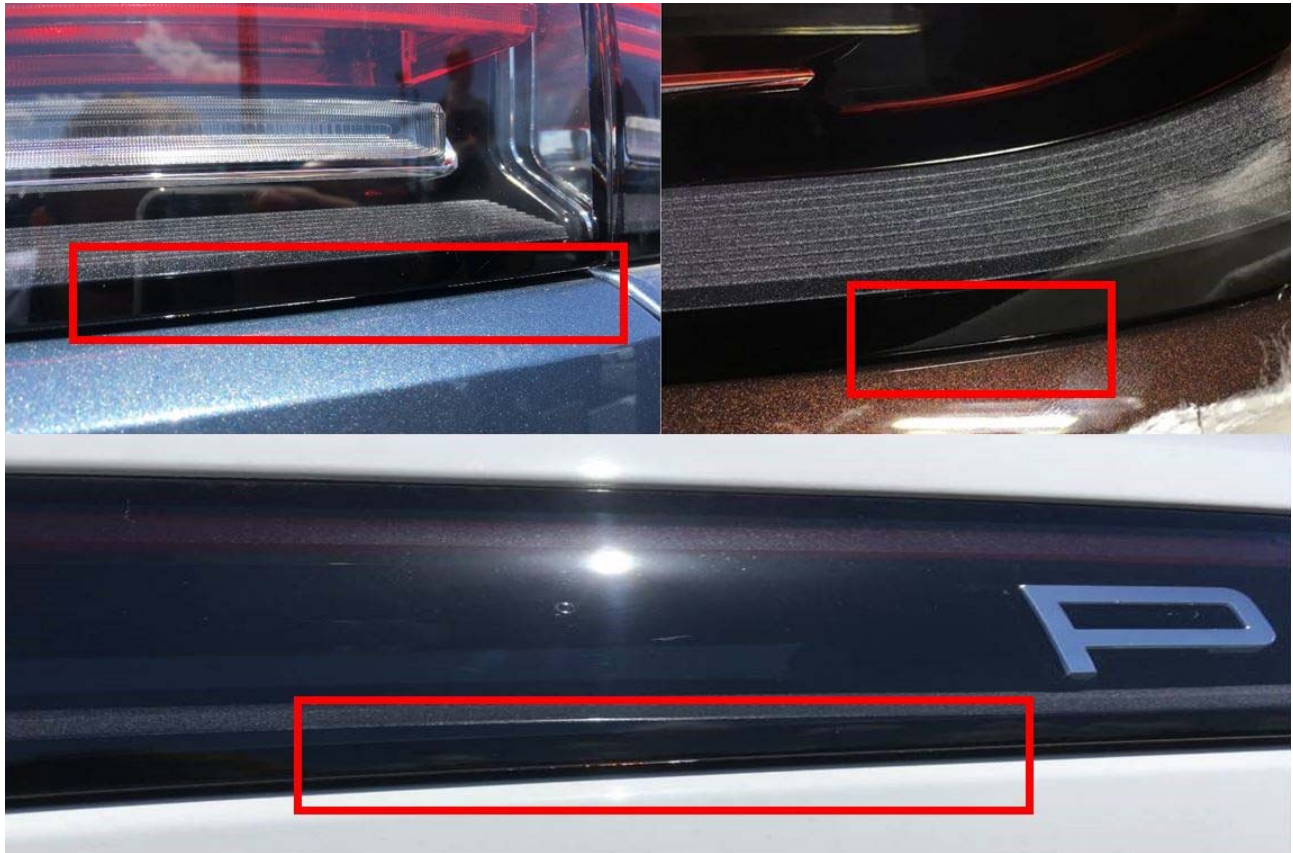
Severity example 1: Slight defect

- Type of defect: "Shining line" - Edge at material joint shining
- Extent of defect: Partial
- Defect detection: Detailed visual inspection (close examination required)
- Visibility of defect: Difficult to see and depends on viewing angle

Tail lights with only a slight visual defect cannot be replaced under warranty or goodwill.

- Do not replace tail lights

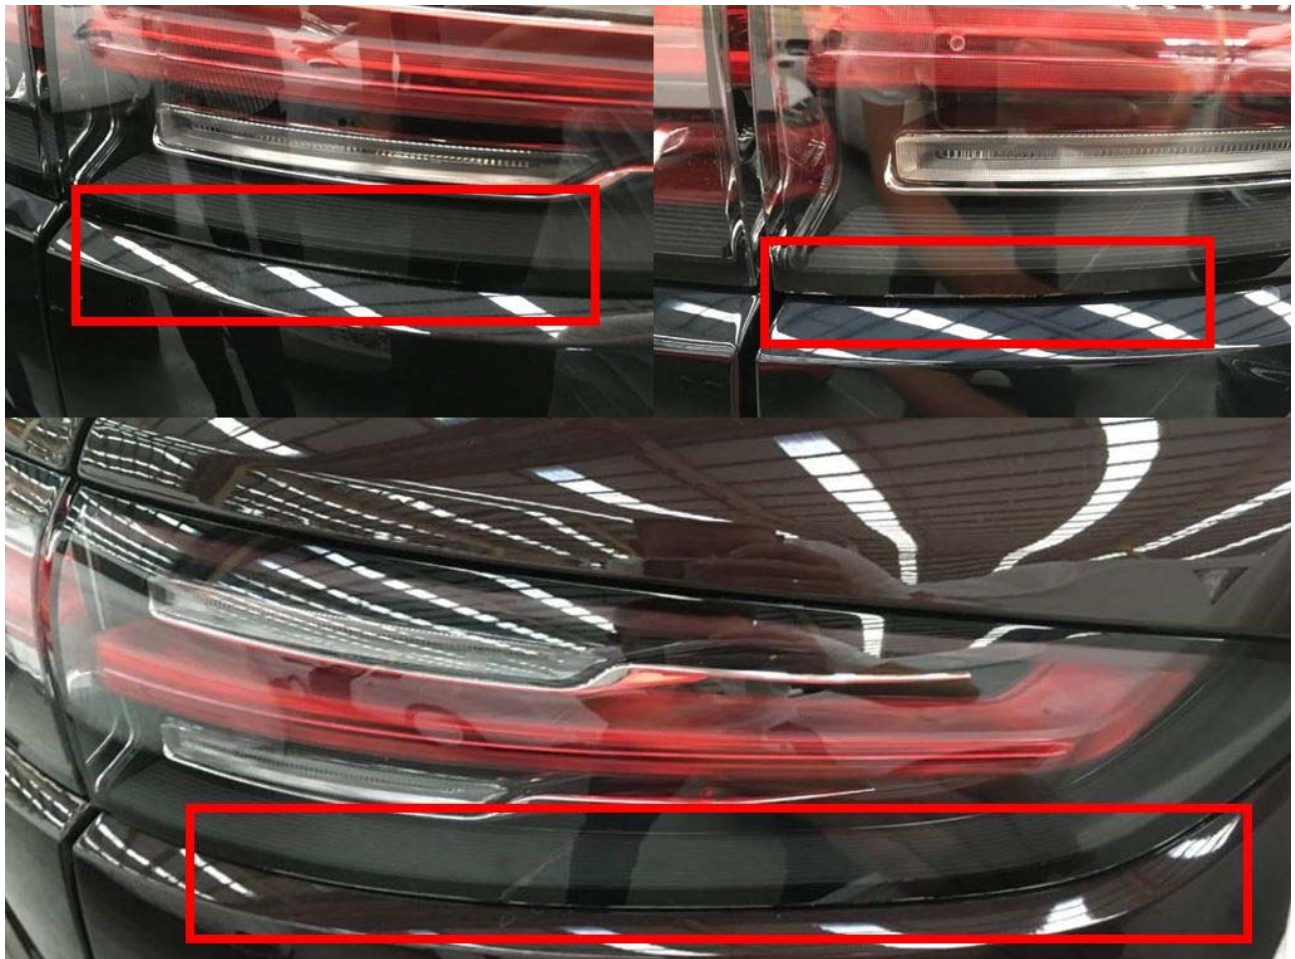
Severity example 2.1: Moderate defect

- Type of defect: Significant "Shining line" (edge at material joint shining) or noticeable to significant delamination (black material peeling off and showing first signs of cracking) **and/or** "shell fractures" (round fractures) **and/or** visible cracks in the material
- Extent of defect: Single defect **and/or** several defects/widespread defects
- Defect detection: Visual inspection finds clear defect (at a distance of 1 meter, for example) **or** defect visible even without checking (clearly visible at a distance of 1-2 meter)
- Visibility of defect: Visible by focussing on the defect **or** visible by looking at the rear of the whole vehicle

- Replace affected tail light(s), for instructions, see ⇒ *Workshop Manual 'Removing and installing tail light'* ⇒ *Workshop Manual 'Removing and installing tail light (rear lid)'*
