# Emissions Recall Code: 26M4

Subject	Catalyst					
Release Date	May 19, 2020					
Affected Vehicles	Country	Beginning Model Year	Ending Model Year	Vehic	le	Vehicle Count
	USA	2018	2018	ATLA	S	42,932
	CAN	2018	2018	ATLA	S	7,260
Problem Description	<ul> <li>action. Elsa is the <u>only</u> valid campaign inquiry &amp; verification source.</li> <li>Campaign status must show "open."</li> <li>If Elsa shows other open action(s), inform your customer so that the work can also be completed at the same time the vehicle is in the workshop for this campaign.</li> <li>Over time and mileage, the factory-installed catalyst may not perform as required. If the effectiveness of the catalyst is reduced, this may result in increased tailpipe emissions and the same time the vehicle is in the work catalyst.</li> </ul>					
Corrective Action	vehicle could fail an emissions (IM) inspection. Replace catalyst and update ECM software.					
Code Visibility	On or about May 19, 2020, the campaign code will be applied to affected vehicles.

#### Subject: Emissions Recall 26M4 - Catalyst

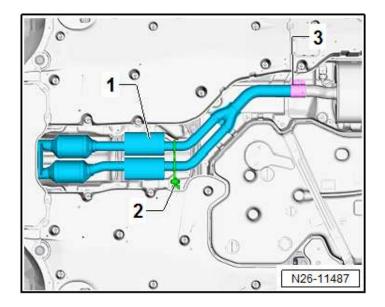
Replace catalyst and update ECM software.

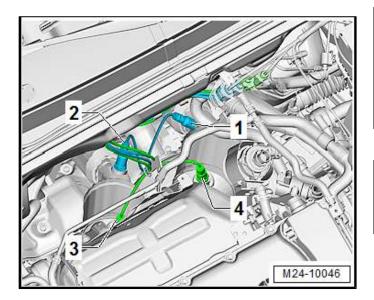
Oxygen sensors <1>, <3> and <4> can be removed with tools from the Ring Wrench 7-Piece Set -3337-.

Oxygen sensor <2> will have to be removed with a locally sourced oxygen sensor socket.

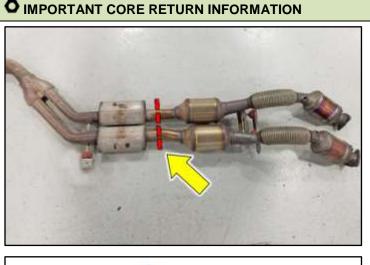
The catalysts MUST be separated from the exhaust system for recycling. Cut the exhaust pipe between the muffler and the catalyst in the area shown <arrow>.

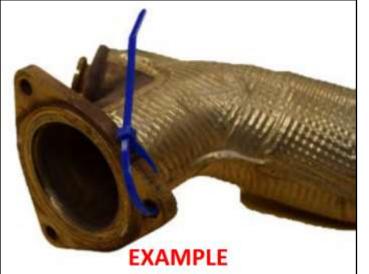
The Catalyst must be tagged with a red or blue zip tie <as shown> and returned in order to be considered for core charge reimbursement.
