Emissions Recall Code: 26M4

Subject Catalyst

Release Date May 22, 2020

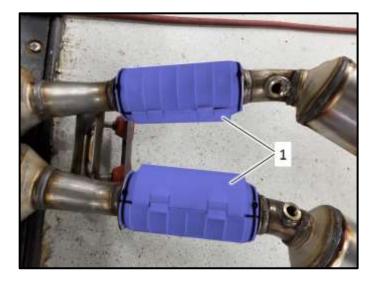
Danger of causing damage to the decoupling element!

Do not bend the decoupling element more than 10°. Do not damage the wire mesh on the decoupling element.

- Ensure the transportation protection <1> is secured on the new catalyst before installing.
- After installing and securing the catalyst to the exhaust manifold, remove the transportation protection from the catalysts.
