SERVICE BULLETIN

APPLICABILITY: 2013-19MY Forester NUMBER: 12-288-20

SUBJECT: Power Front Seat Cushion Frame / Slide Rail- Design Change

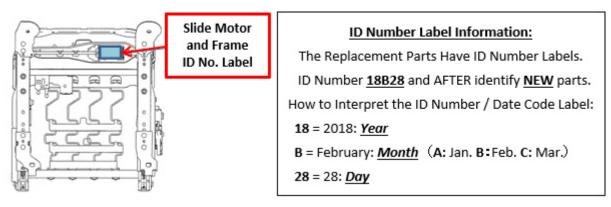
Cross-Section View of Slide Rail

• This illustration shows the design change made to the shape of the Slide Rail.

• The information below instructs how to confirm the replacement seat frame assembly contains the new Slide Rails.
