Technical Service Bulletin

72 Squeaking noise from front seat height adjustment

72 20 24 2059448/1 May 11, 2020.

Model(s)	Year	VIN Range	Vehicle-Specific Equipment
Q5, SQ5	2018 - 2019	All	Not Applicable

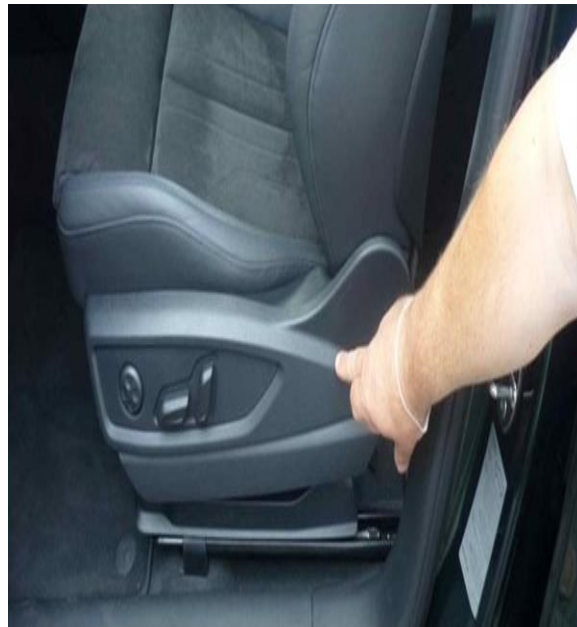
- The source of the squeaking noise can be tracked to the front seat outer hinge area. The noise originates from behind the seat frame trim panel.

Figure 1. Noise originates from behind seat frame trim panel near hinge.

Depending on the seat position, under certain conditions, squeaking noises from the front seat height adjustment can occur. Specifically in the lower seat adjustment positions, the toothed segment of the seat height adjustment can interfere with the support bracket resulting in squeaking noises.

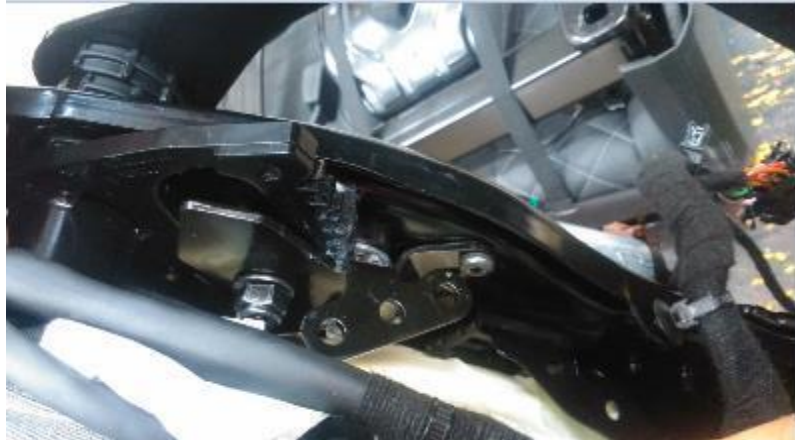
Figure 2. Toothed segment of seat height adjustment.

1. Remove the affected seat from the vehicle according to the repair manual.
2. Attach the seat to the seat repair fixture VAS6136 mounted to the engine and transmission holder VAS6095A according to the repair manual.
3. Remove the seat frame trim panel and tilt the seat forward to gain access to the seat height adjustment toothed segment.

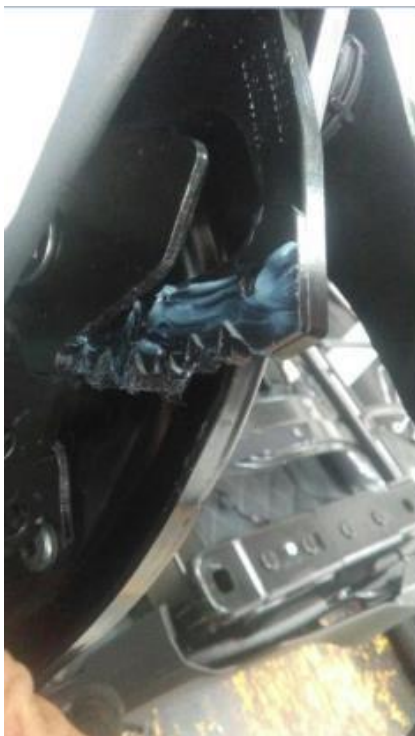
Figure 3. Grease applied to the seat height adjustment toothed segment.

4. Apply grease spray Part No. G.052.778.A2 on the toothed segment as shown in **Figure 3** (lubricate teeth and lateral surfaces).

5. Reinstall seat frame trim panel and install the seat in the car according to repair manual.
6. Adjust the seat up and down three times covering the full range of vertical movement to equally distribute the grease on the toothed segment.
