Technical Service Bulletin

90 Audi virtual cockpit center display is black

90 20 47 2059568/1 May 20, 2020.

Model(s)	Year	VIN Range	Vehicle-Specific Equipment
Q3	2019	All	Audi virtual cockpit plus
Q3	2020	000001 - 000731	Audi virtual cockpit plus

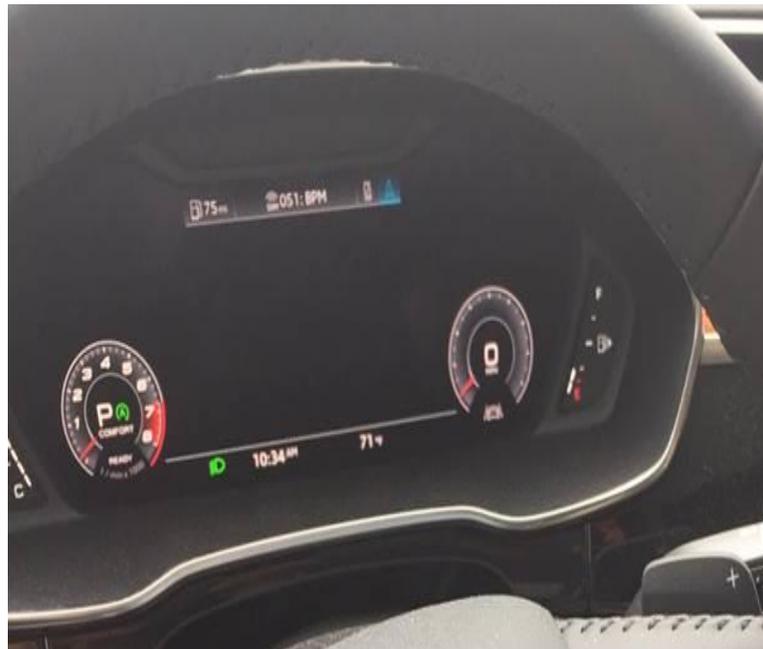
- The center display in the Audi virtual cockpit is black and does not show the expected tab (Figure 1). It is not relevant which tab the Audi virtual cockpit currently displays (on-board computer, infotainment, phone, and navigation).

Figure 1. The center display in Audi virtual cockpit is black.

- After switching the ignition off and on the central display area is correct again.

A software bug can cause the center display to sometimes become black.

New software in the instrument cluster control module, J285 (address word 0017) addressed the condition.

1. Follow all instructions in TSB 2011732: *00 Software Version Management (SVM), operating instructions* and TSB 2047812: *00 SD Creator: how to set up and use the SD Creator for obtaining vehicle software updates via the MirrorServer*.
2. Update the instrument cluster control module, J285 (address word 0017) using the SVM action code and instructions as listed in the table below:

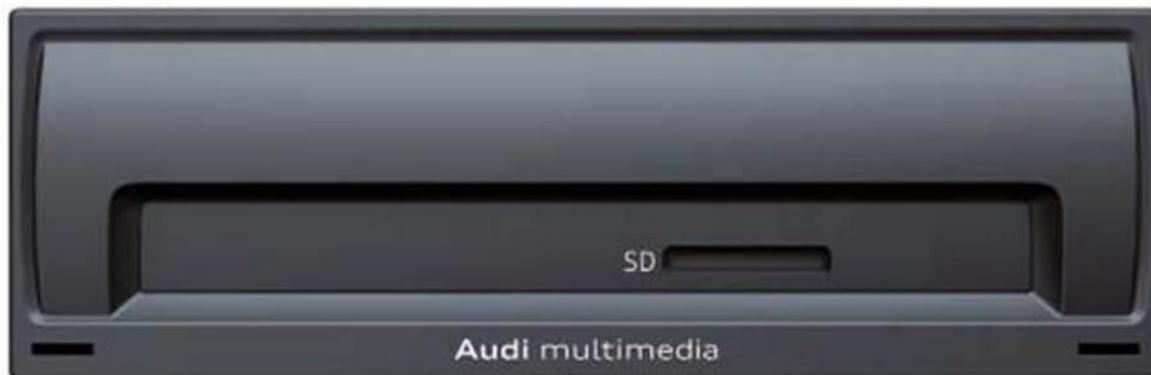
Figure 2. An infotainment control module (example).

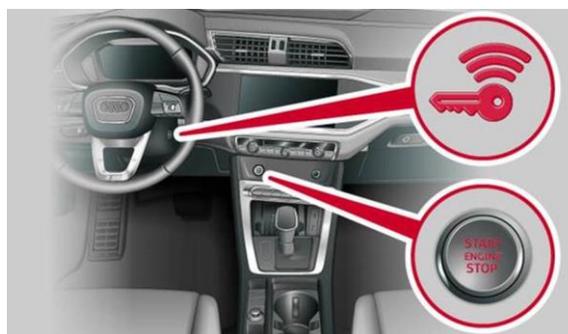
Figure 3. A steering column with mark for the vehicle key.

6. If the message: "...hold the vehicle key on the transponder..." appears, hold the vehicle key to the marked location on the steering column (Figure 3) until the update is completed.

Tip: It is recommended to affix the vehicle key in this position with an adhesive tape that can be removed without leaving any residue.
