PRODUCT CAMPAIGN BULLETIN

APPLICABILITY: 2017-19MY Impreza
2018-19MY Crosstrek

NUMBER: WUQ-02R

SUBJECT: Ignition Coil Short Circuit

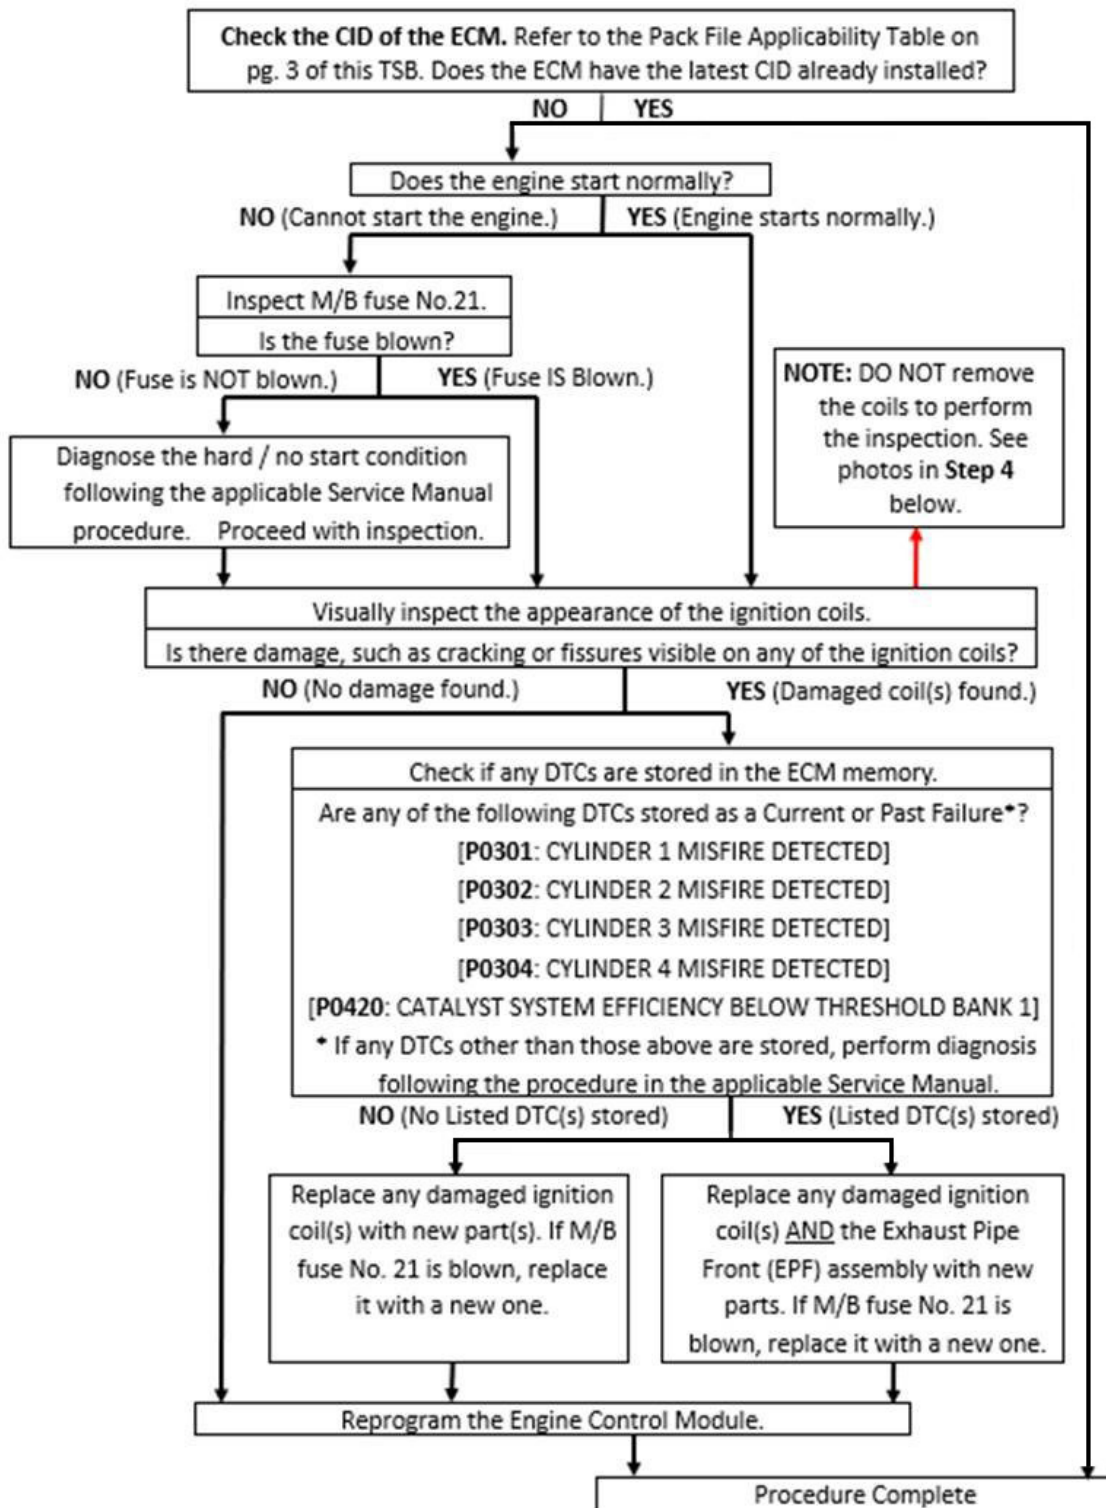
WUQ-02 Service Procedure Flow Chart

The following Flow Chart is provided as an overview of the procedures required to perform this Recall. A detailed Service Procedure is also supplied below.
