SERVICE BULLETIN

APPLICABILITY: 2020MY Legacy and Outback **NUMBER:** 07-176-20

SUBJECT: DTCs B118B, B11E5, B11E6 in Driver Monitoring System (DMS) **DATE:** 05/18/20

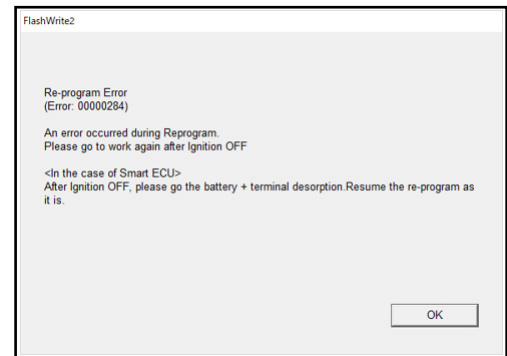
NOTE: If during the reprogramming, the screen shown here is displayed ignore it and select OK. If no error screen is displayed, select OK.

Step6) Proceed with reprogramming. Install the **FIRST** of TWO DMS update files: **98401AN00AtoB-1.pak2** using FlashWrite.

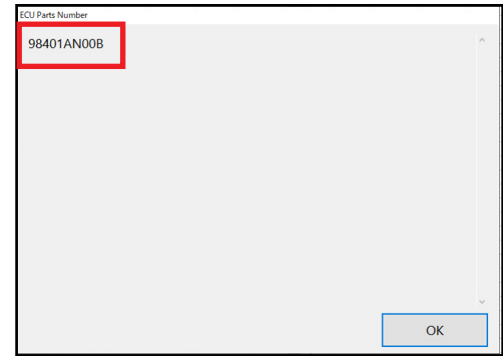
When the update has been completed successfully, the ECU p.n. displayed will be **98401AA00B**. Select OK to complete the procedure.

Step10) Using the SSM4, confirm the DMS Part Number to confirm the update was successful. Go to: Diagnosis > Confirm VIN > Each System > Driver Monitor (scroll down) > Work Support > ECU Parts Number.
