SERVICE BULLETIN

APPLICABILITY: 2019-20MY Forester **NUMBER:** 12-291-20

Staining on Finish of Rear Gate Panel

DATE: 05/19/20

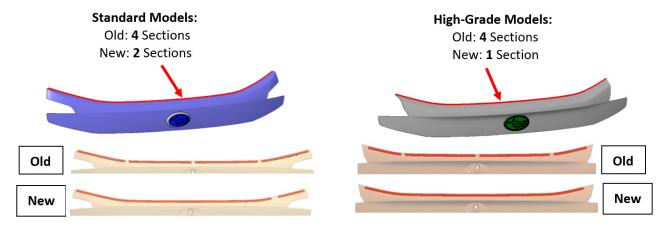
The staining is caused by an anti-hardening chemical used in the rear wiper blade insert. Over time, the chemical may be extracted from the insert by vehicle washing and rainwater. Carried by the runoff water, the chemical can drain through the gaps between the sections of the old-style rubber protector which may cause a stain to develop on the rear gate finish below the garnish. Depending on the vehicle trim level, new style protectors either eliminate or reduce the number of gaps from 4 to 2, redirecting the runoff water. Detailed illustrations are provided below in the Parts section.

In the illustrations below, the protector is shown as the red line along the top edge of the rear gate garnish.
