## SERVICE BULLETIN

**APPLICABILITY:** 2020MY Legacy and Outback Models      **NUMBER:** 15-261-20R  
**SUBJECT:** Reprogramming File Availability for Optimization of Gen 4 Denso CP1 Infotainment Systems      **DATE:** 03/10/20  
**REVISED:** 05/21/20

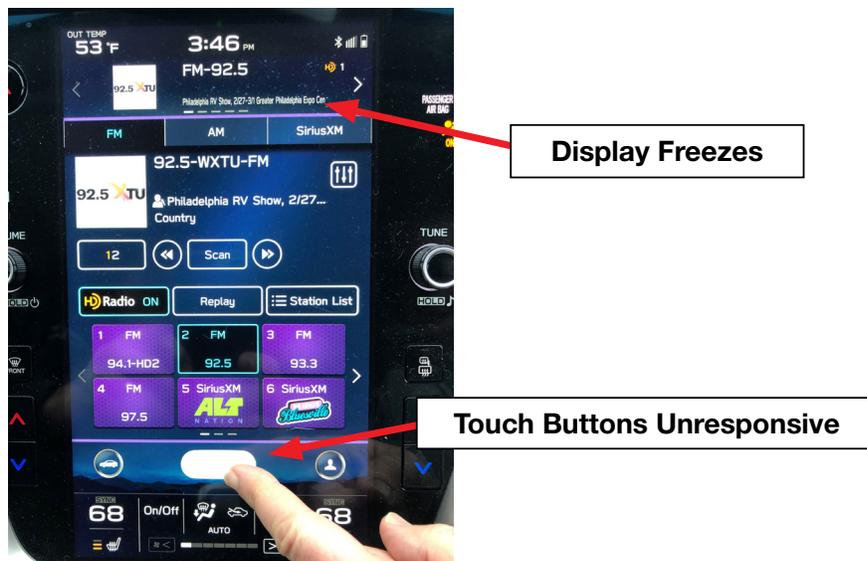
**Symptom #1**

The CP1 display and/or center Combination Meter display freezes. No response from touch screen or voice guidance. After switching the ignition off and opening the driver’s door, the system does not recover\*\*.

**NOTE\*\*** After switching the ignition off and leaving the driver’s door open more than 70 seconds, the system *may* recover after switching the ignition back on.

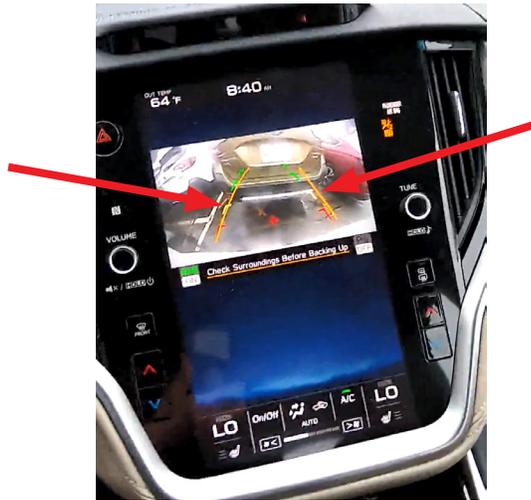
## Symptom #2

Delayed response of rear view camera guide lines.

When the rear view camera is activated and the steering wheel is turned, there is a delay before the steering-responsive guide lines respond to the steering wheel input.

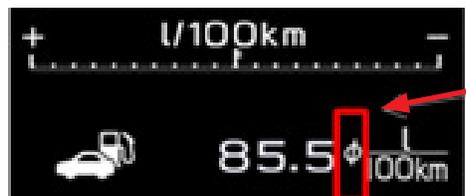
## Symptom #3

Fuel consumption display has unnecessary 'Φ' mark when changing mileage unit to Km.

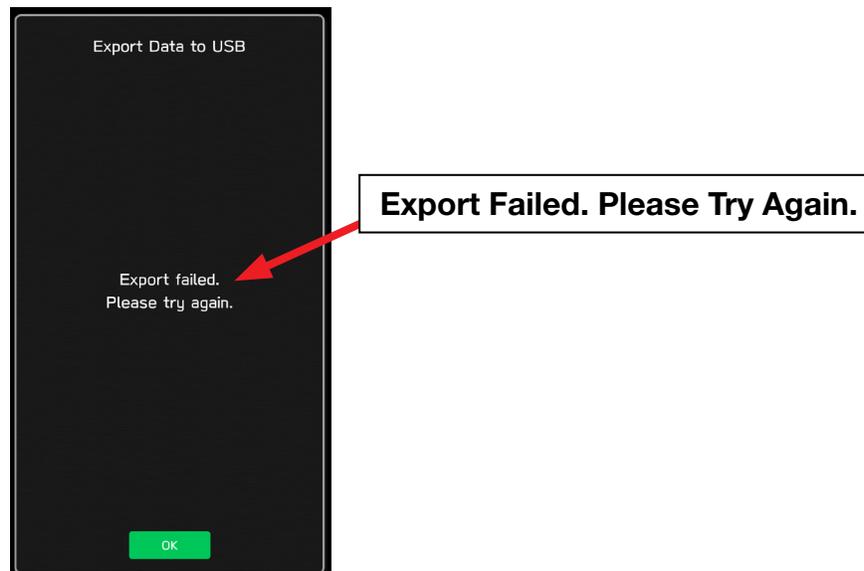
## Symptom #4

Diagnostics Recorder Data cannot be exported to the USB memory device. When the diagnostic log data is being downloaded (by selecting: Dealership Menu > Diagnostics Recorder > Export Data to USB), it fails after the progress bar reaches almost 90% with an error message of Export failed. Please try again.

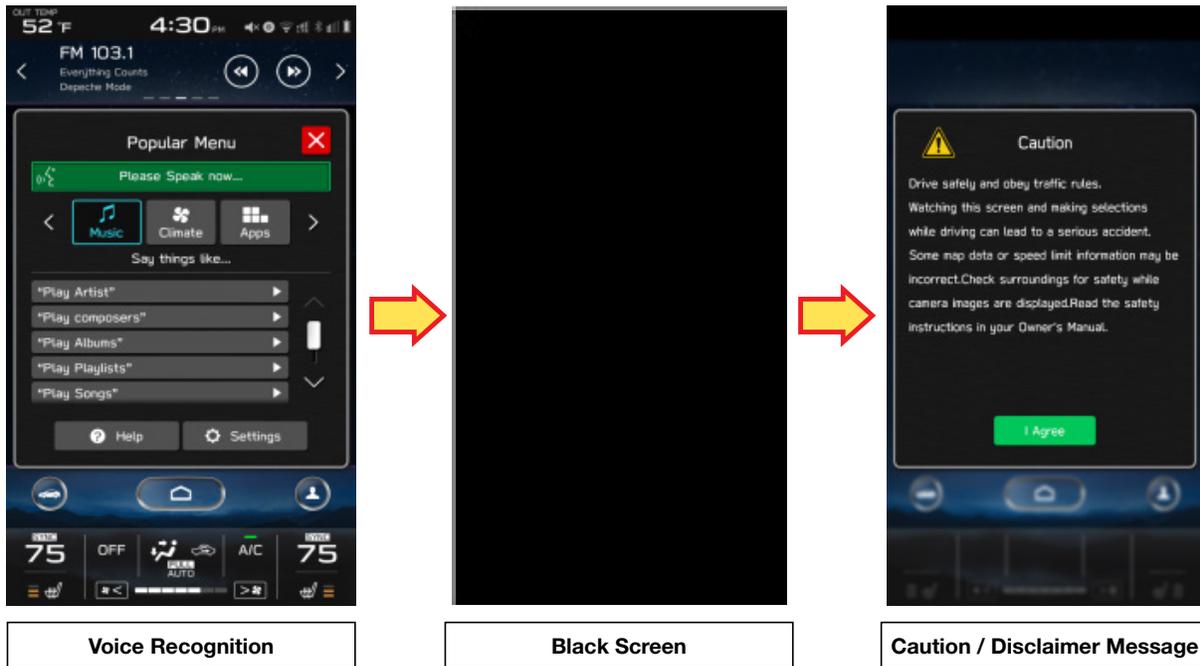
## Symptom #5

When using Voice Recognition to search for a 'Nearby POI' (Point of Interest) in Canada with FRENCH language selected, the CP1 display turns black and displays a Caution / disclaimer message.
