Articles Contained in this Issue

15 Incorrect Operation of Audio Unit After Rockford Fosgate Upgrade Installation

2020 Outback/Legacy Rockford Fosgate Audio Upgrade Kit

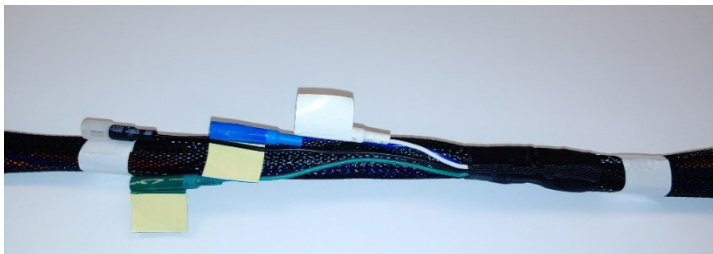
Harness jumper setting with tape flags for Outback Premium/Onyx

Configure sound characteristic (Tuning) programming to specific models
1. Using the chart on this page, connect the black wire to the correct colored wire based on the model being upgraded. NOTE: For Outback Premium and Onyx models, no wires will be connected.

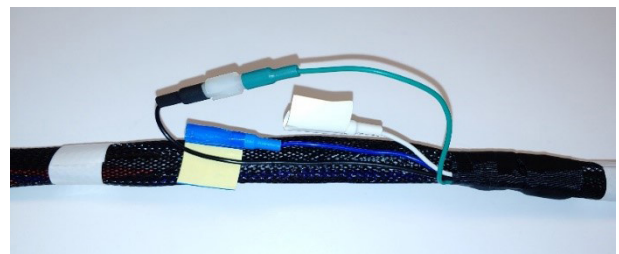
Harness jumper setting for Legacy Premium/Sport with tape flag removed and connection made

NOTE: Incorrect harness setting, selecting the wrong audio profile for the vehicle trim, will allow some audio system operation, but the sound quality would be below the specified performance.

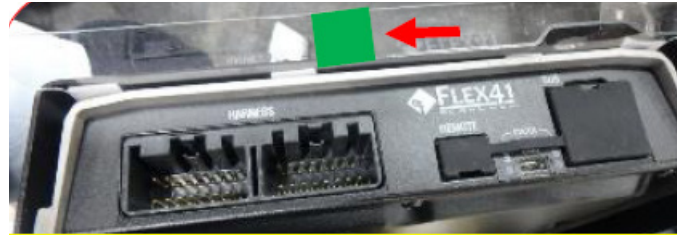
Example of the cap cover from the jumper harness visual configuration. In this example "green" was used for Legacy Premium Models.

- If the WHITE, BLUE, or GREEN jumper wires were used, the colored tape flag removed from the jumper should be placed on the amplifier as a visual indicator of the audio profile selected to match the target vehicle's trim level.
