# Technical Service Bulletin

## PSS 91 MMI screen goes blank after iPhone is connected to USB port

91 20 66 2044130/7 May 20, 2020. Supersedes Technical Service Bulletin Group 91 number 18-84 dated March 5, 2018 for reasons listed below.

Model(s)	Year	VIN Range	Vehicle-Specific Equipment
A4, A5, Q5, and Q7	2018	All	Audi smartphone interface

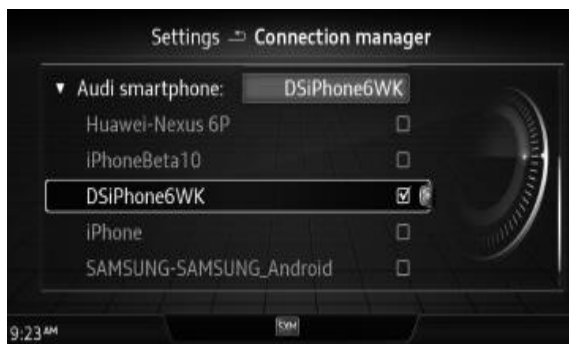
Figure 1. iPhone is selected for ASI (CarPlay).

3. Create a PSS record in the PSS application through the Pending Service Solutions (PSS) link in AccessAudi (under *App Links* >> *Service* >> *Pending Service Solutions (PSS)*), or through the Technical Assistance page in Elsa.
4. As a temporary workaround, ask the customer to:
  - If the screen goes blank when CarPlay is accessed immediately after the car is started or if the screen flashes back to the MMI menu after selecting CarPlay: connect the iPhone after the car is started and while the transmission is still in the park position. If the customer gets into this condition they can fix the concern by going to the connection manager (Figure 1) and deselecting the iPhone (Figure 2) and reselecting under Audi Smartphone Interface (*Settings* >> *Connection Manager* >> *Audi Smartphone Interface*; Figure 1). This will force the MMI to start a new CarPlay session with the iPhone.

- If the screen flashes when selecting CarPlay after using the backup camera: inform the customer there is no current workaround. If the customer has this issue they can temporarily fix the concern by going to the connection manager (Figure 1) and deselecting the iPhone (Figure 2) and reselecting under Audi Smartphone Interface (*Settings* >> *Connection Manager* >> *Audi Smartphone Interface*; Figure 1). This will force the MMI to start a new CarPlay session with the iPhone.

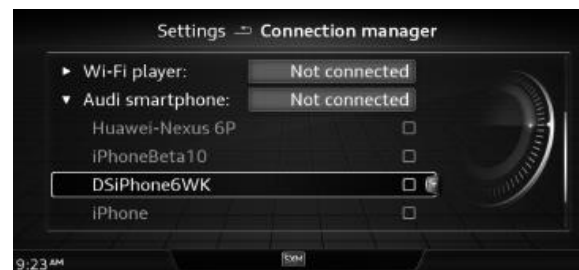
Figure 2. iPhone is no longer selected for ASI (CarPlay).
