# Technical Service Bulletin

Subject: DTC U2050:55 STORED AFTER REPLACING OR REPROGRAMMING TCU	Bulletin No.: 09-013/20
	Last Issued: 05/08/2020

2019 Mazda3 vehicles (Japan built) with VINS lower than JM1BP\*\*\*\*\*147656 (produced before June 29, 2019)

2019 Mazda3 vehicles (Mexico built) with VINS lower than 3MZBP\*\*\*\*\*115095 (produced before June 29, 2019)

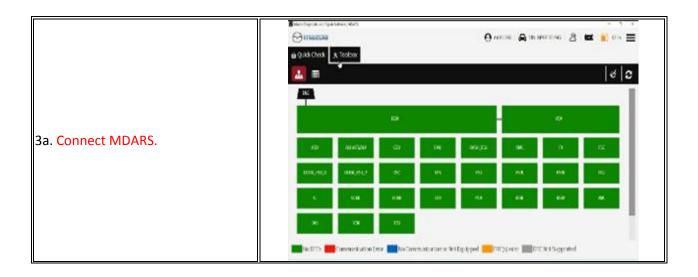
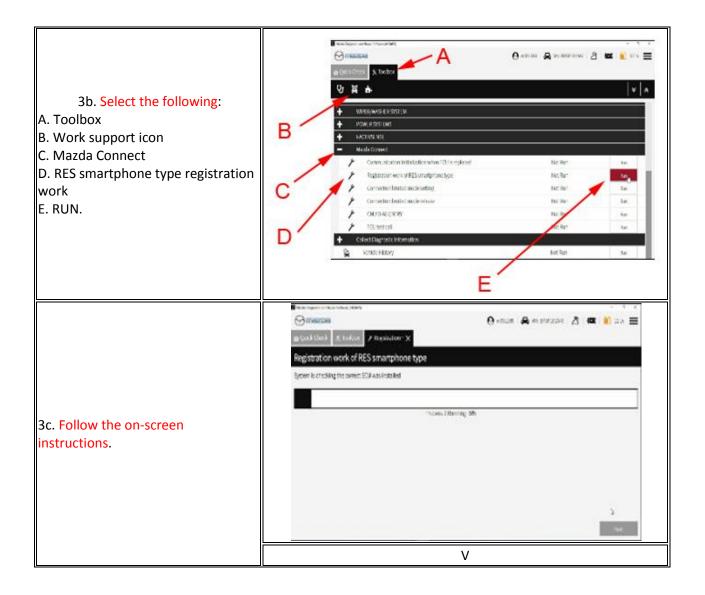
NOTE: If this is not performed, DTC U2050:55-TCU and/or U2050:55-BCM will be stored.

3. Perform "Activation Remote Control by Smart Phone"
