Technical Service Bulletin

Subject: REAR CONSOLE / CUP HOLDER WARMING	Bulletin No.: 09-020/20
	Last Issued: 05/01/2020

2016-2020 CX-9

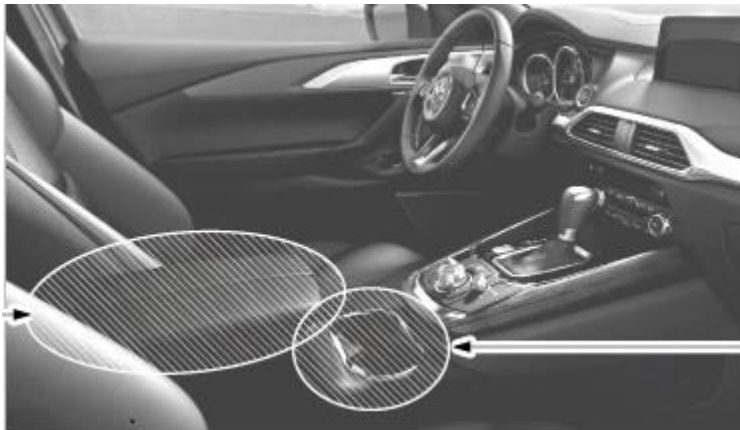
Some customers may complain that the rear console / cup holder area is warming.

The warming is caused by heat radiating from the rear heater core, which is located under the console. The warm air created by the heater core escapes through small gaps and carries heat along the inner walls of rear console / cup holder, causing an increase in temperature.

Customers having this concern should have their vehicle repaired using the following repair procedure.

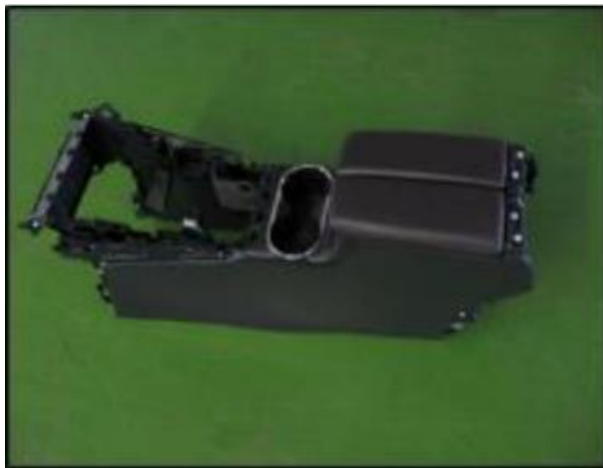
Rear Console Removed

1. Remove the rear console according to MGSS online (REAR CONSOLE REMOVAL/INSTALLATION).

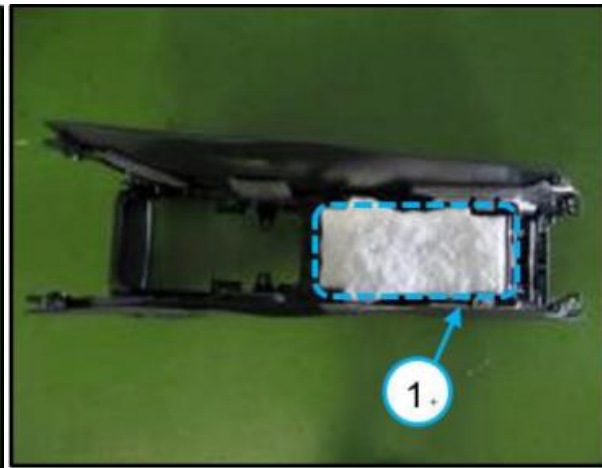
Rear Console Bottom, (1) White Insulator

2. Thoroughly remove all the white insulator (1) from the bottom of the rear console.

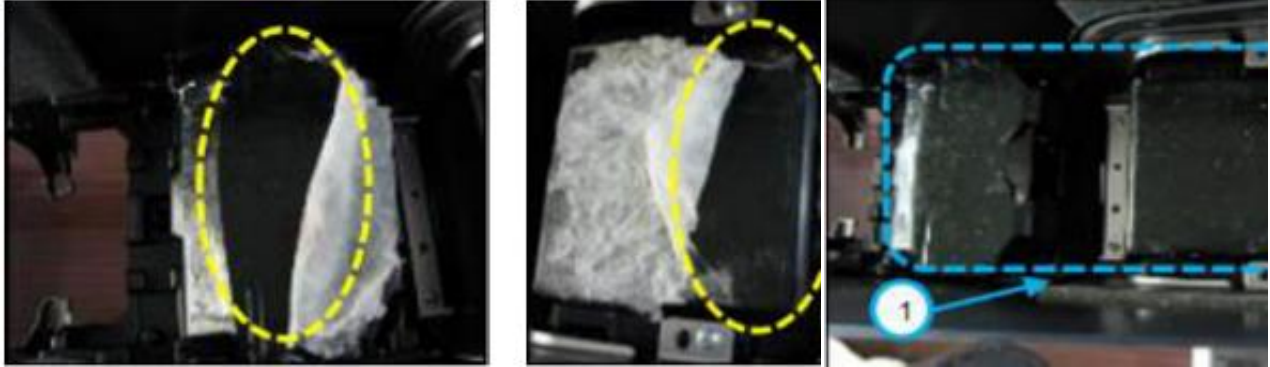
(1) After Insulator Removal

NOTE: Make sure there are no leftover pieces of insulator. Use parts cleaner to remove any stuck insulator remains.

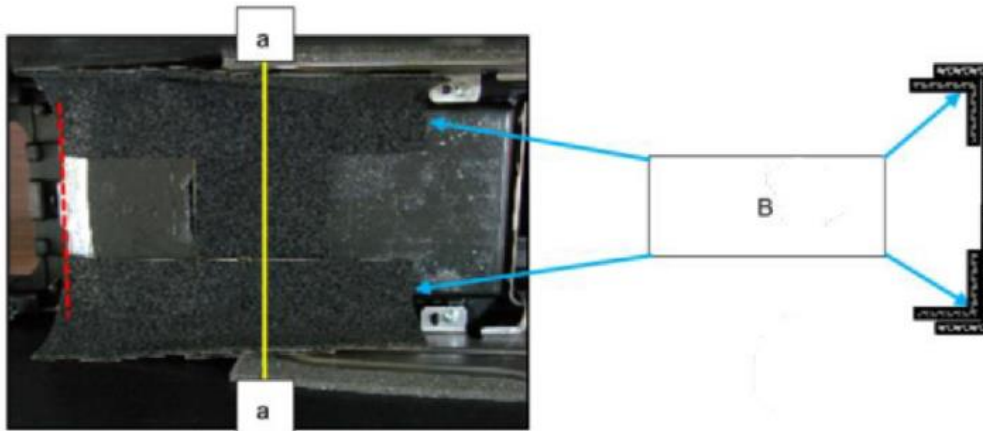
Adjust SEALs A to the border (red dotted line) on the left (A) Place SEALs A centered into the corners (B) Place SEALs A centered into the corners

5. Place the remaining two SEAL As over the first SEAL A placed there in Step 3. Place one seal on each side, begin gluing from the left edge.

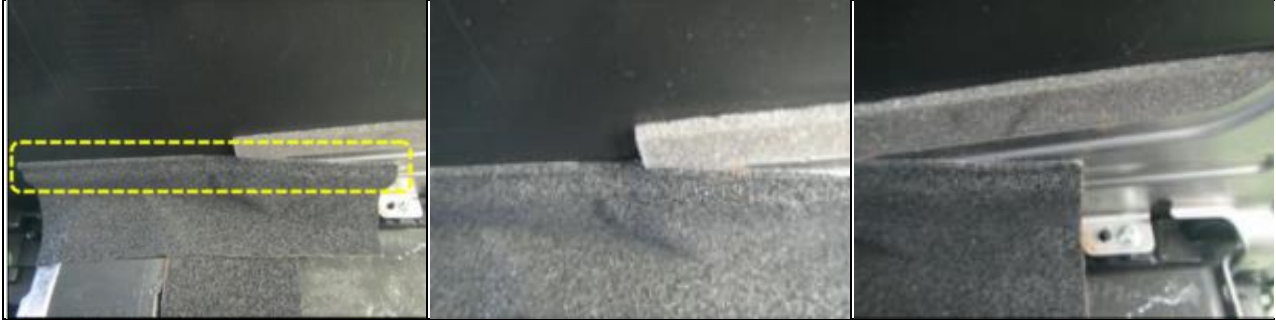
Step Between Side Cover
And Sponge Tape

Irregularities Of Console Bracket

NOTE: Carefully place each seal to completely eliminate any existing gaps (as shown below). Fit the seals into the irregular surfaces as well as possible.
