Service Alert

CONNECTED VEHICLE SYMPTOM TROUBLESHOOTING

Service Alert No.: SA-031/20

2020 Mazda3 2020 CX-30

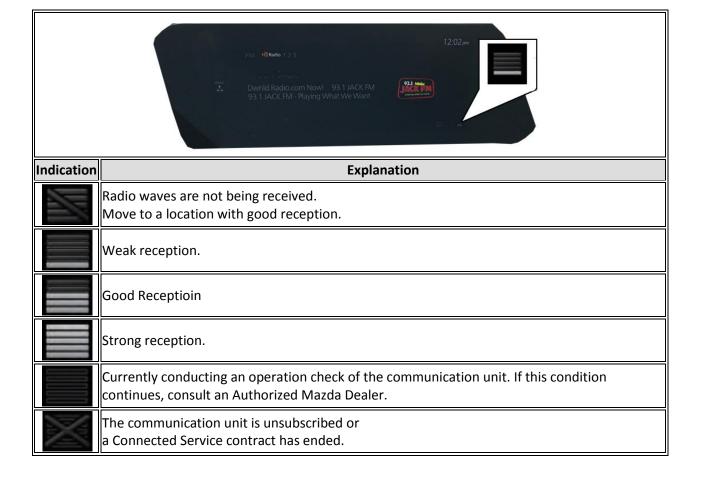
Confirm the customer's phone and vehicle have good to strong reception during the concern as shown in the table below.

- If the reception is weak, move the vehicle to a location where the reception is good to strong as shown in the table, then try to get the One Time Pass Code and/or operate the remote functions before proceeding to the Repair Procedure if there is still an issue.
- If the reception is good to strong, proceed to the Repair Procedure.
