Service Action

Code: 57H3

Subject	e-tron Service Package														
Release Date	May 20, 2020														
Revision Summary	Coolant claiming part number updated Customer letters updated														
Affected Vehicles

Subject: Service Action – e-tron Service Package

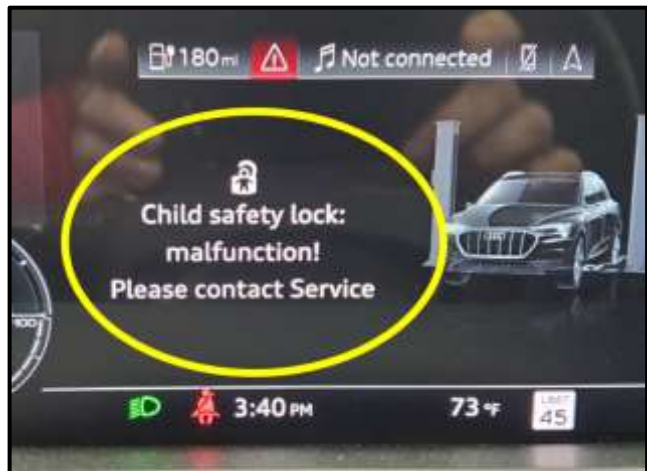
After completing the SVM code, there may be a warning in the instrument panel as shown. Cycling the ignition, then operating the child door lock buttons from the driver's door then opening and closing the doors should eliminate the warning.

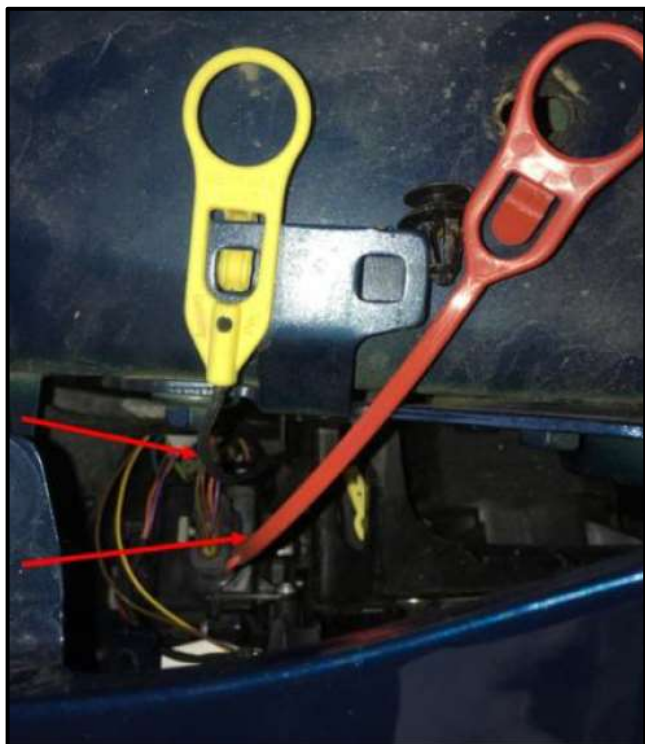
This photo shows the release mechanism properly installed.

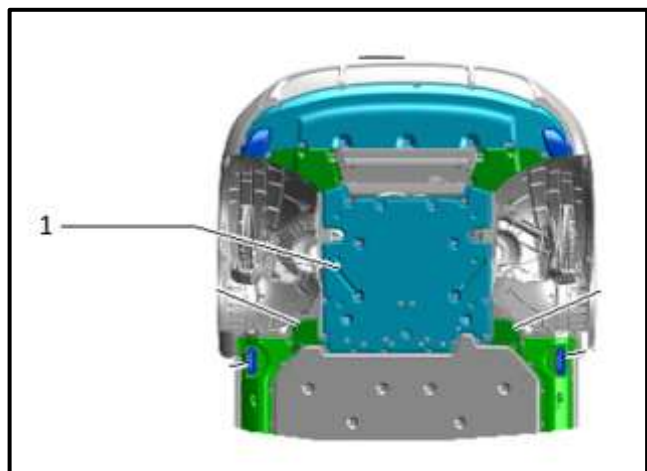
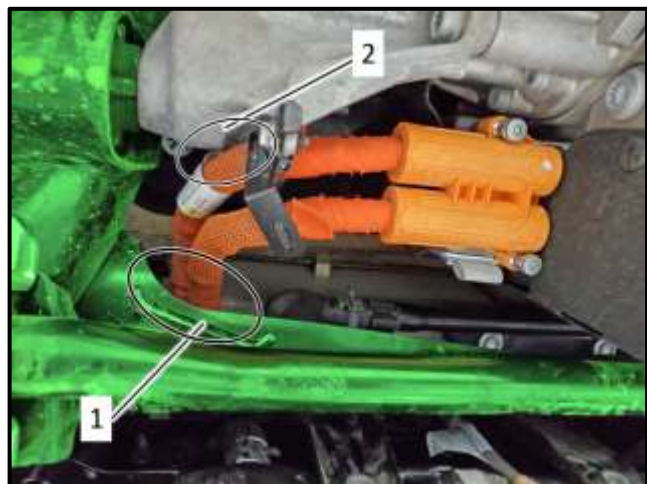
Criteria 09 – Service High-voltage Cable

- Remove rear underbody trim panel <1>.
- Visually inspect the high-voltage cable to the rear electric drive.
 - The cable must not be in contact with the subframe <1> or rear electric drive unit <2>.

- Torque other bolts to 2 Nm.
- If the high-voltage cable is making contact with either component and only the outer woven aramid covering is damaged:
 - The high-voltage cable requires aligning.

- If the high-voltage cable is not making contact:
 - No further work is required.
 - Re-install underbody trim panel in the reverse order of removal.
 - Torque M6 bolts to 8 Nm.

- Proceed to repair step “**Aligning high-voltage cable**”.
- If the inner insulation is damaged:
 - The high-voltage cable must be replaced.
 - See ELSA Repair Manual: *Repair manual > Motor > Electric Drive Motor 0EF > 93 Electric drive > High-Voltage Cables > Drive Motor High-Voltage Wiring Harness, Removing and Installing > Rear Motor High-Voltage Cable Set, Removing and Installing*

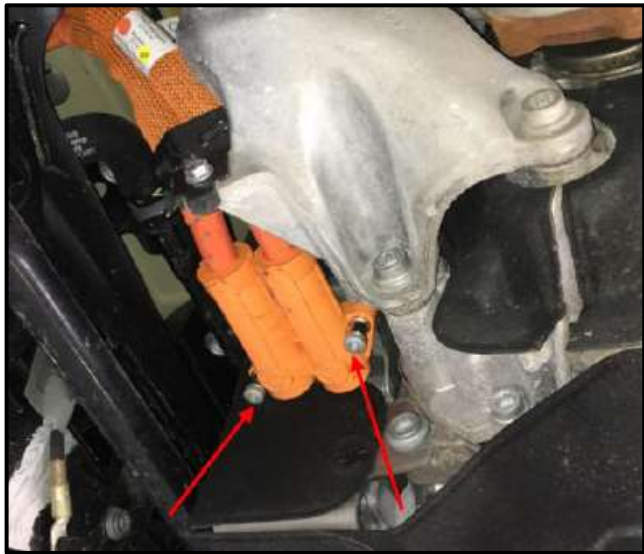
- If the high-voltage cable is still making contact:
- De-energize the high-voltage system.

- See ELSA Repair Manual: *Repair manual > Motor > Electric Drive Motor 0EF > 93 Electric drive > High-Voltage System, De-Energizing*
- Remove bolts <arrows>.
- Unplug connector.
