Service Alert

Subject: ENGINE NO START / NO CRANK WITH DTC P0615:12 AND/OR B112A:12 STORED	Service Alert No.: SA-051/20
	Last Issued: 05/11/2020

2017-2020 CX-5

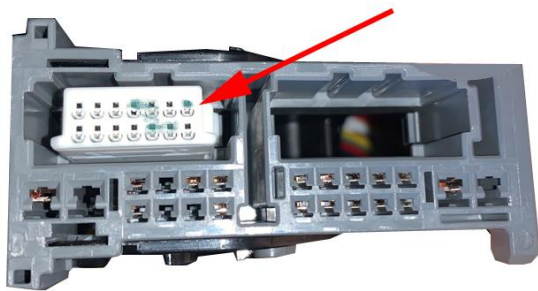
This may be caused by water contamination/corrosion at electrical connector C-04 due to:

- Windshield tint installation:
 - Windshield tint installed to block UV light. The water used during the installation of the tint may run down behind the dashboard. Carefully inspect the windshield to see if window tint has been installed or not. Some window tint film appears clear and is for UV light only.
- Windshield repair/replacement:
 - Poor windshield sealing during installation can cause an internal water leak. Water may run down behind the dashboard.

1. Verify customer concern.
2. Inspect electrical connector C-04 for water contamination/corrosion. Is water corrosion present?
 - Yes - Repair or replace connector C-04.
 - No - This service information does not apply. Go to MGSS:
 - DTC P0615:12 [START STOP UNIT]
 - DTC B112A:12 [START STOP UNIT]
3. Verify repair.
