Technical Service Bulletin

Topic	New Flying Spur - Flying "B" Mascot
Market area	Bentley: worldwide (2WBE)
Brand	Bentley
Transaction No.	2058354/2
Level	EH
Status	Released for publishing
Release date	May 4, 2020

New Flying Spur

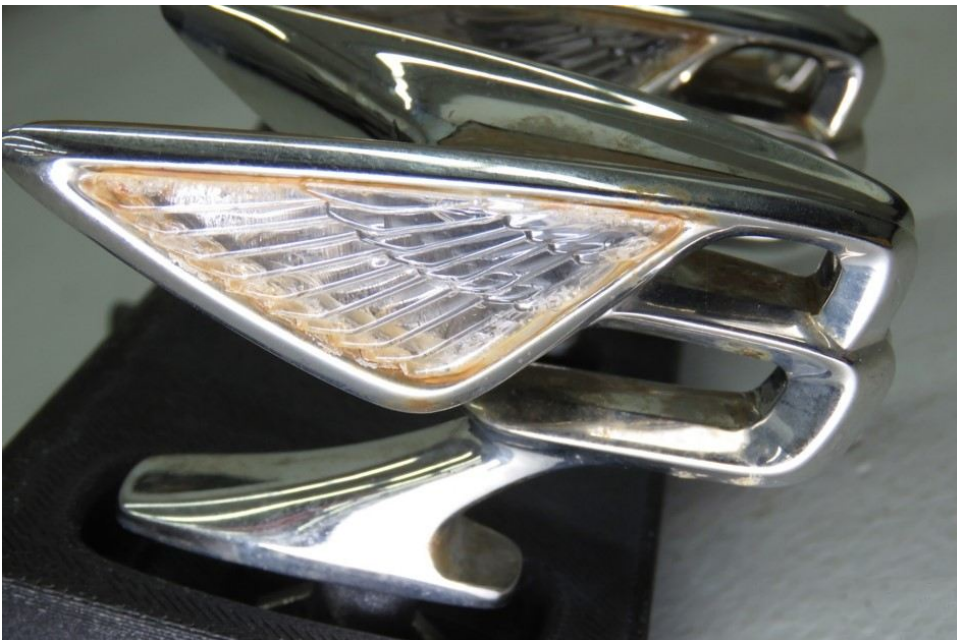
Figure 1

Corrosion – Damage codes 0001 and 0002

Description	Damage Code	Solution	Information
Corrosion beneath "clear" section of Flying "B" wings.	0001	Replace Flying "B" elevating assembly.	Figure 1.
Corrosion on edges of Flying "B" wings.	0002	Remove corrosion using metal polish. If corrosion cannot be removed successfully or there is a repeat complaint of corrosion, replace Flying "B" elevating assembly.	Figure 2. Care must be taken not to damage paint on Radiator Shell.
Functionality Slow operation / vibrates / fail to deploy / fail to stow / bounces back.	0017	Apply "Tri-Flow" lubricant. If the concern is still present after applying the lubricant, raise a DISS query and seek advice.	Figure 5. <i>See Functionality – Damage Codes 0017 and 0020 below.</i>
Functionality Noise during operation.	0020	Apply "Tri-Flow" lubricant. If the concern is still present after applying the lubricant, raise a DISS query and seek advice.	Figure 5. <i>See Functionality – Damage Codes 0017 and 0020 below.</i>

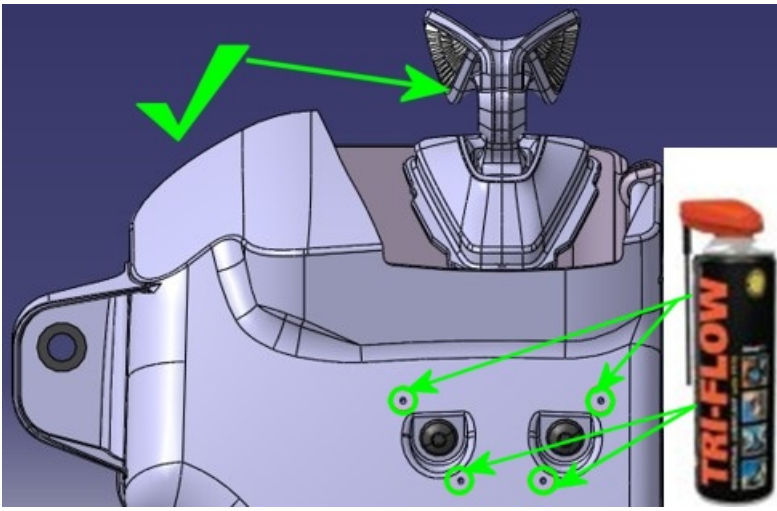
Functionality – Damage codes 0017 and 0020

Referring to Figure 5 - Ensuring the Flying “B” is revealed - Using the precision spray nozzle, lubricate the Flying “B” mechanism, apply “Tri-Flow” industrial lubricant into the four holes shown, the lubricant should be dispensed for two seconds at each location – Figure 5.

Conceal and reveal the Flying "B" five times to distribute the lubricant.

Remove any excess lubricant with a clean dry wipe.

If the complaint is still present, conceal the Flying "B" and repeat the lubrication process.

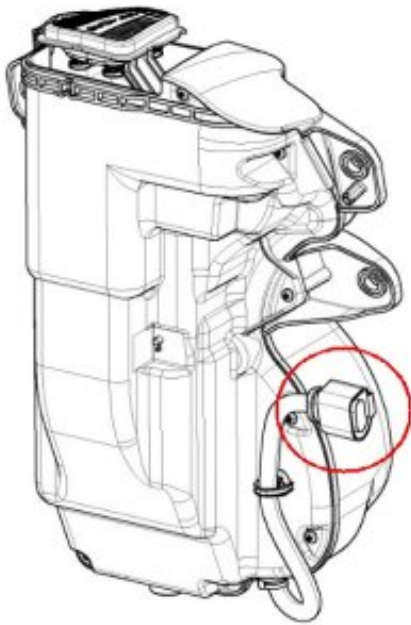
Figure 6

Electrical fault – Damage code 0040

Surface Finish Surface - visual damage.	0030	Remove light surface damage using metal polish – if damage cannot be successfully removed replace Flying "B" elevating assembly.	Care must be taken not to damage paint on Radiator Shell.
Electrical fault - fail to deploy / fail to stow, wings do not illuminate or "flicker" when illuminated.	0040	If Diagnostic Trouble codes are stored in 8108 – Control Unit For Hood Ornament -follow <i>Guided Fault Finding</i> paths to determine root cause. Check condition of electrical connector and connections. If no fault found replace Flying "B" elevating assembly.	Figure 6.

Check condition of electrical connector and connections – Figure 6.

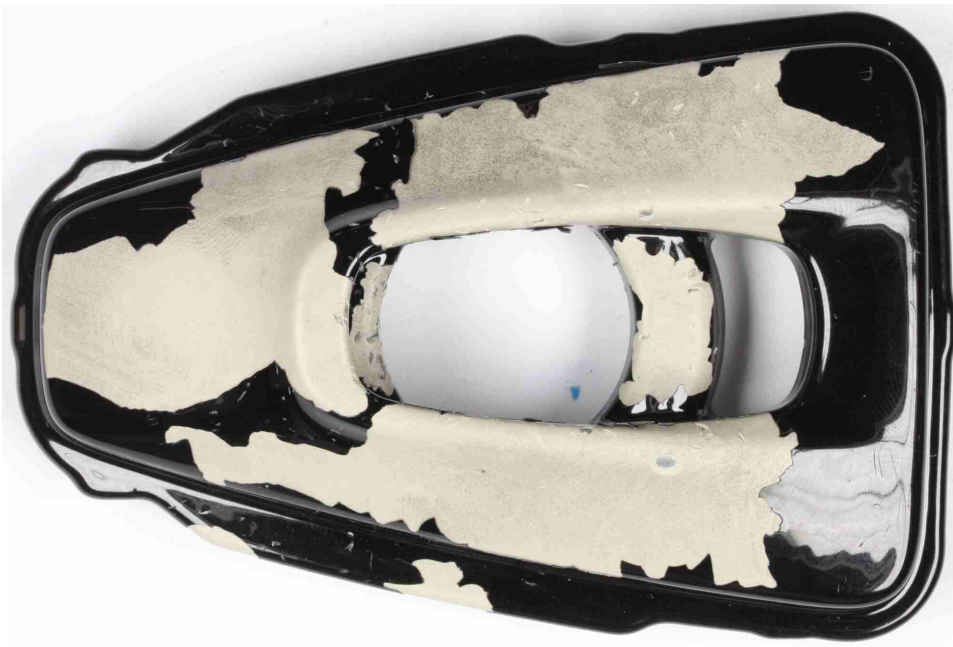
Figure 7

Paint – Damage code 0067

Surface Finish – black painted variant. Insufficient paint adhesion.	0067	Replace Flying “B” elevating assembly.	Figure 7. Black variant only.
Surface Finish – Polished variant. Polishing marks.	0072	Remove using metal polish - if marks cannot be removed replace Flying “B” elevating assembly.	Care must be taken not to damage paint on Radiator Shell.
Surface Finish – Polished and black painted variants. Surface Scratch Pre Delivery Inspection (PDI) only	0080	Remove using metal or paint polish – For PDI only - if scratch cannot be removed replace Flying “B” elevating assembly.	Care must be taken not to damage paint on Radiator Shell.
Surface Finish – Black painted variant. Inclusions within paint.	0084	Replace Flying “B” elevating assembly.	Black variant only.
Surface Finish – Polished variant. Sanding marks / grooves.	0086	Replace Flying “B” elevating assembly.
