## Technical Service Bulletin

20-ST-002H

Elantra ADa

STEERING COLUMN & HOUSING NOISE

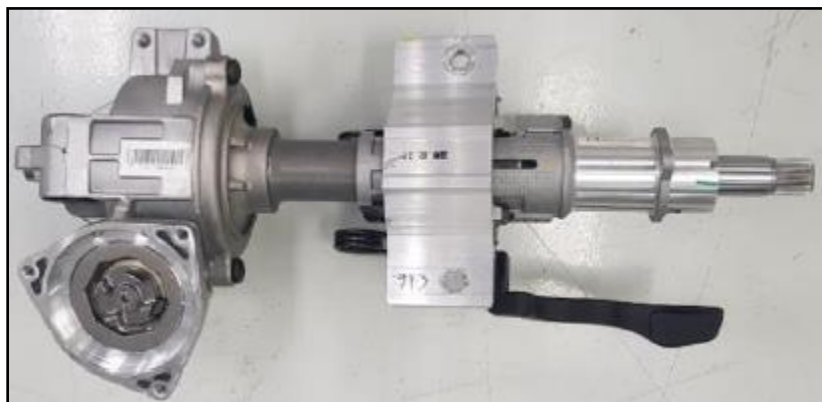
**Description:** A bearing noise may develop within the Motor Driven Power Steering (MDPS) column of the housing worm gear assembly. If bearing noise is heard, follow the procedure in this bulletin and if necessary, replace the steering column and housing.

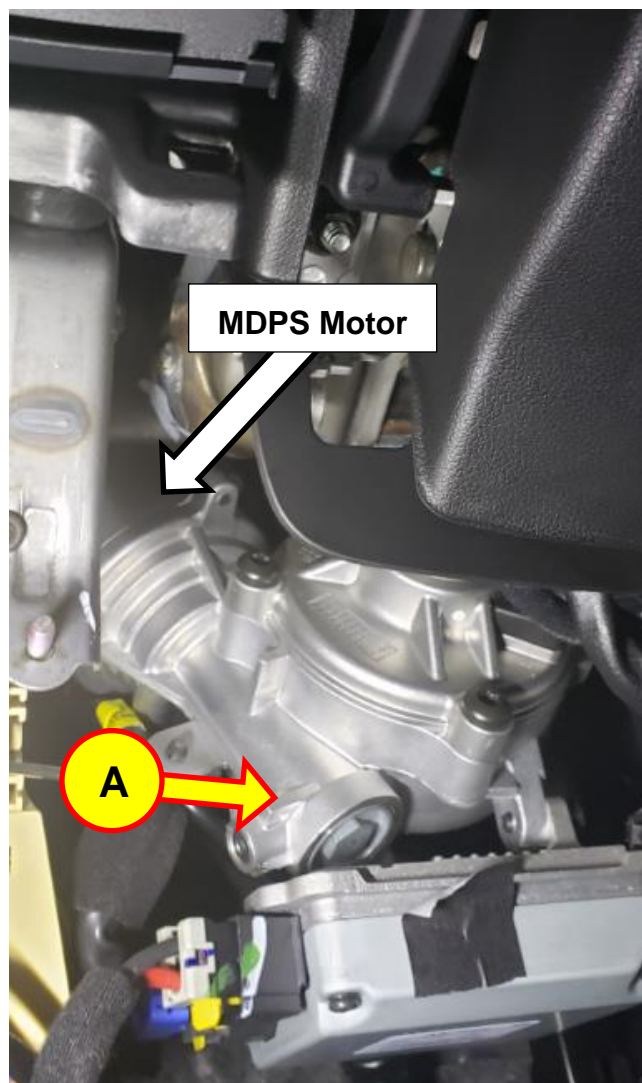
- How to determine MDPS column and housing bearing noise:
  - Start the engine and turn the steering wheel left and right.
  - Listen for the bearing noise occurring from the worm gear housing (A). This noise will be located near the MDPS motor on the steering column.
  - To hear an example of the bearing noise, refer to the link below.  
<https://youtu.be/ZCxFSskN-Rg>
- Replace the column and housing if the bearing noise is heard.

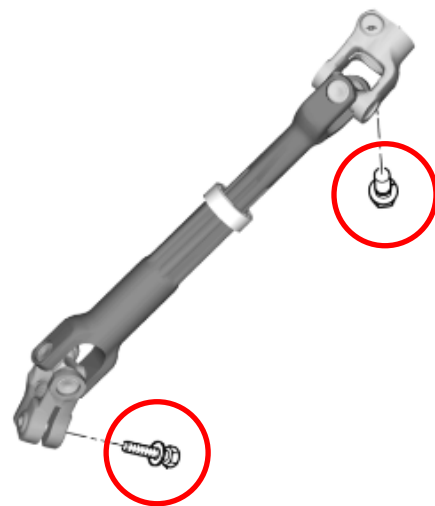
If the pinch bolts on either ends of the steering universal joint assembly are removed, the bolts **cannot** be reused during reassembly.
