HYUNDAI Technical Service Bulletin	GROUP CAMPAIGN	NUMBER 20-01-022H
	DATE MAY, 2020	MODEL(S) NEXO (FE) PALISADE (LX2)
SUBJECT: POWER TAILGATE SPINDLE WIRE HARNESS INSPECTION/REVISION (SERVICE CAMPAIGN T4X)

Description: Some 2019-2020 Nexo (FE), and 2020 Palisade (LX2) vehicles equipped with the power tailgate may not operate. This bulletin provides the service procedure to inspect and when necessary perform the power tailgate spindle wire harness revision.

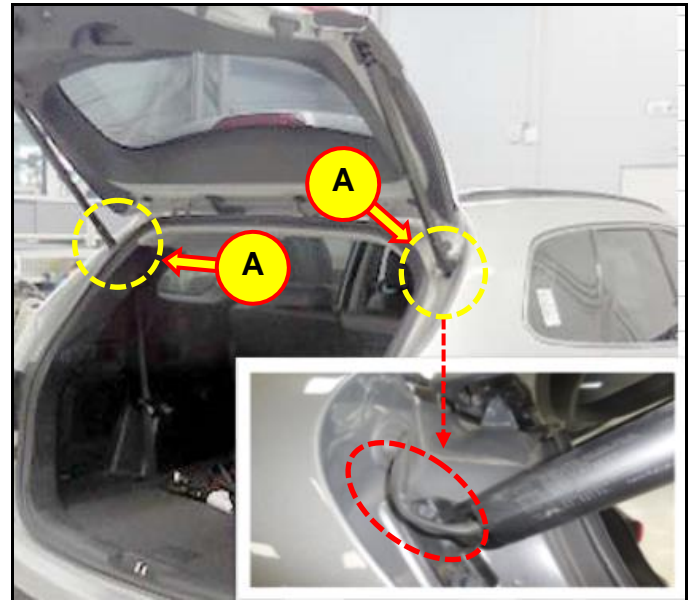
1. Open the tailgate to inspect the LH/RH power tailgate spindle wiring harness (A).

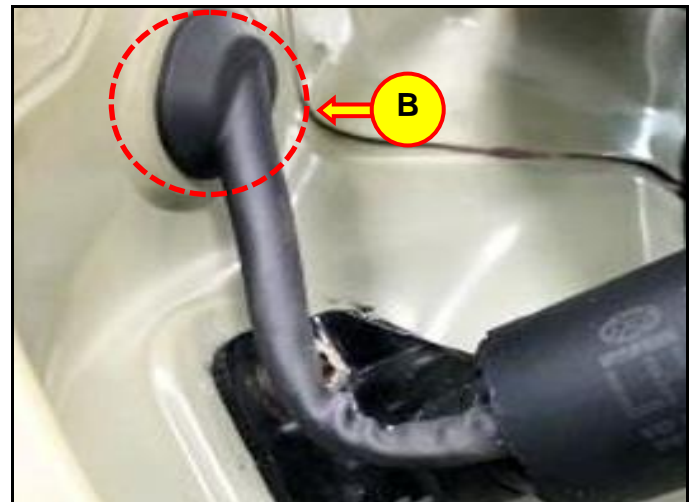
2. Remove the rubber grommet (B) of the tailgate spindle wiring harness and inspect the material.

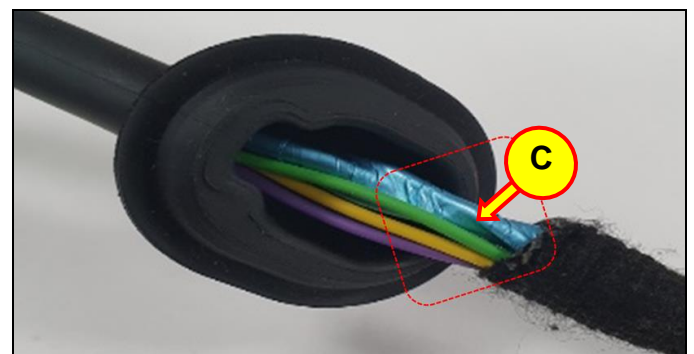
If the wire harness has a metallic shield (C), no further action is required.

If the wire harness shield does not have the metallic shield, perform the power tailgate spindle wire harness enhancement on page 4.

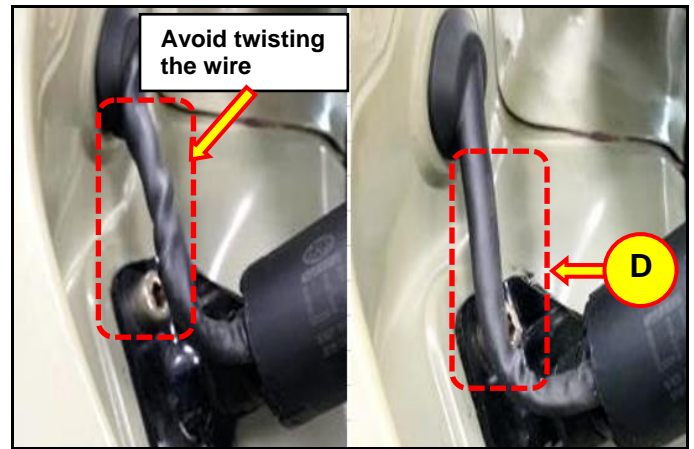
*After inspecting the power tailgate spindle wire harness, **reinstall and ensure the wire harness is not twisted (D) as shown in the picture to the right.***

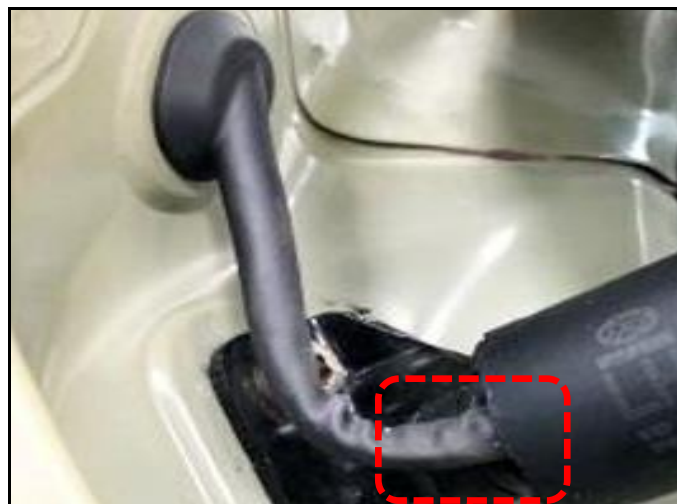
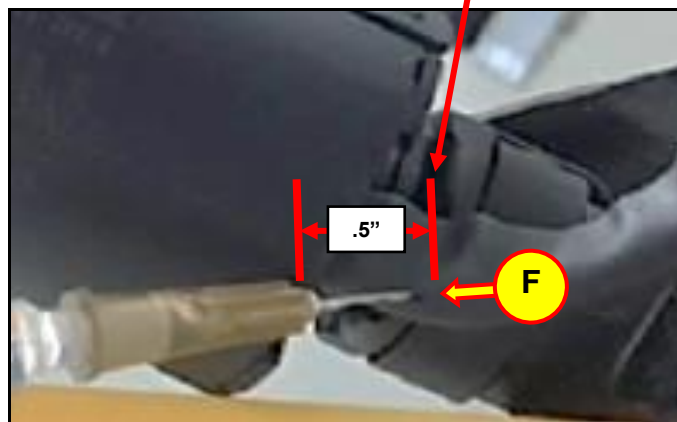
- Carefully insert the syringe into the spindle wire harness sleeve approximately .5 inches away from the spindle (F). Inject 0.2ml of Loctite 401 into one side of the spindle wire harness, and the remaining 0.2ml into the other side.

Be careful not to pierce the wire. Inject the Loctite 401 into the wire harness sleeve only.
