GROUP	NUMBER	
	AUTOMATIC TRANSMISSION	20-AT-017H	
ΗΥΠΠΑΙ	DATE	MODEL	
Technical Service Bulletin	MAY, 2020	Accent (RB), Azera (TG/HG), Elantra (UD/MD/GD/JK), Santa Fe (CM/AN/NC), Sonata (YF/YF HEV, LF/LF HEV/PHEV), Tucson (LM/TL), Veloster Turbo (FS)	
SUBJECT: AUTOMATIC TRANSMISSION DTC P0880/P088000

# SUBJECT: AUTOMATIC TRANSMISSION DTC P0880/P088000

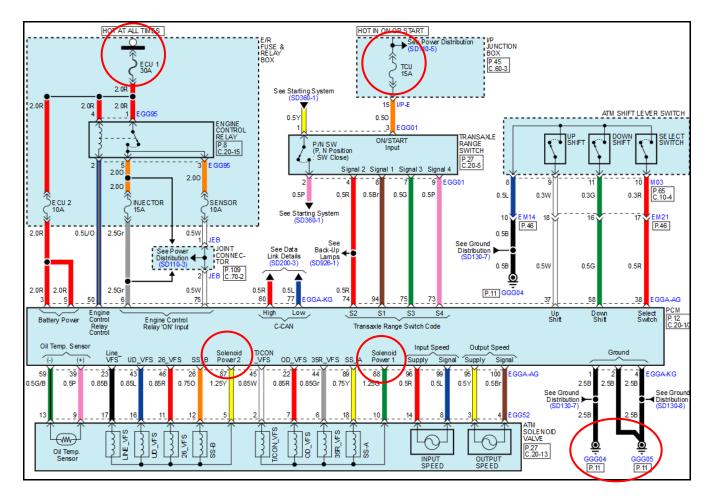
**ETM INFORMATION:** Example only – refer to the related shop manual

**P0880/P088000** is set when solenoid power voltage is lower than 7v or higher than 22v. **Possible Causes:** Poor connection/circuit fault or faulty PCM.
