HYUNDAI Technical Service Bulletin	GROUP Body	NUMBER 20-BD-010H-1
	DATE May, 2020	MODEL(S) Accent (RB), Accent (HC) Elantra (MD/UD), Azera (HG), Sonata (LF/LFa), Sonata Hybrid (LF HEV),
SUBJECT: TRUNK LATCH BASE REPLACEMENT

Description: The trunk latch base can be ordered separately from the trunk latch assembly. This bulletin describes the procedure to replace the trunk latch base.

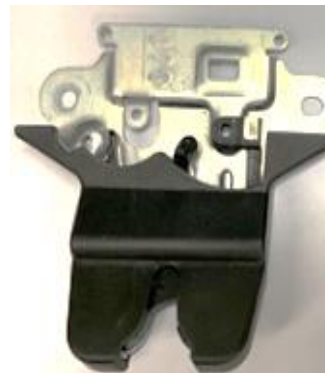
When reusing the actuator, do not contaminate the motor area.

3. Replace the trunk lid latch base and reuse the actuator.
