SERVICE BULLETIN

BT18-008a

NTB18-042a

2018-2020 LEAF; FRONT DOOR WILL NOT OPEN

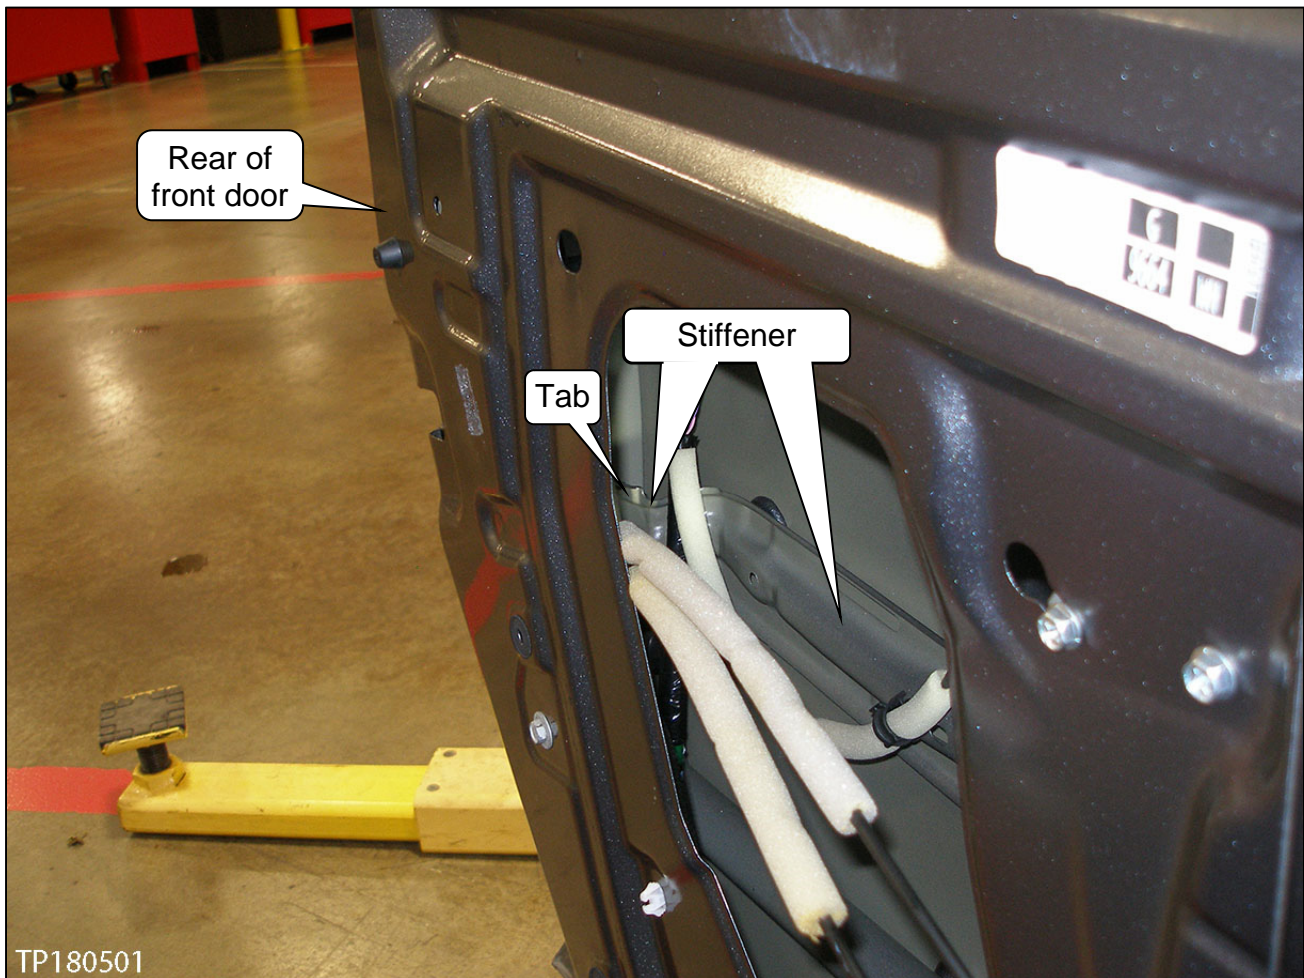
1. Remove the front door finisher of the affected door.
 - Refer to the Electronic Service Manual (ESM), section **BODY INTERIOR > INTERIOR > REMOVAL AND INSTALLATION > FRONT DOOR FINISHER** for front door finisher removal.
- NOTE:** It may be intermittent that the door will not open. Attempt to open the door multiple times with both handles. If the door does not open normally, follow normal repair procedures for consequential damage during front door finisher removal.
2. Connect the power window switch, and then close (roll up) the door glass.
 3. Access the tab stiffener and door latch lever.
 - Refer to Figure 1 below, and Figure 2 on the next page.

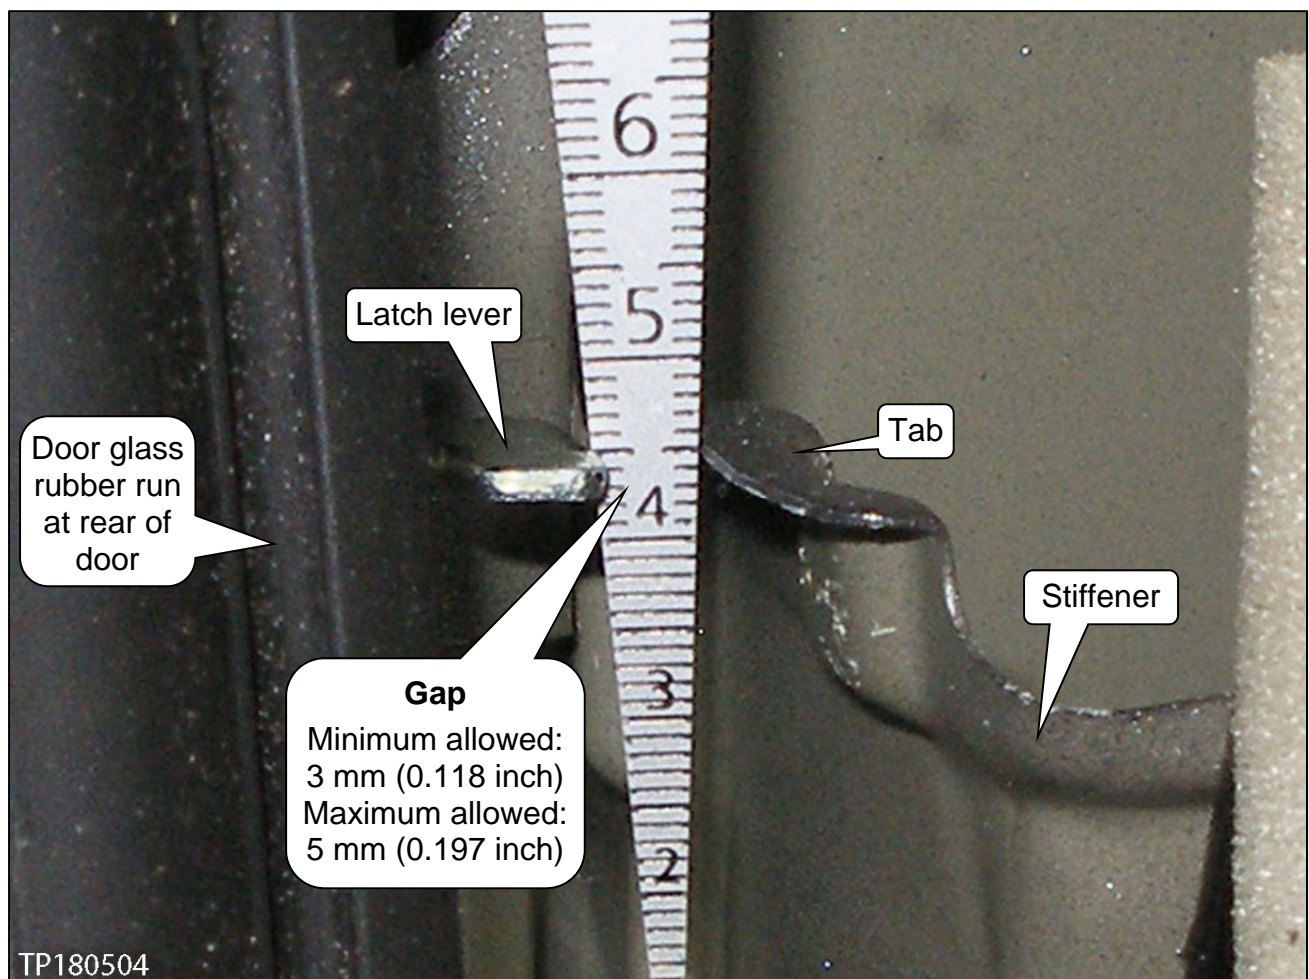
Figure 2

5. With the lever and stiffener tab still level with each other, inspect the gap between the latch lever and stiffener tab.

- Lever-to-door stiffener gap:

Minimum 3 mm (0.118 inch), maximum 5 mm (0.197 inch)
