2019FA08, Rev. D  
May 28, 2020  
Product Code(s): 65, 66  
Page 1 of 18

SUBJECT: Special Coverage for TIDB Aluminum Main Valve Body – Proactive

MODELS AFFECTED: 3000 Series™, 4000 Series™, B200™, B300™, B3400 xFE™, B400™, B500™, T200™, T300™, T400™, T500™ Models

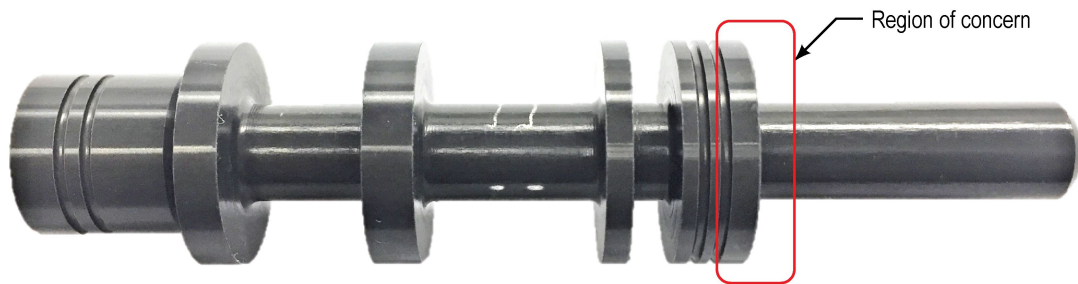
**Figure 1.**

**NOTE:** Closely inspect the Main Regulator Valve P/N 29563501 for the presence of a manufacturing burr shown in [Figure 1](#) and [Figure 2](#) below. See [SIL 01-WT-20](#) for additional clarification.
