Bulletin No.: PIC6396A
Published date: 05/11/2020

PIC6396A Towing Recovery Eyelet Found In Rear Compartment During PDI

Brand:	Model:	Model Years:	VIN:		Engine:	Transmissions:
			from	to		
Buick	Encore GX	2020	All	All	All	All

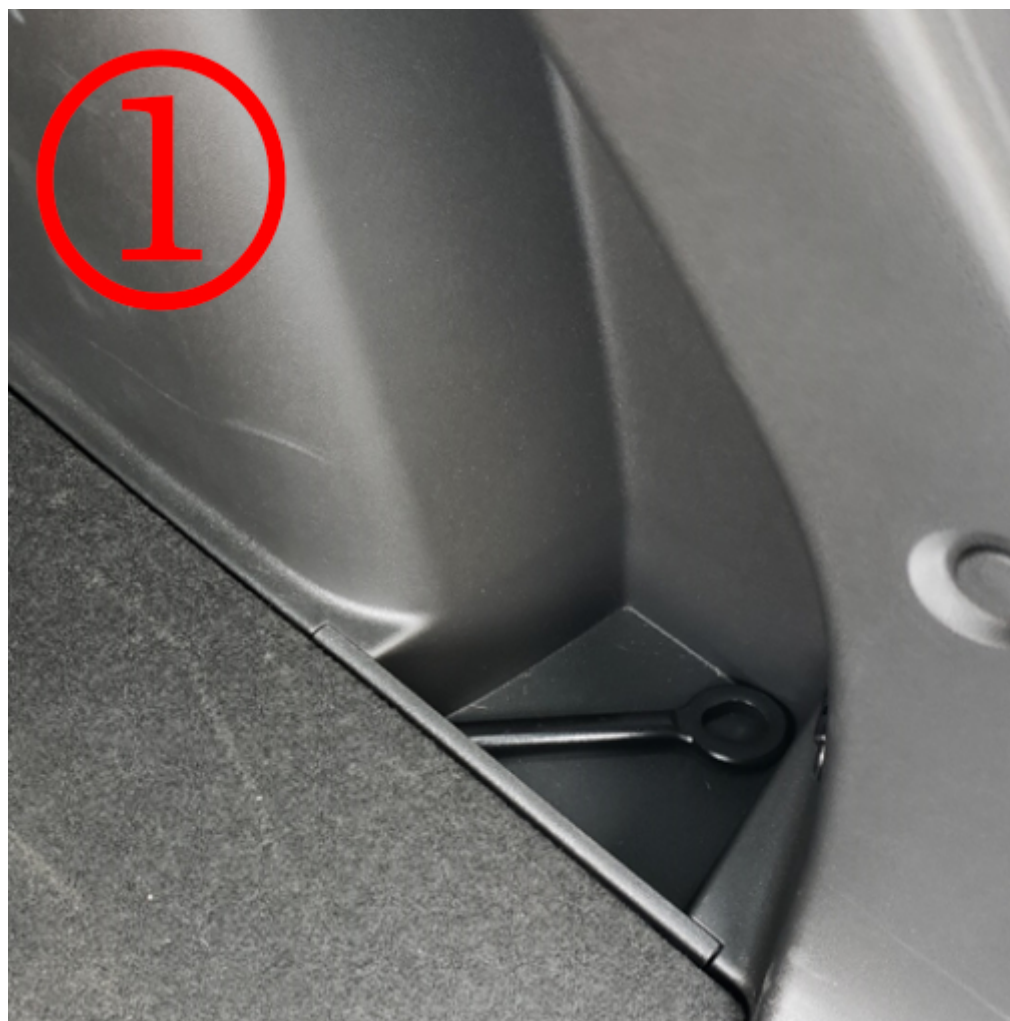
Involved Region or Country	North America
Condition	Dealers might find a towing recovery eyelet in the right side rear compartment bin during PDI.
Cause	Towing recovery eyelet is placed in this location (1) after it arrives at the port.

Remove the eyelet from the right side rear bin and place it into the foam holder with the jack tools under the cargo floor, refer to pictures below.

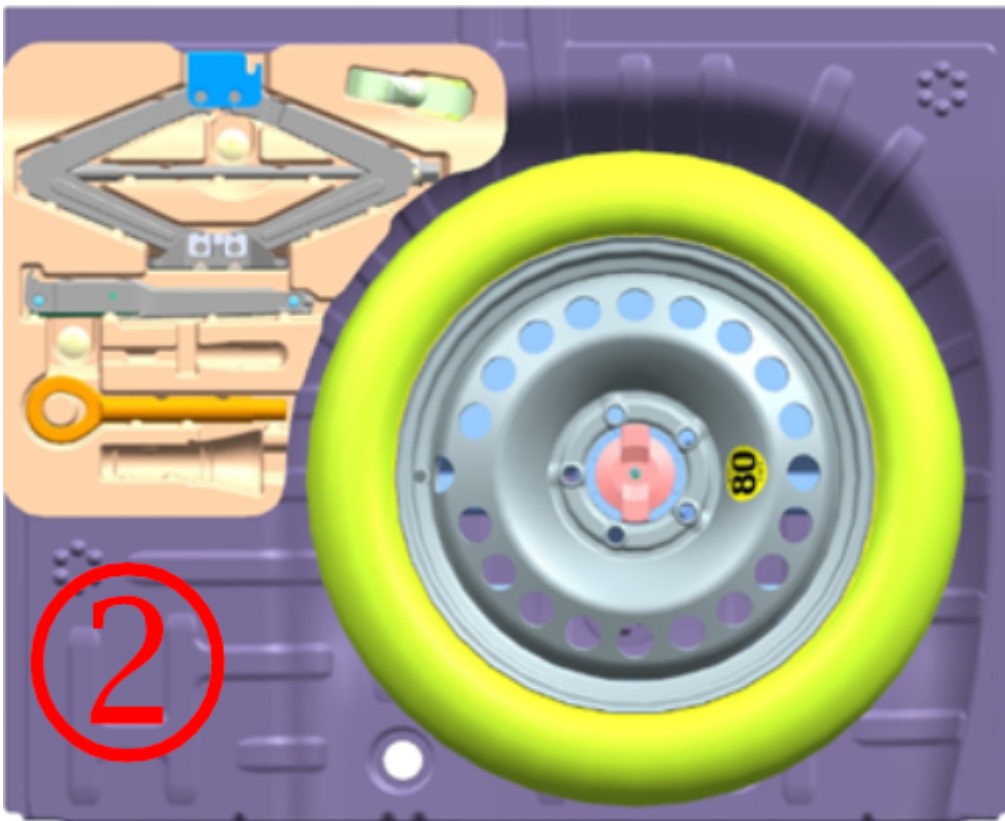
Bose Audio stow beside spare tire

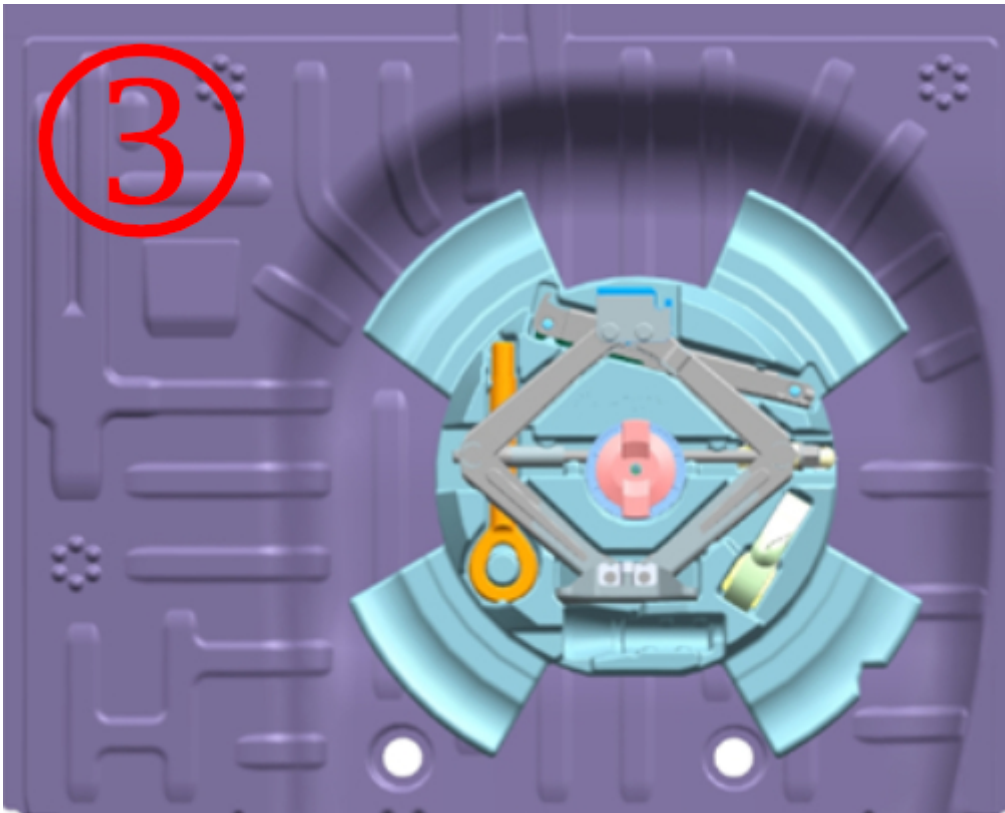
Non-Bose Audio stow under spare tire
